ADDENDUM NUMBER II
MACKENZIE STREAM CATALOGUE
TO
BASE DATA REPORT
SECTION D - MACKENZIE HIGHWAY
MILES 715 TO 936

October 1974

DEPARTMENT OF PUBLIC WORKS OF CANADA
EDMONTON, CANADA

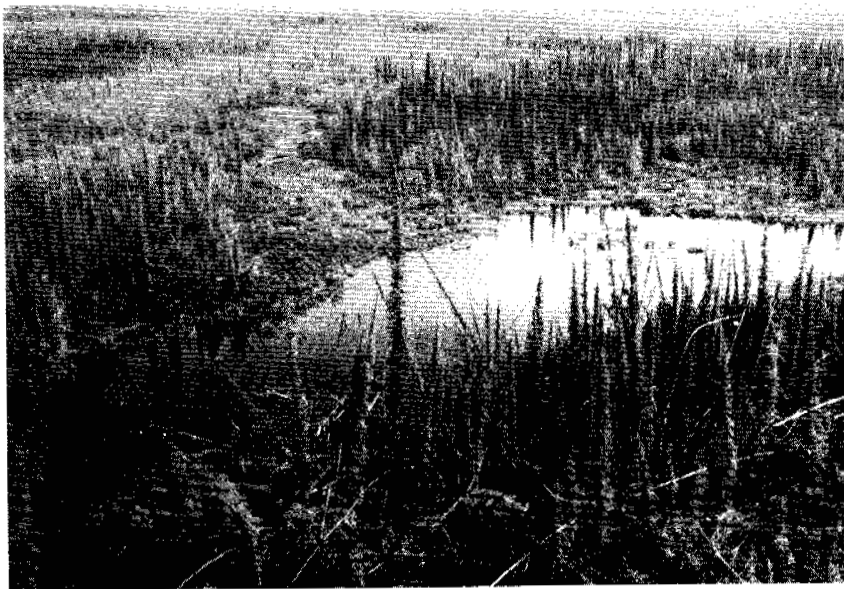
STREAM 1.158 (JACKFISH CREEK) - UPSTREAM

STREAM 1.158 (JACKFISH CREEK) - DOWNSTREAM

No fish but looks good.

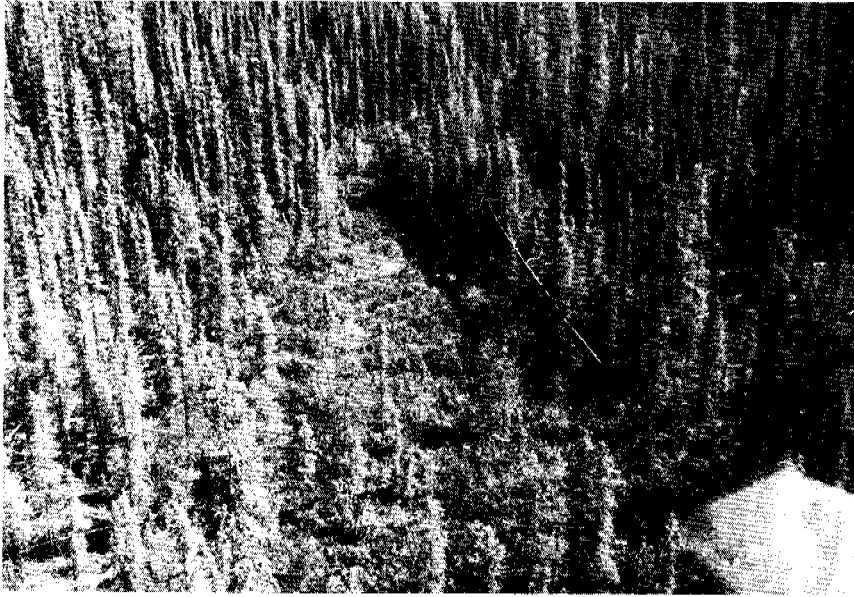
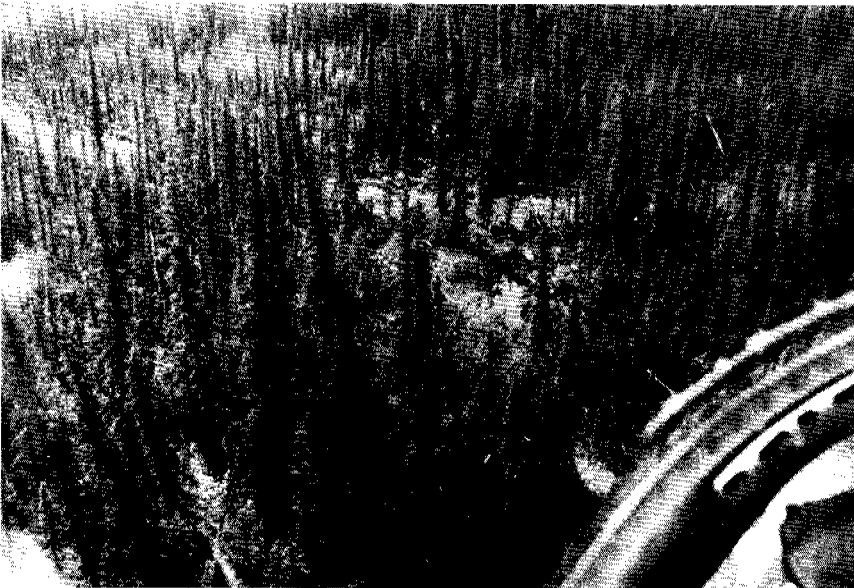
STREAM 1.152 - UPSTREAM

STREAM 1.152 - DOWNSTREAM

Comments: This stream appeared to be excellent grayling fry
habitat. Numerous caddis flies and crustaceans were
observed. The pool-riffle ratio was about 75:25.

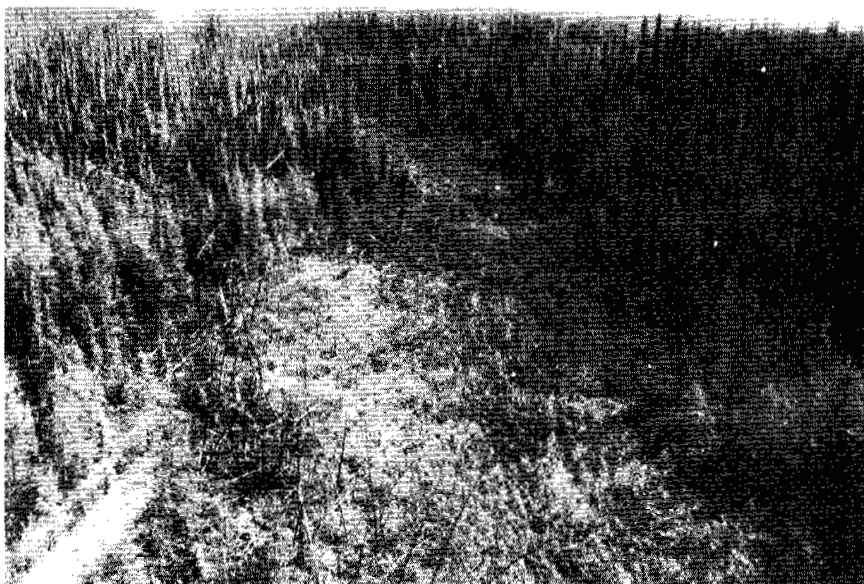
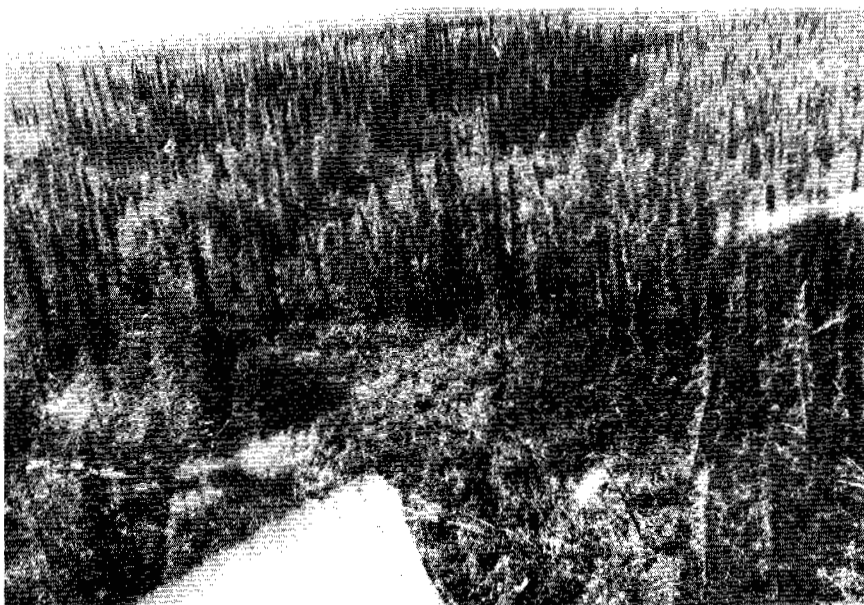
STREAM 1.148.01.02 - UPSTREAM

STREAM 1.148.01.02 - DOWNSTREAM

Comments: At the time of sampling this stream was in flood. The
flow was through grass and sedge. The stream is probably
poor fish habitat when flood waters subside.

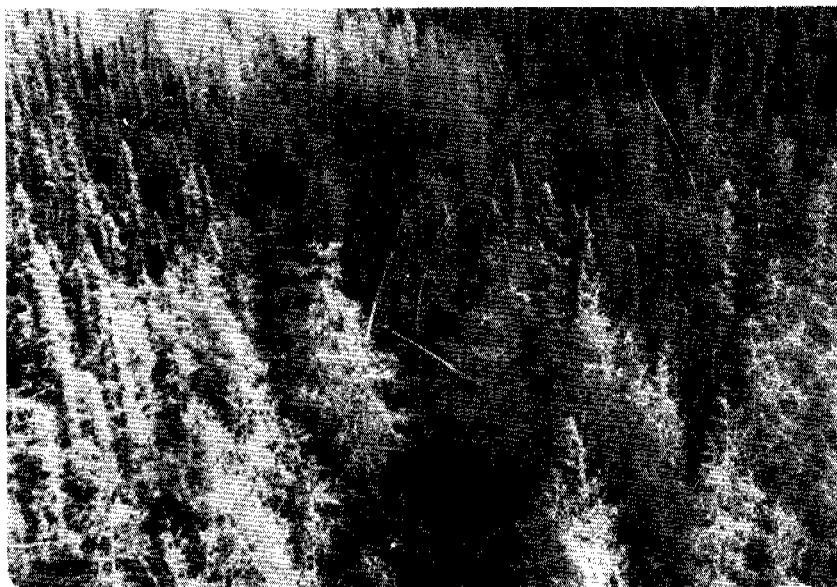
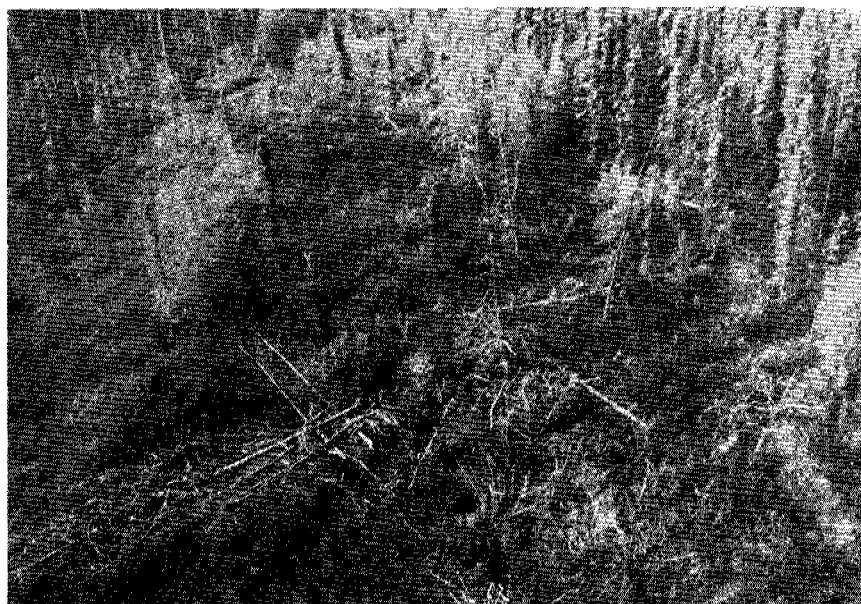
STREAM 1.140.01 - UPSTREAM

STREAM 1.140.01 - DOWNSTREAM

Comments: This creek drains from lakes 2 - 4 miles east of Eagle Falls.
There was a very steep section below the crossing site
which would block fish passage from the Mackenzie River
upstream.

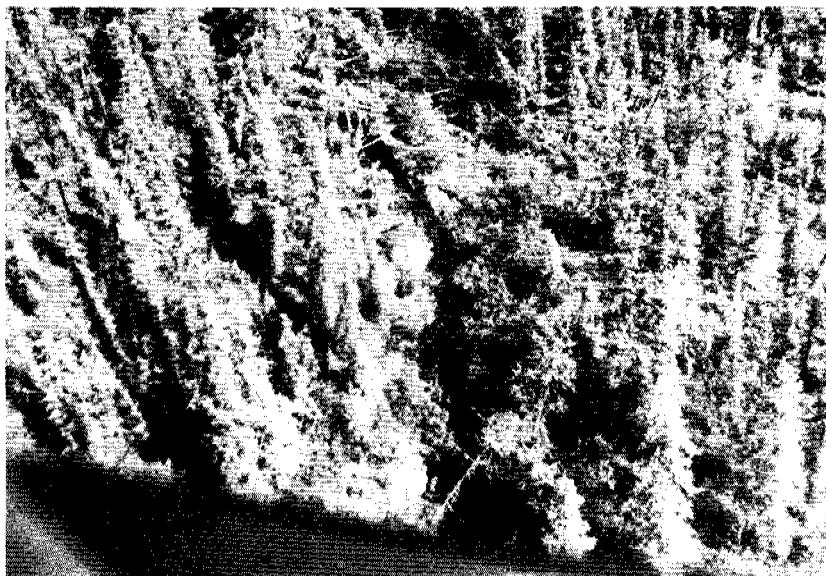
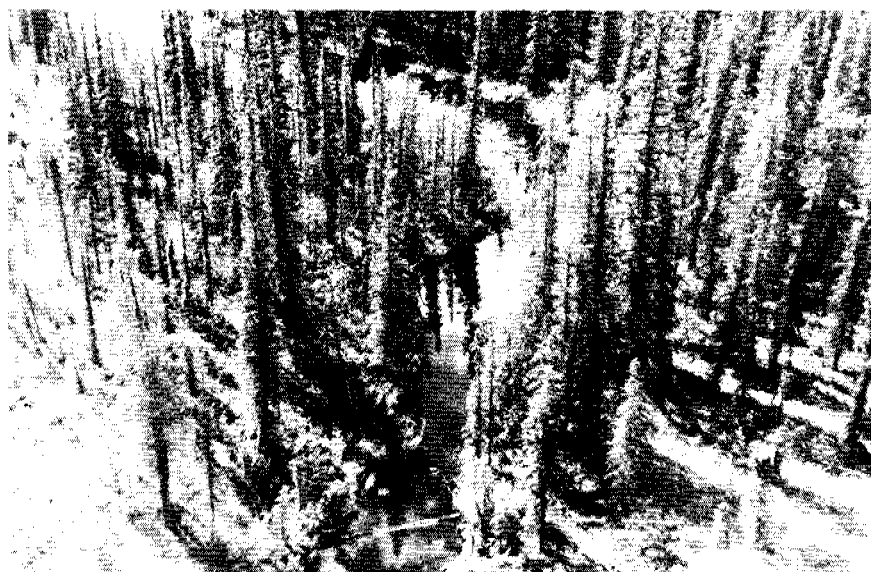
STREAM 1.128 - UPSTREAM

STREAM 1.128 - DOWNSTREAM

Comments: Although this stream appeared to be good fish habitat,
none were observed. Below the crossing site there was
a large marsh area which may block fish movement.

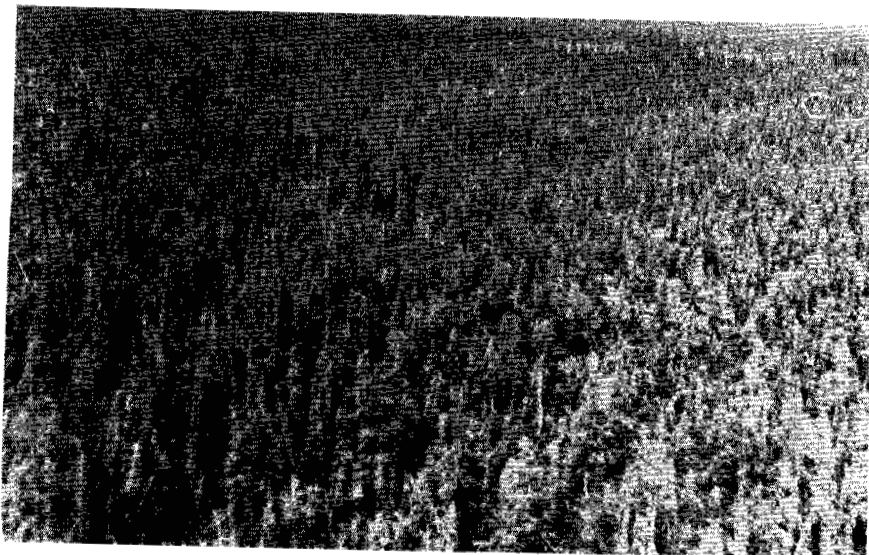
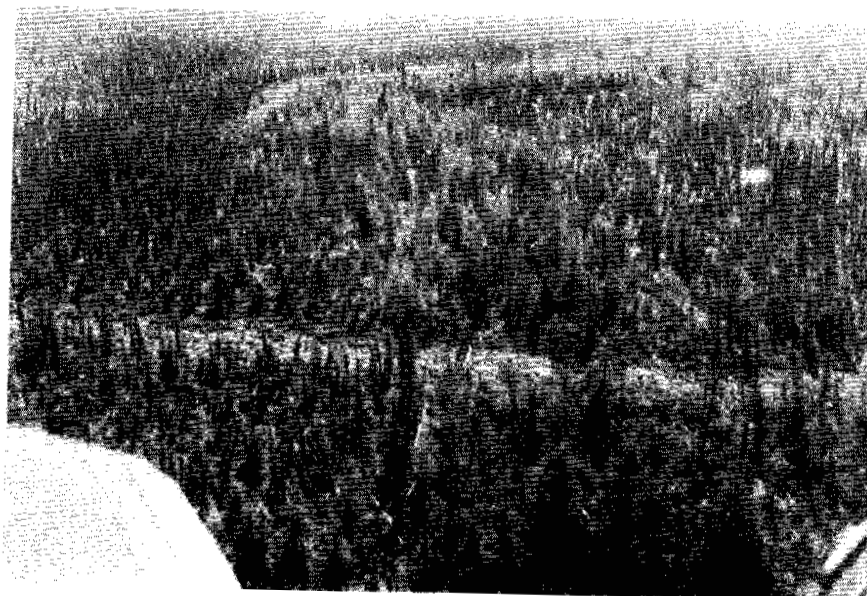
STREAM 1.128.04 - UPSTREAM

STREAM 1.128.04 - DOWNSTREAM

Comments: At crossing site this stream was only a marsh but 1/4 mile
downstream it became a gravel-bottomed watercourse. Fish
may be present in the downstream section.

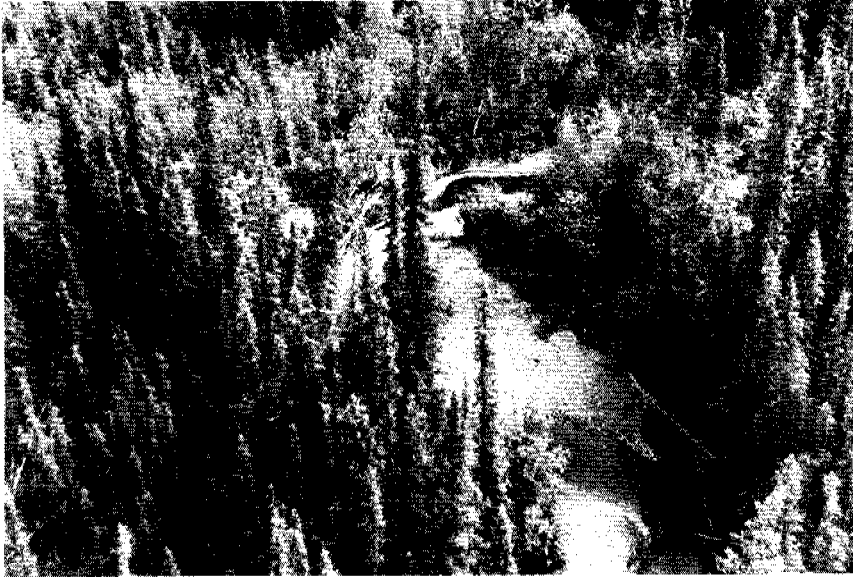
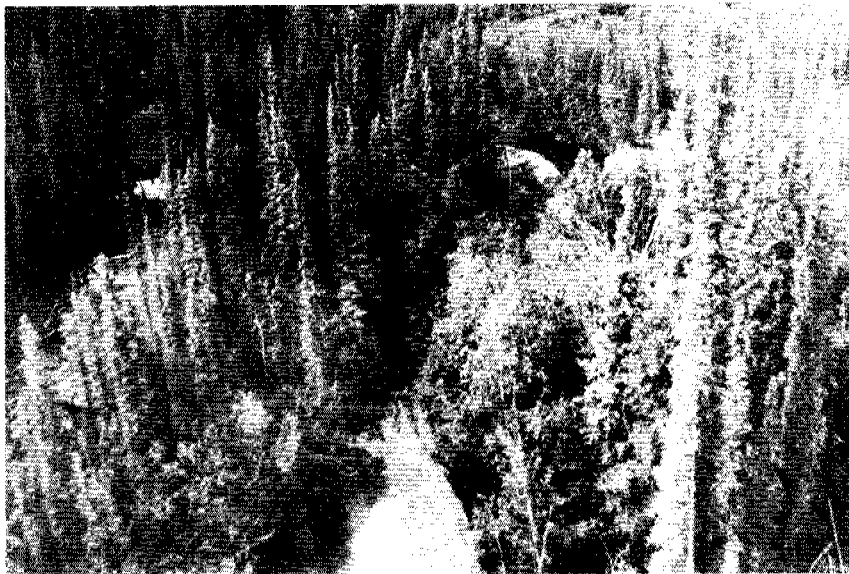
STREAM 1.118 - UPSTREAM

STREAM 1.118 - DOWNSTREAM

Comments: This stream had stable banks. Above and below the crossing
site the stream was 80 percent shaded and flowed very
slowly; although no fish were observed in this section,
it appeared to be good pike habitat.

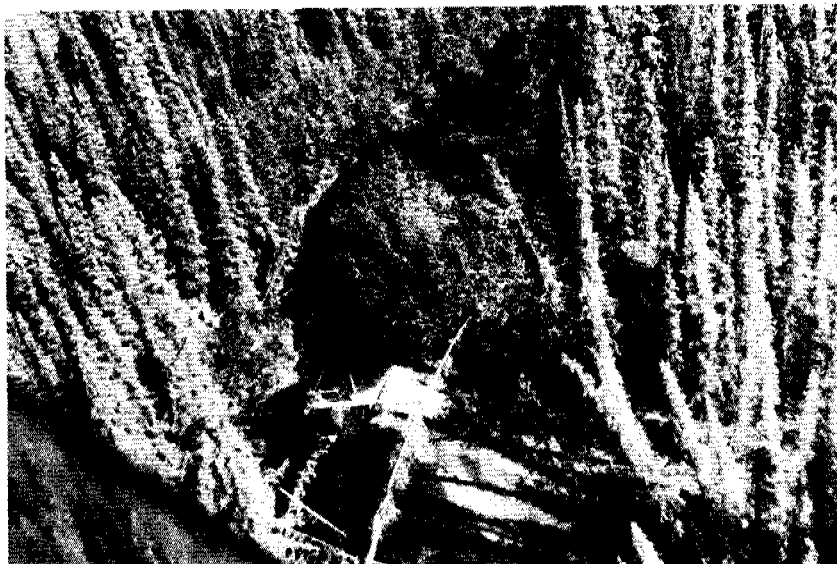
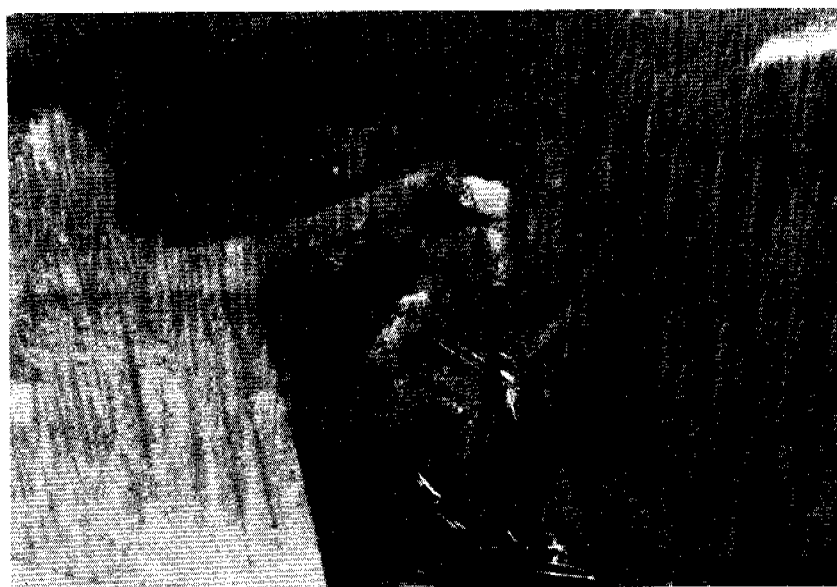
STREAM 1.088.18 - UPSTREAM

STREAM 1.088.18 - DOWNSTREAM

Comments: This stream appeared to be excellent grayling fry habitat.
The creek bed was quite wide with substantial gravel beds.
Use of the stream gravel should be prohibited.

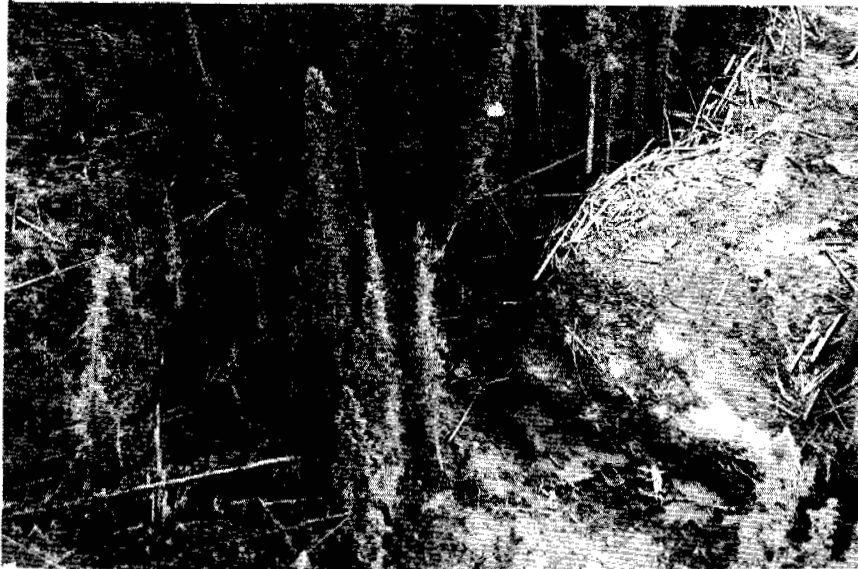
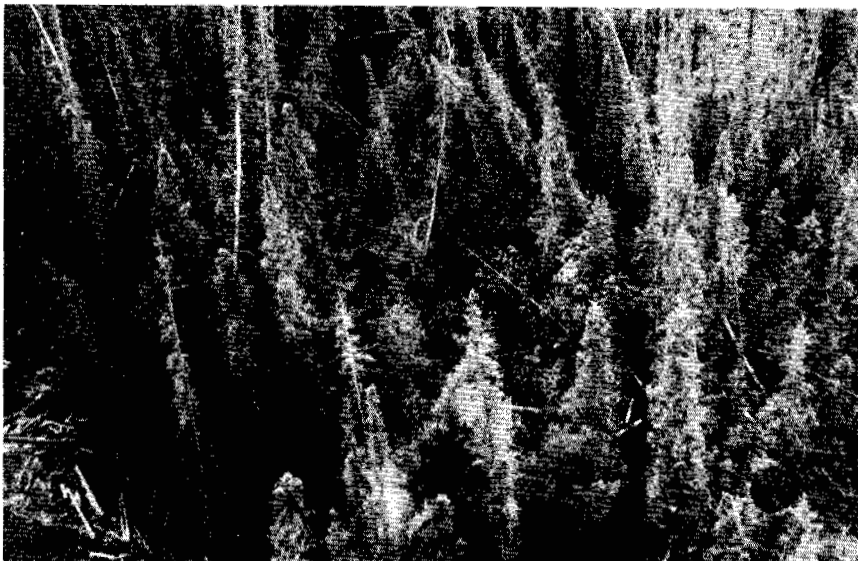
STREAM 1.088.08 - UPSTREAM

STREAM 1.088.08 - DOWNSTREAM

Comments: This stream appeared to be a permanent creek with stable banks with sedge and grass. It is probably not mature grayling habitat but is used for spawning.

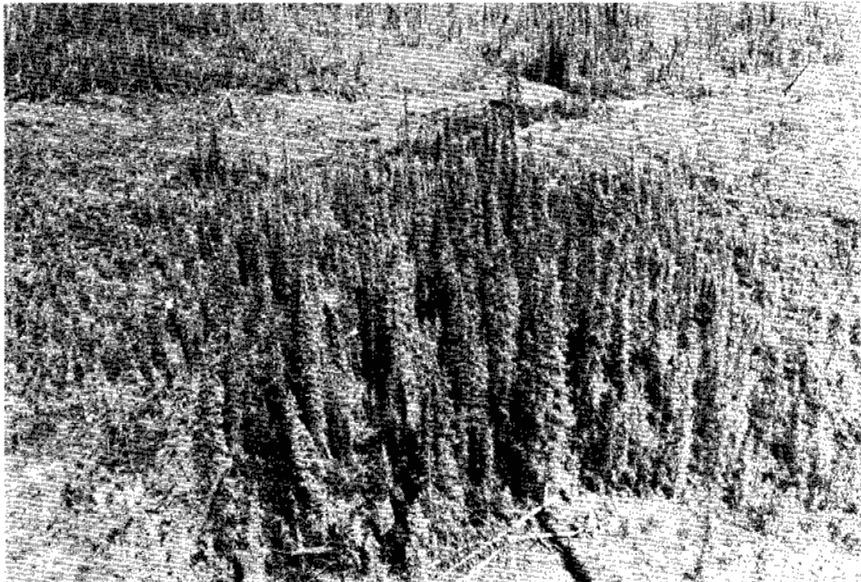
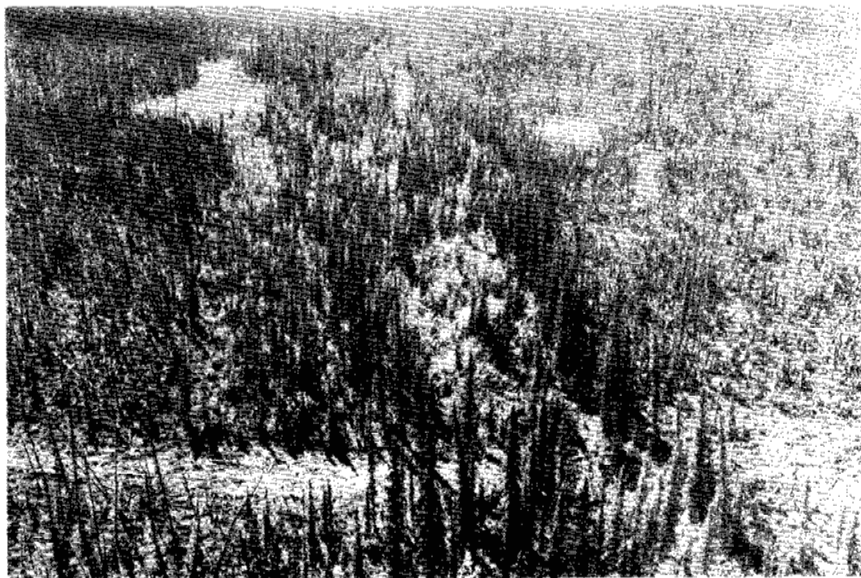
STREAM 1.076 - UPSTREAM

STREAM 1.076 - DOWNSTREAM

Comments: This stream appeared to be a good grayling spawning stream
although no fry were observed. There was a considerable
brush-log jam downstream, which may block fish passage.
Although mature grayling were observed, the stream is only
marginal habitat.

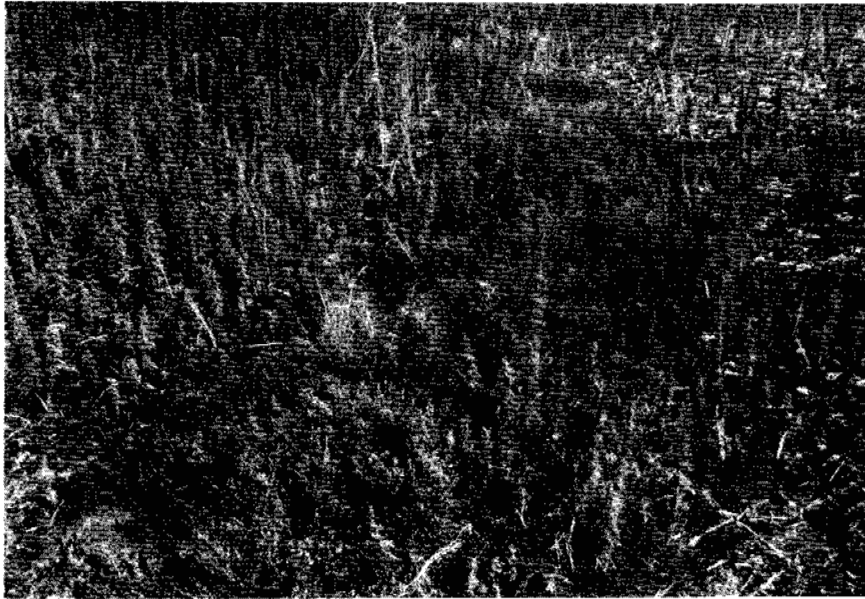
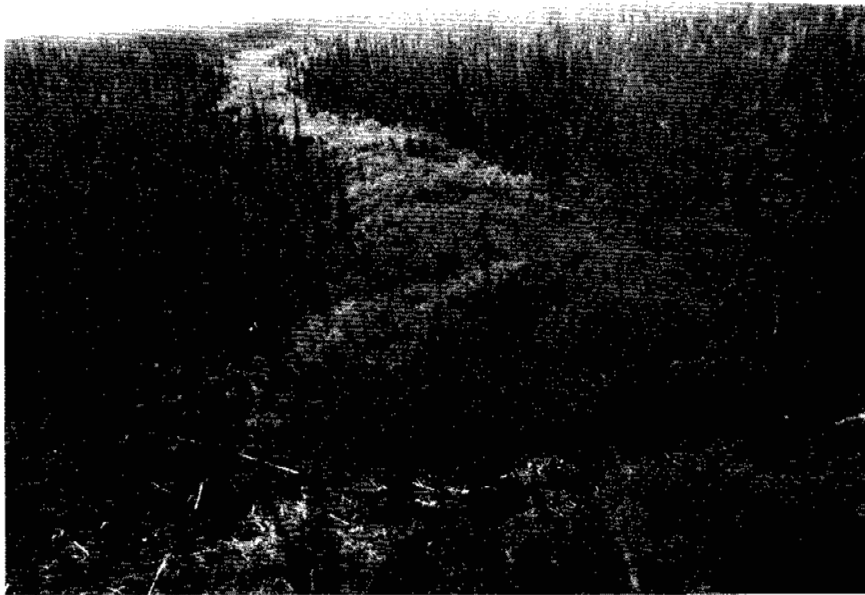
STREAM 1.050.03 - UPSTREAM

STREAM 1.050.03 - DOWNSTREAM

Comments: This was a slow moving stream with stable banks and much
plant growth on the bottom. Probably serves as a pike
nursery for Travaillant River.

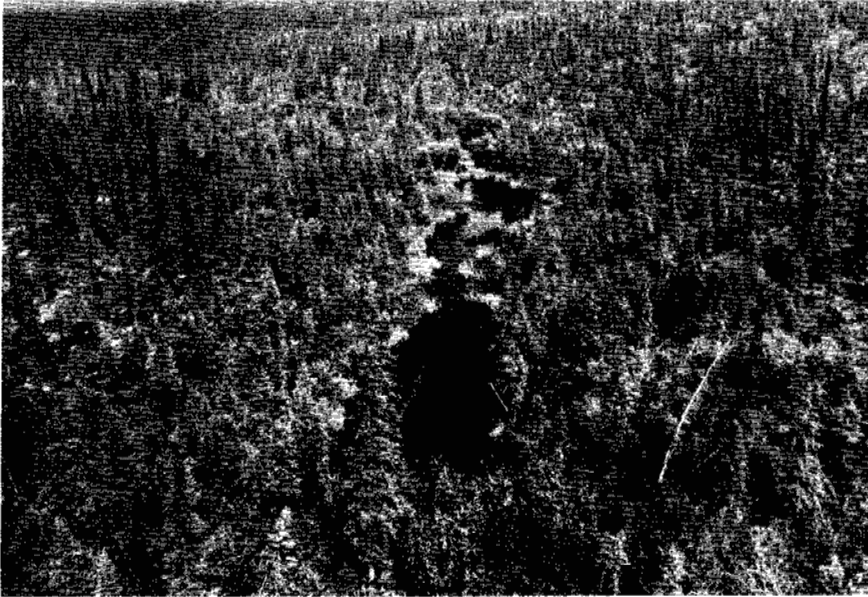
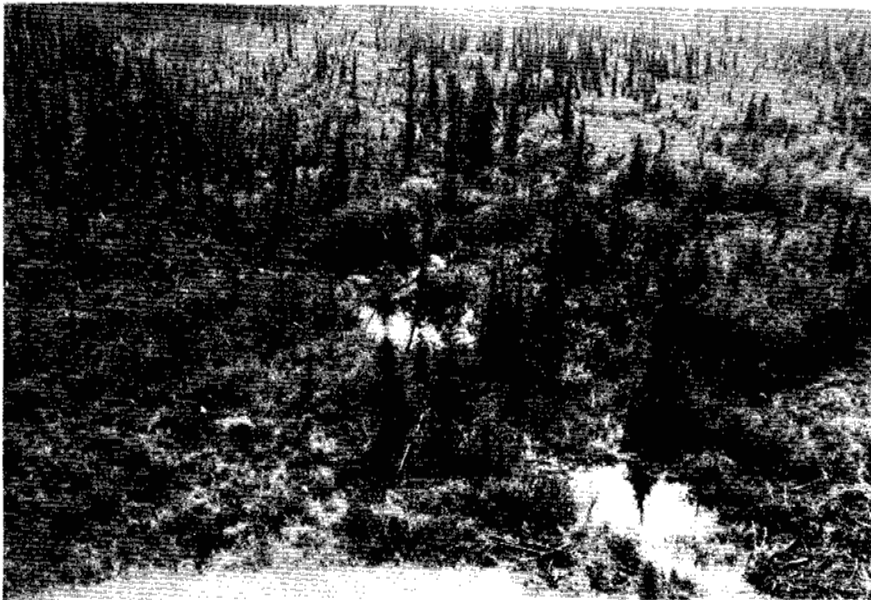
STREAM 1.050.12.08 - UPSTREAM

STREAM 1.050.12.08 - DOWNSTREAM

Comments: A beaded stream which had the appearance of pike habitat,
although none were observed.

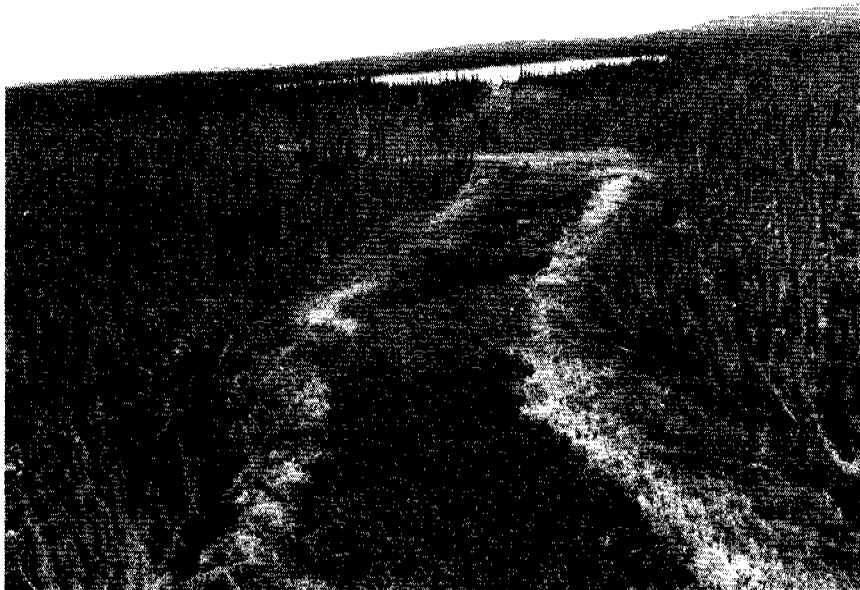
STREAM 1.002.38.23 - UPSTREAM

Comments: A beaded stream with shallow pools filled with plants. The
stream is probably important for movement of fish from
Rengleng River to Bathing Lake.

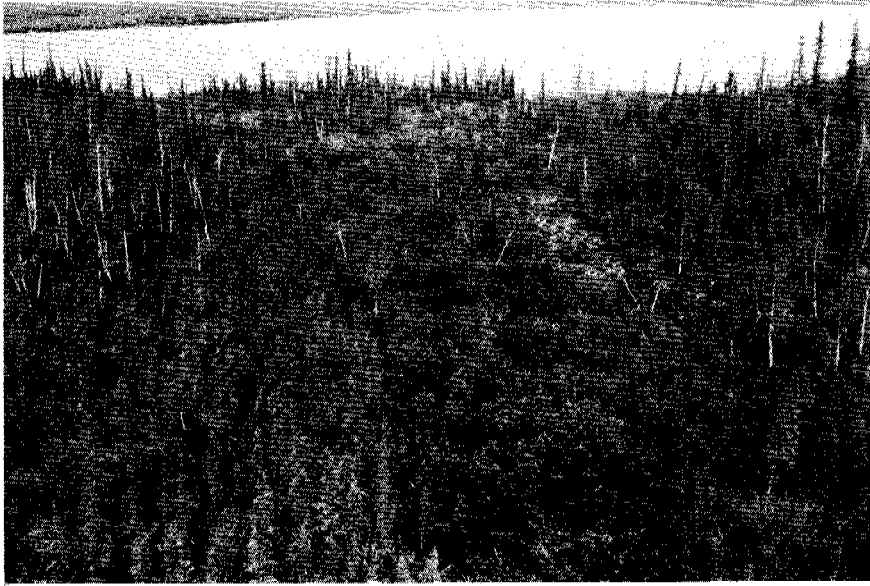
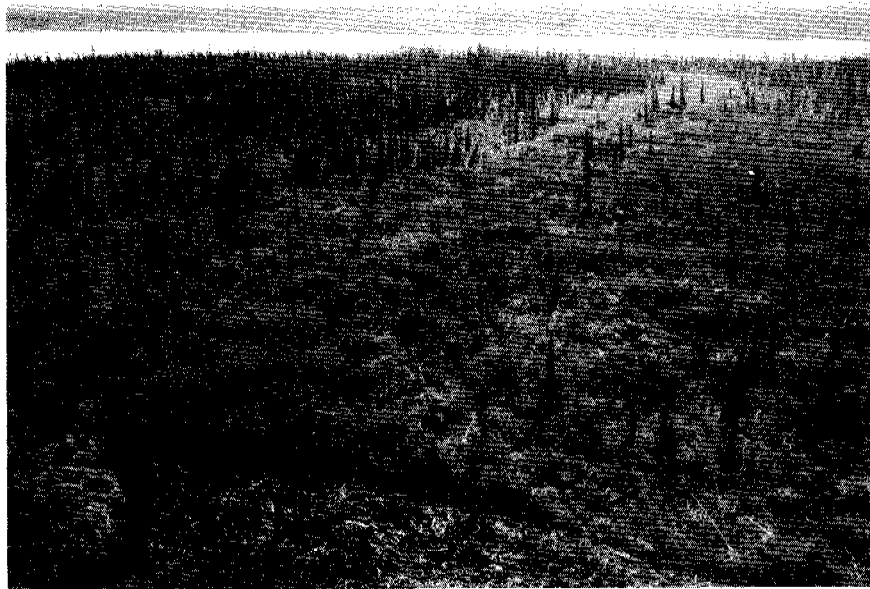
STREAM 1.002.38.25 - UPSTREAM

STREAM 1.002.38.25 - DOWNSTREAM

Comments: The stream was heavily overgrown. The water was stagnant
and had an oily scum. Possibly pike habitat, although none
were observed.

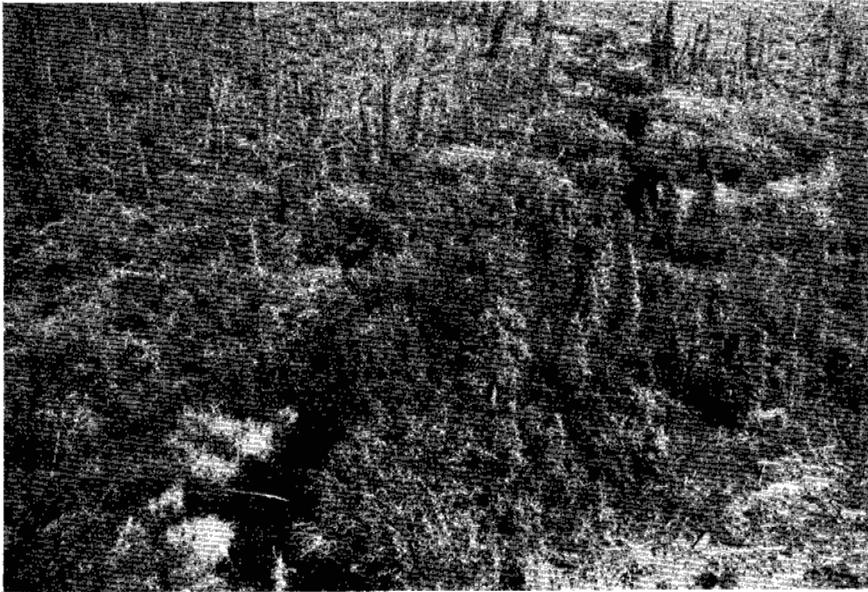
STREAM 1.002.38 - UPSTREAM

STREAM 1.002.38 - DOWNSTREAM

Comments: Rengheng River into Wounded Bear Lake. Probably pike
habitat although none were observed. The stream may be
important for fish movement between lakes.

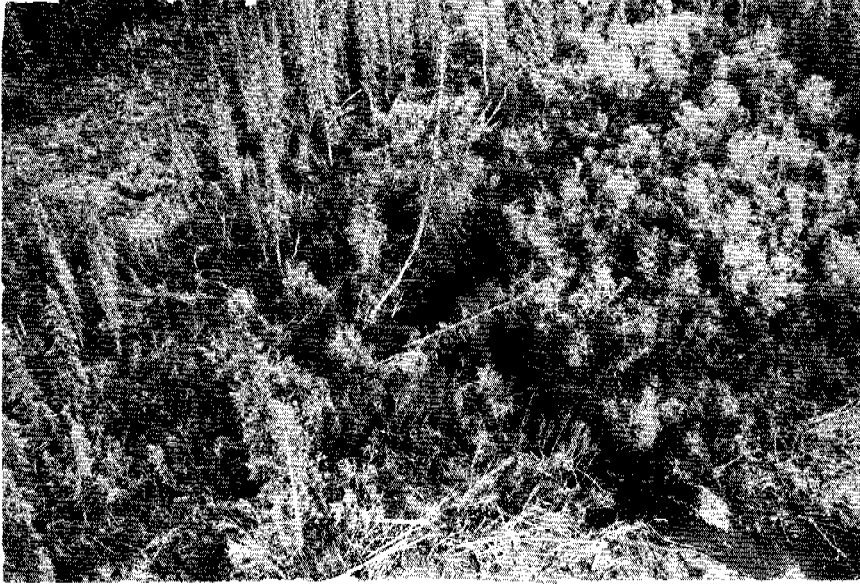
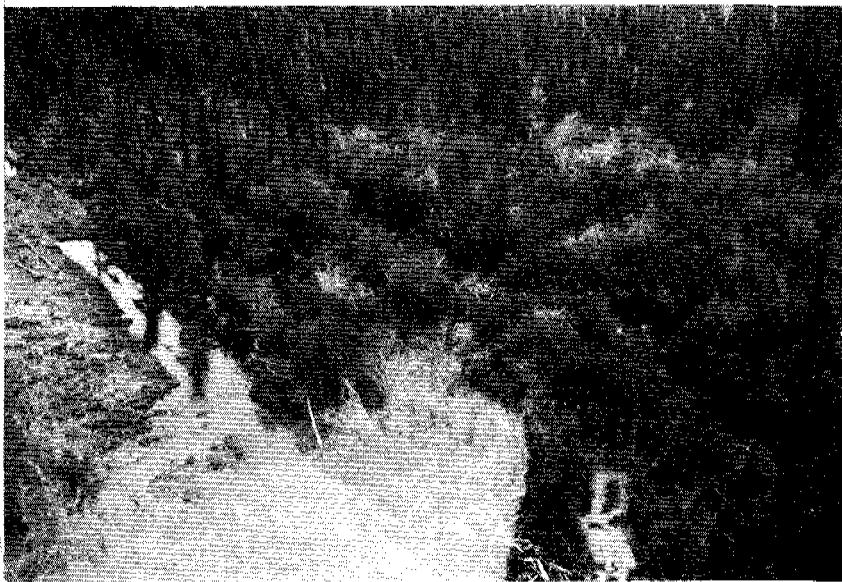
STREAM 1.002.38.06 - UPSTREAM

STREAM 1.002.38.06 - DOWNSTREAM

Comments: The stream appeared to be good habitat but no fish were
observed. Downstream the channel became marshy with numerous
"branch-jams" (possible blockage to fish movement).

Revisited July 24 - no fish.

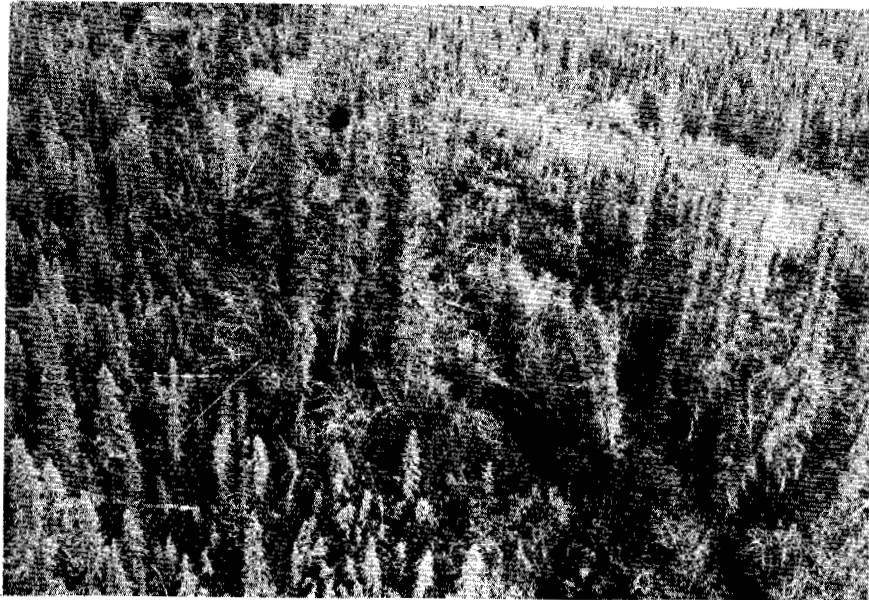
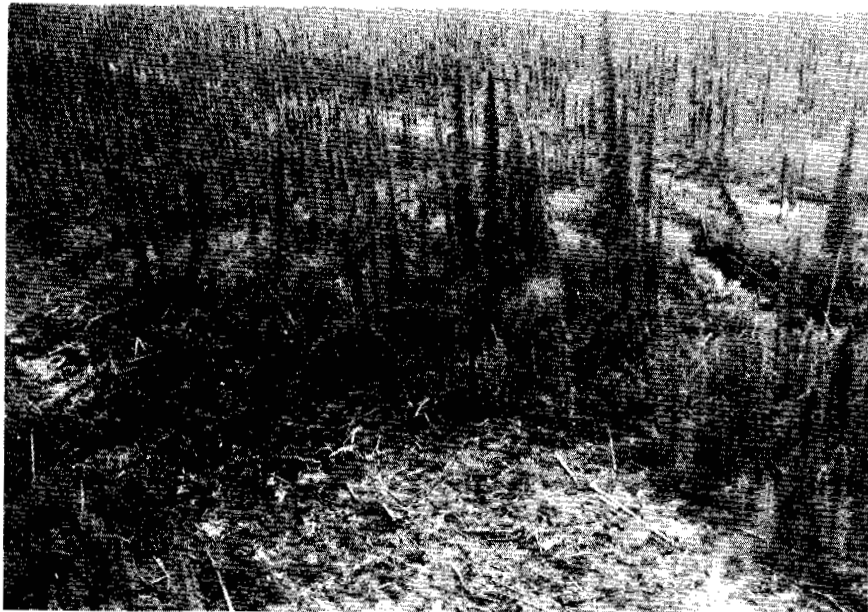
STREAM 1.002.38.04.04 - UPSTREAM

STREAM 1.002.38.04.04 - DOWNSTREAM

Comments: Although stream had appearance of good habitat, no fish were
observed or captured.
