Killiniq Environmental Clean-Up Project Phase 1 1995

Makivik Corporation

December 1995

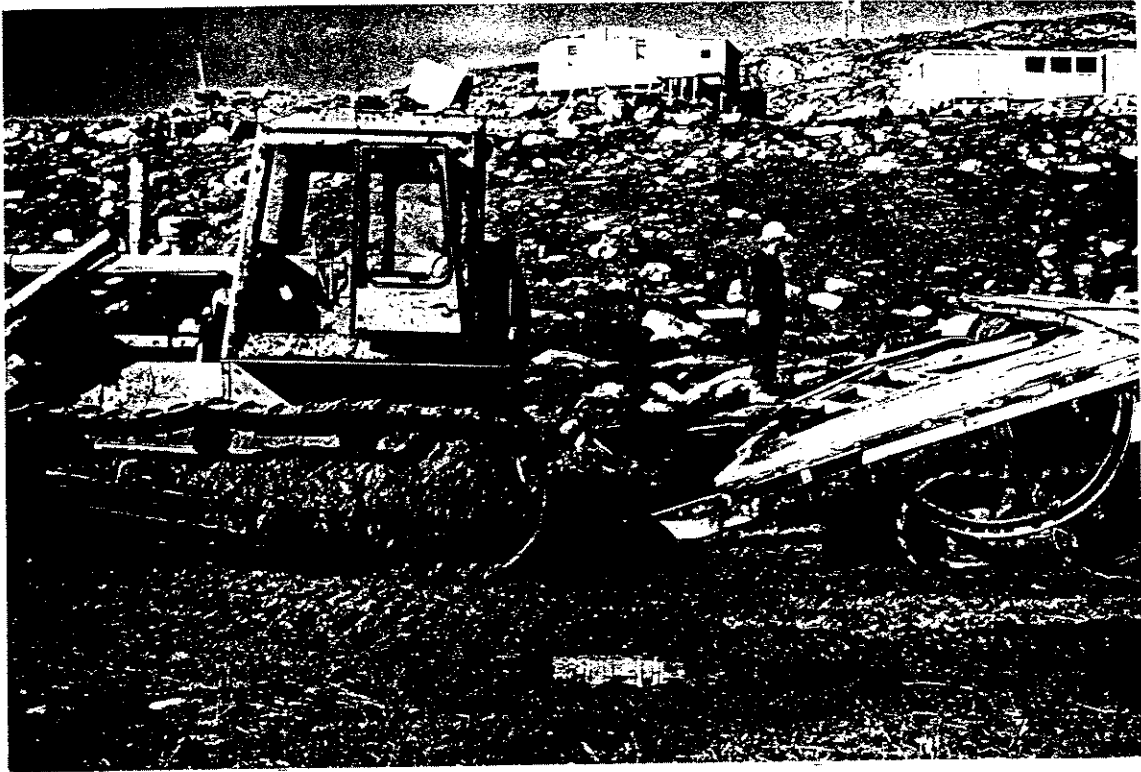
D-5 Bulldozer and Tracked Trailer

The D-5 bulldozer was re-examined. Allan York, a mechanic from Kuujjuaq later returned with Bill Doidge and concluded that with some basic repairs the bulldozer would be serviceable.

Most materials were loaded by hand onto a farm wagon, then hauled by the muskeg or on a tracked wagon hauled by the bulldozer. Roads within the town site had deteriorated and access to the dump was, at the best of times, very rough.

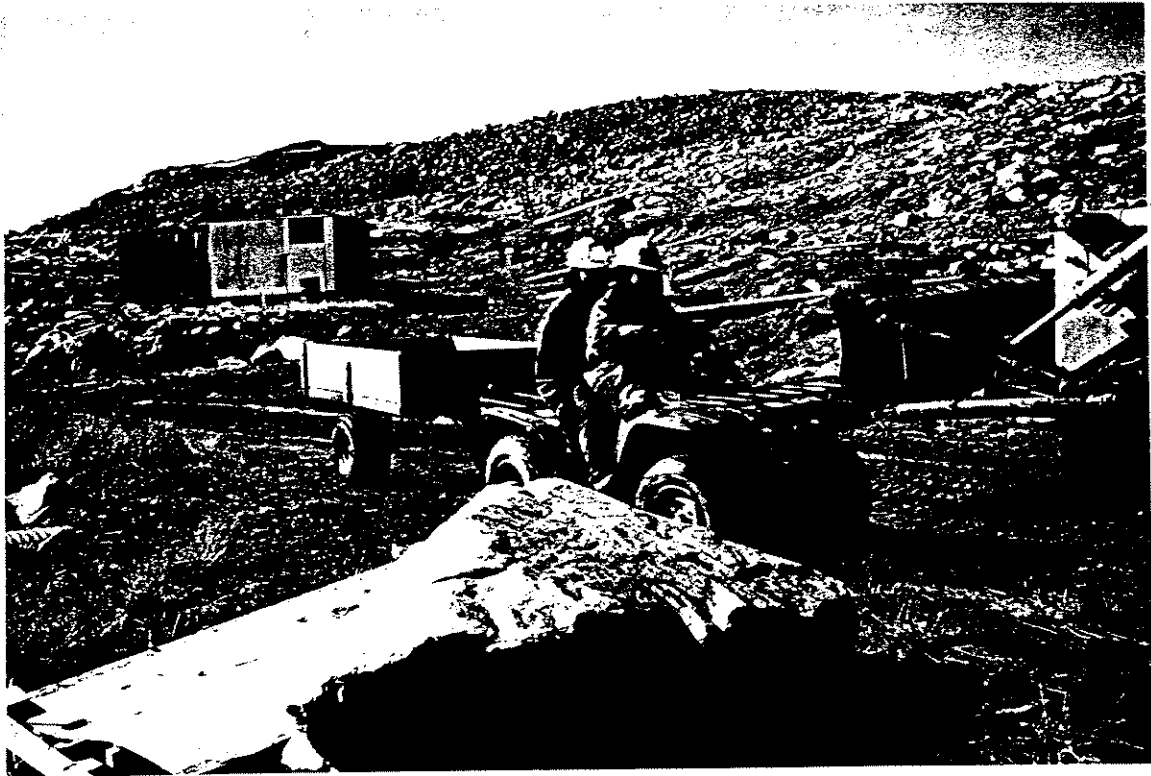
ATV and Trailer on Barrel Collection

Using an ATV with a trailer, the 45 gallon barrels were collected and transported to the dump. There was a large concentration near the Shell building, but drums were found from one end of the community site to the other. All other drums were collected with the exception of approximately forty located in the old dump site. Drums were rusted and in various states of deterioration. Some contained residues and others, found in isolated locations and not identified in the original survey, contained fuel oil.

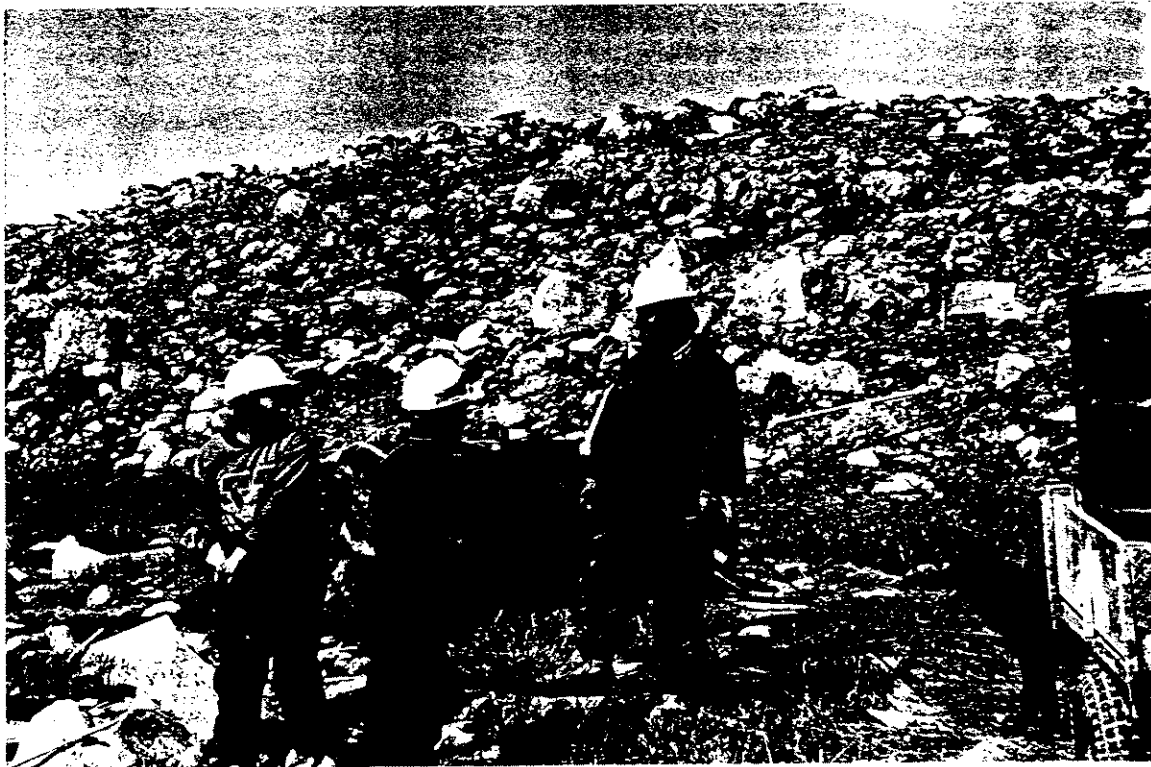
Cutting Wires

- 1.7 This recommendation, concerning the electrical lines and poles, was fully implemented.
- 1.8 Over 600 45 gallon barrels were collected and stored in the solid waste disposal site. Approximately 40 barrels remain in the old solid waste disposal site.

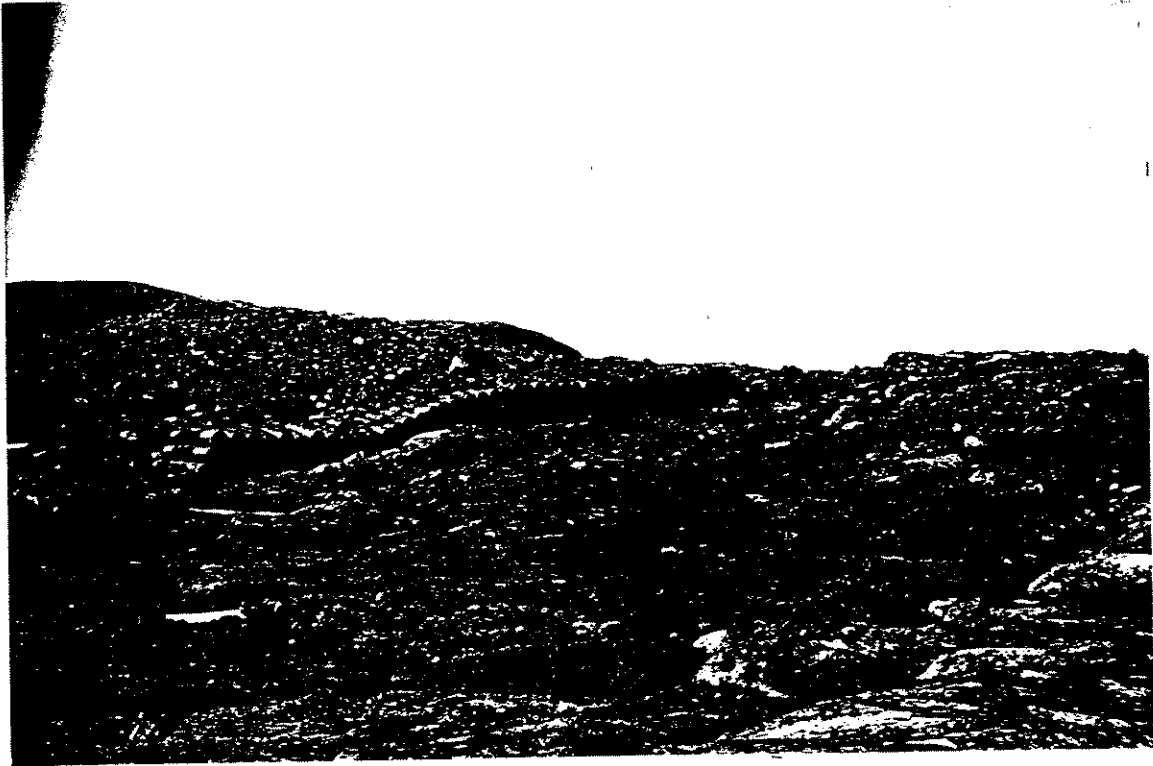
New Barrel Storage Site

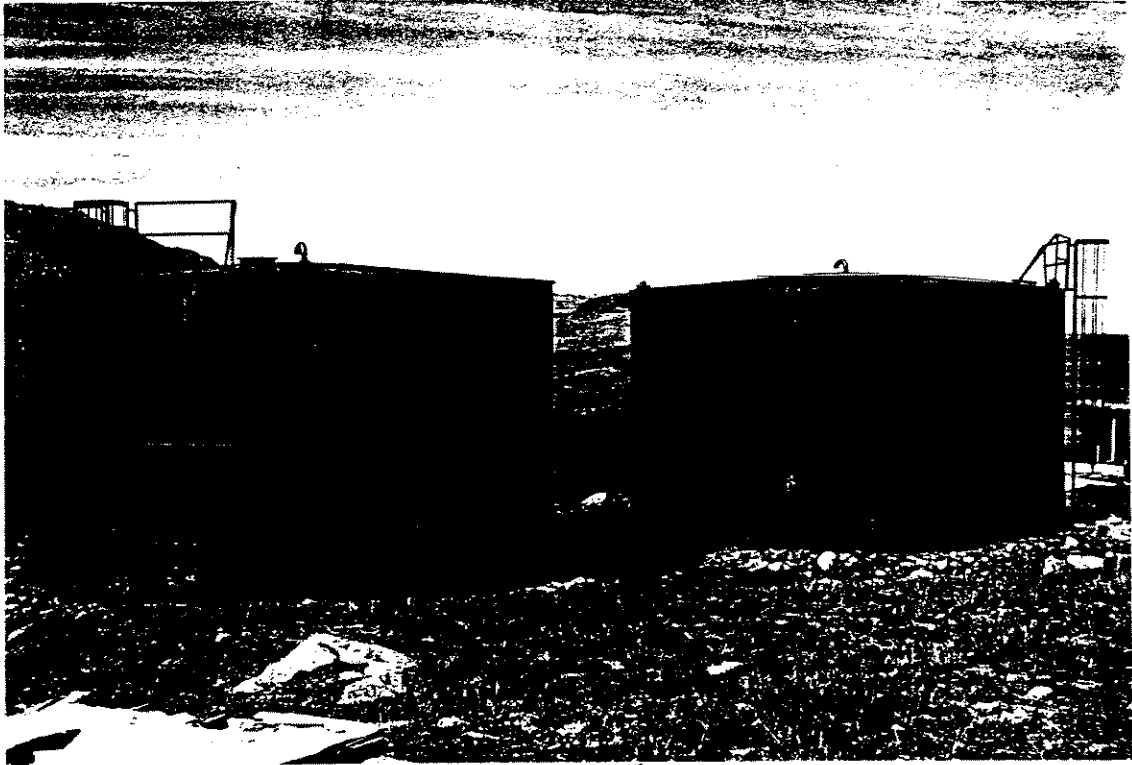
Large Fuel Tanks

- the recommendation to remove the oil from the two large fuel tanks was problematic for the CCG, as they still use these tanks in the resupply of the small tanks located at their installation. This subject will be studied. This issue is being revised by the coast Guard;

- 1.2 In this recommendation, concerning the removal or safe storage of the diesel fuel, no action was undertaken. This matter is being studied by the CCG.

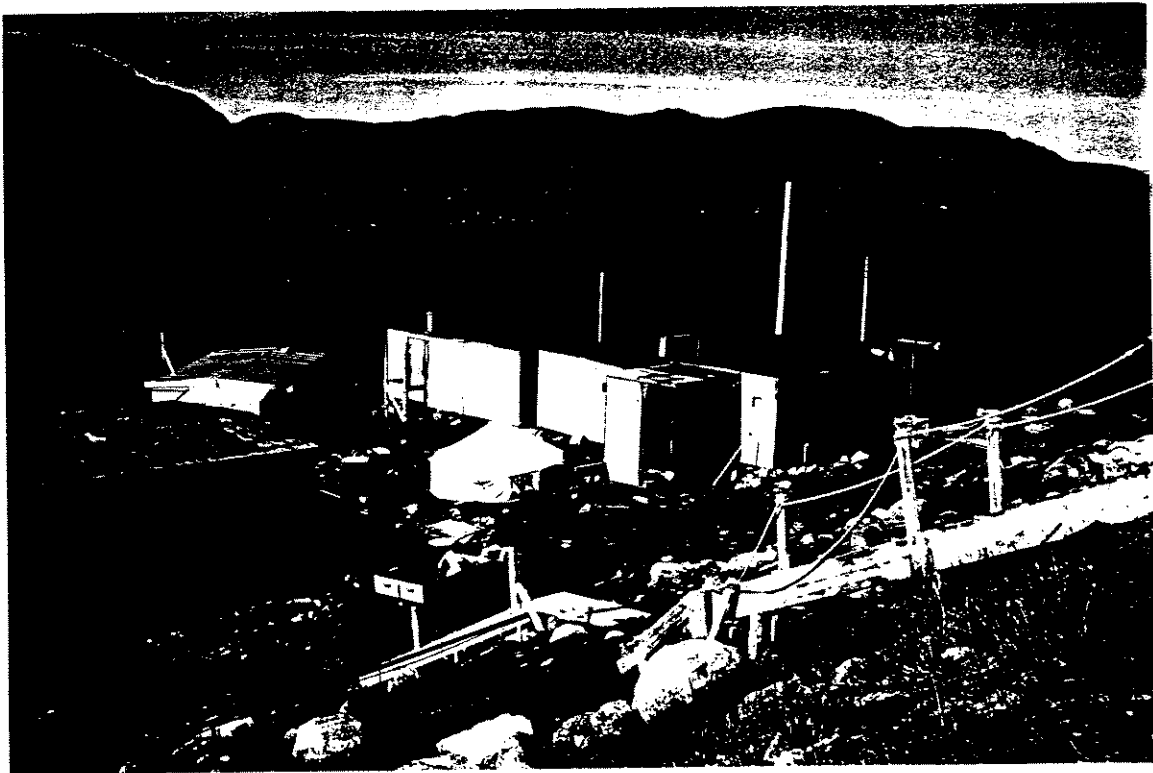
Houses in Lower Sector Stabilized for Workers

Seven buildings were used for accommodation during the project. These include two in the lower town, four uphill from the generator plant and garage, and one which had formed part of the nursing station. These buildings were cleaned of all debris. Some of the broken windows were replaced by plexiglass. They were boarded up when the workers departed. These buildings are all in a state of deterioration but may be used by Inuit hunters for a few years. The areas around these building were also cleared of debris. Another building on the hill along the road to the CCG installations was cleaned of debris. However, this building is in poor condition.

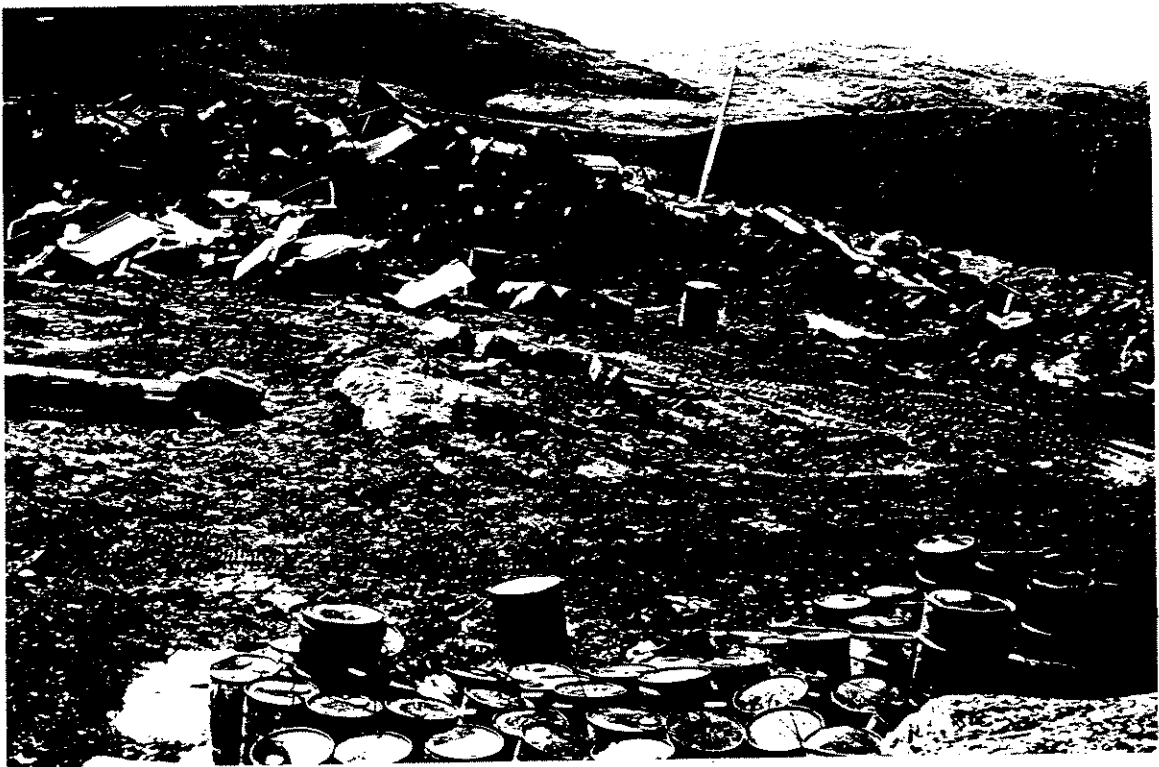
Material on Solid Waste Disposal Site Prior to Incineration

The drums of oil found next to the electrical shed were transported to the dump and the contents incinerated. Their contents were primarily used 20W engine oil. Six of the barrels of 20W engine oil had not been opened or used but upon examination were found to be contaminated by rust and water.

and transmission oil were incinerated at the dump site. Materials remaining from CCG use of the warehouse, such as old paper products, were burned at the dump. The large quantity of battery acid and acid for rust removal were packed in a sizable plastic water tank and transported to Kuujjuag.

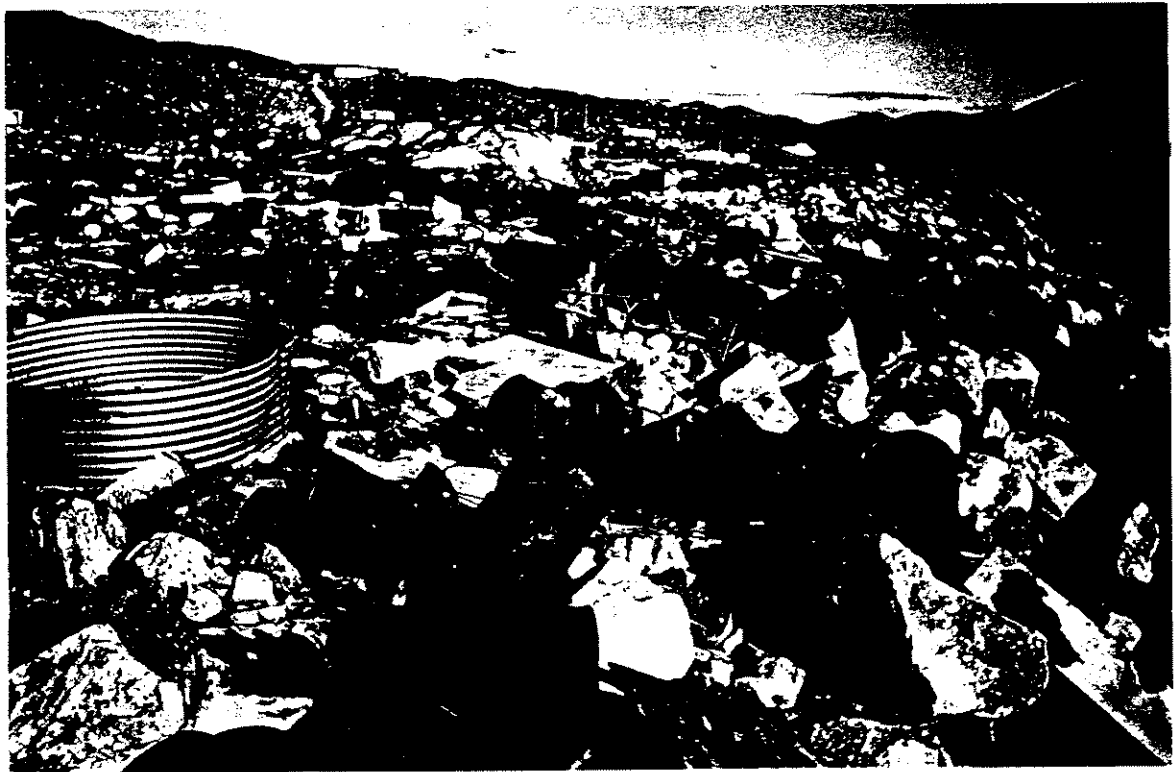
Old Solid Waste Disposal Site
