INVENTORY OF EXISTING GRAVEL PITS
ALONG MAJOR HWYS. & COMMUNITIES
IN THE YUKON TERRITORY

DAWSON - KLONDIKE HWY.

Vol. 1

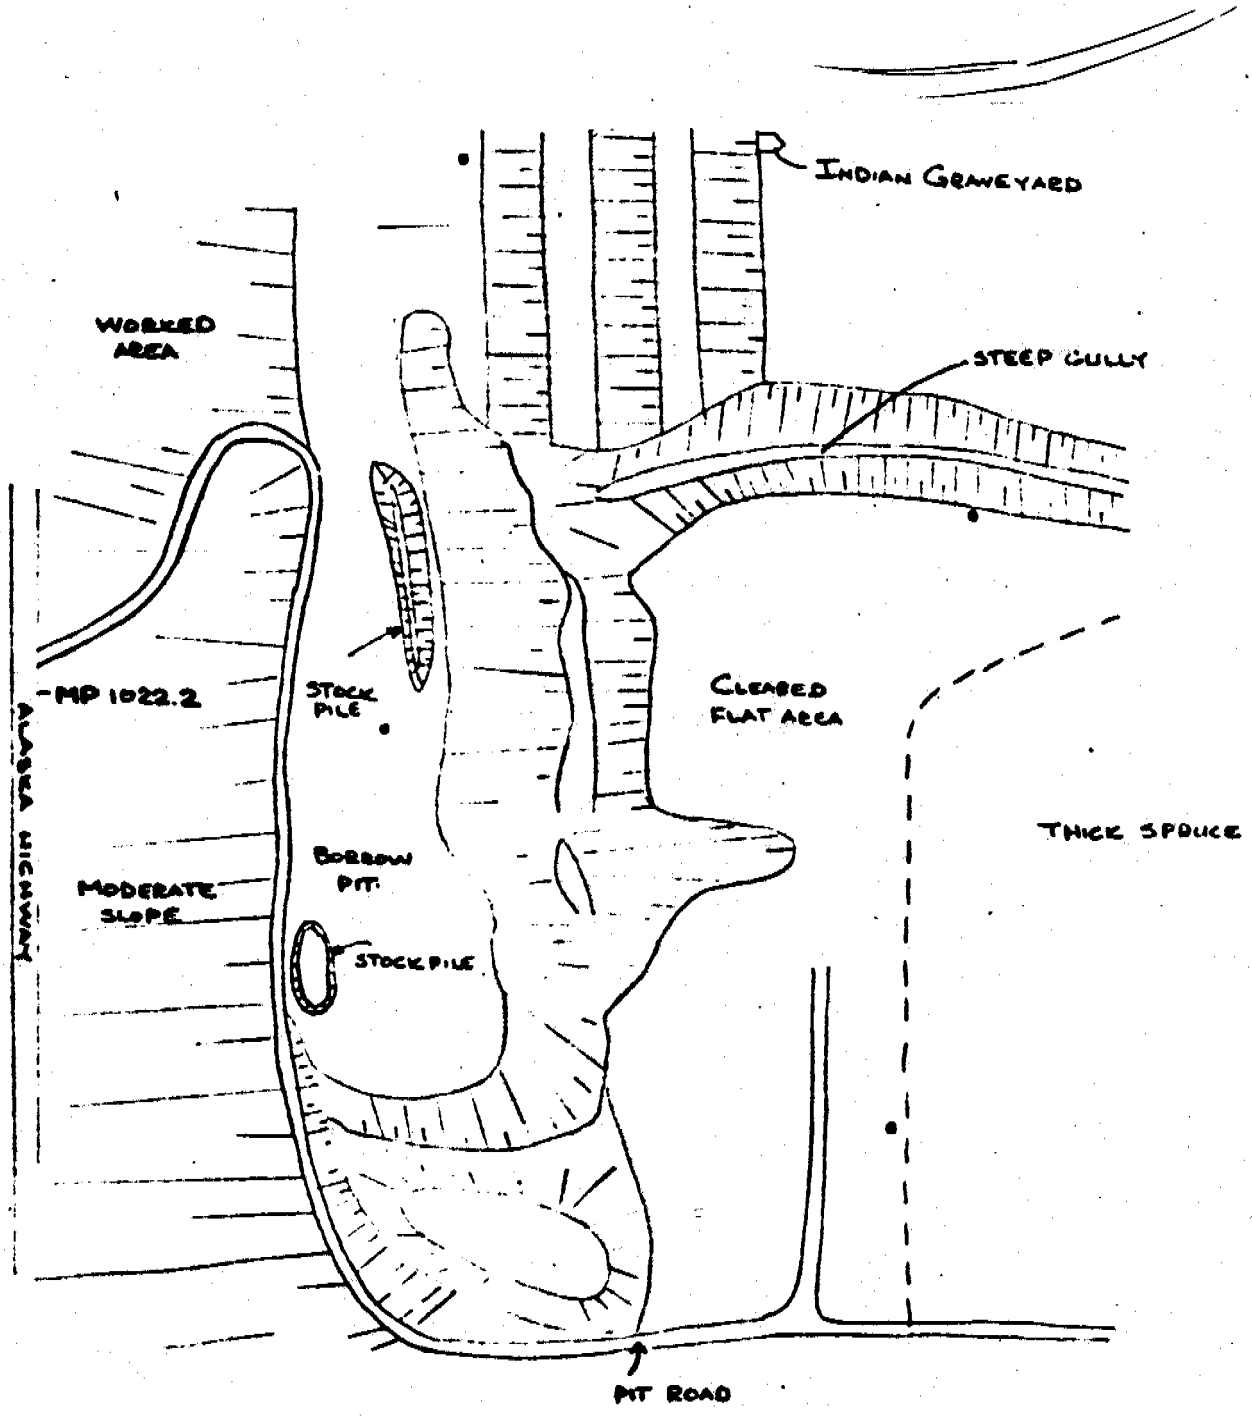
SITE NO 65

Remarks: Some calcite coating gravel.

Environmental: Indian Grave, Scenic Viewpoint
