Impact of groundwater flow on permafrost degradation: implications for transportation infrastructures

I. de Grandpré^{1,2}, D. Fortier^{1,2,3} and E. Stephani^{2,3,4}

¹ *Département de Géographie, Université de Montréal, Québec, Canada*

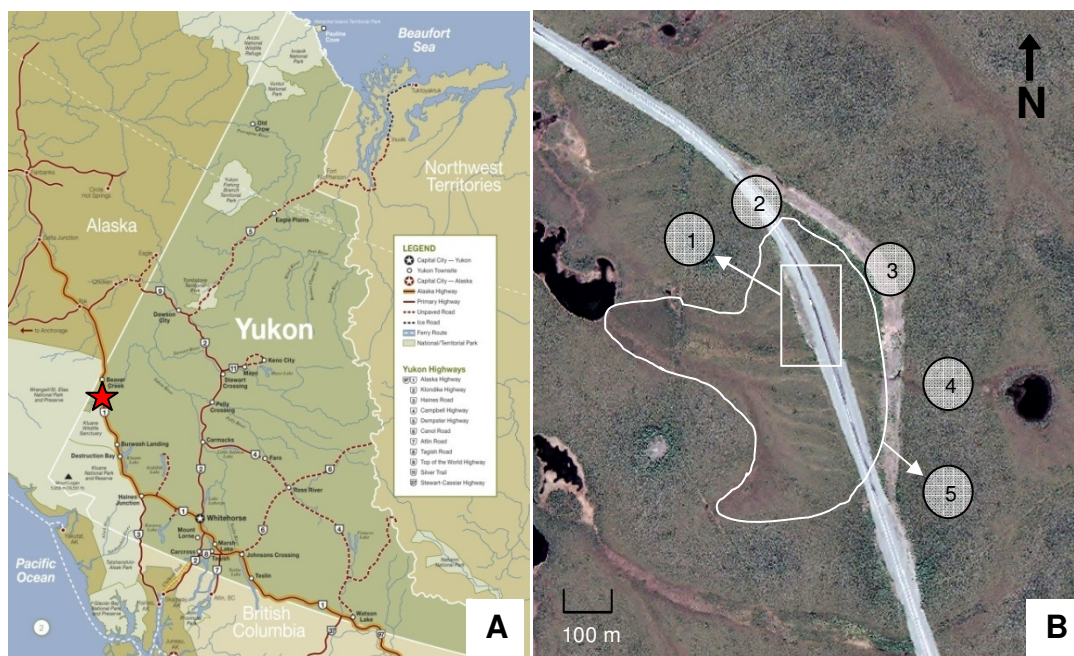
at the study site comprise a layer of poorly-decomposed organic matter and wood fragments overlying well-decomposed cryoturbated peat mixed with silt and tephra grains. This organic unit rests on several meters of coarse silt. At the location of the study site the embankment is sub-perpendicular to the local slope and thus intersects the natural drainage network (Figure 2B).

Figure 2. Localization of the study site (62°20' N, 140°50' W) A. Map of Yukon Territory, Canada (www.gov.yk.ca) B. Satellite image (QuickBird) of the study site taken on June 14, 2006. 1. Inset: groundwater measurements location (piezometers and pressure sensors) 2. Alaska Highway 3. Former Alaska Highway alignment 4. Stream 5. The line shows an area with a vegetation pattern (lighter grey) aligned with the direction of groundwater flow.

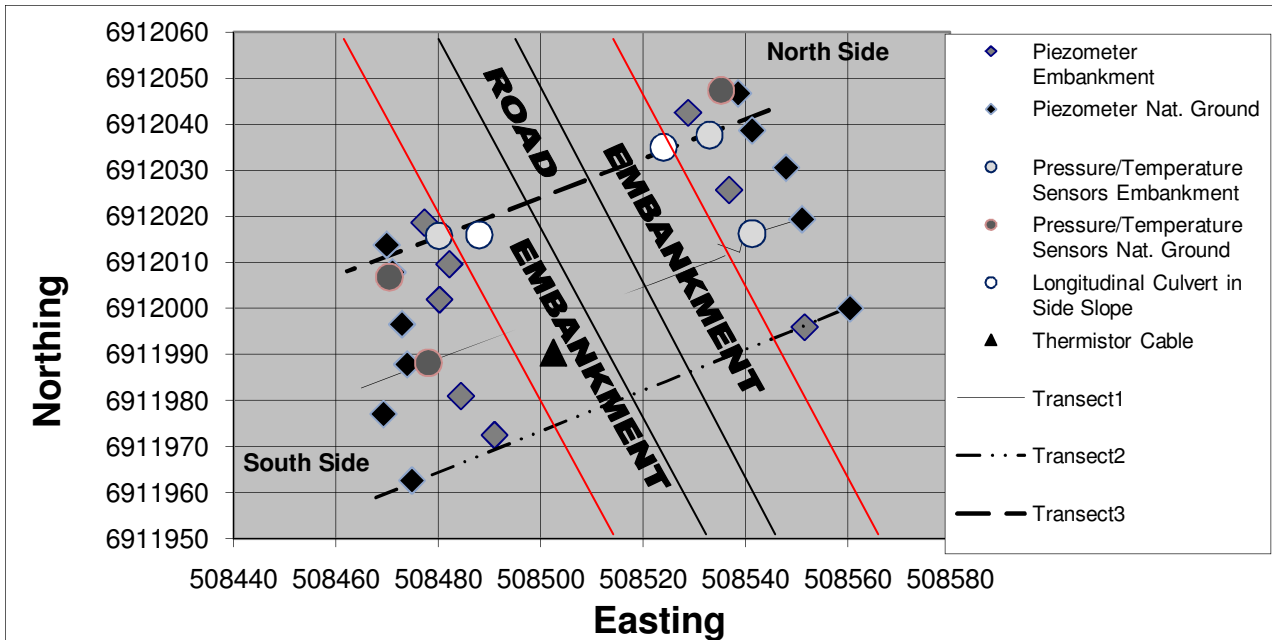
Figure 4. Research design. The piezometers are located on each side of the road at the toe of the embankment (grey diamond) and in the adjacent natural ground (black diamond). Automated pressure and temperature sensors installed in piezometers are located at the toe of the embankment (light grey circles) and in the natural ground (dark gray circles). White circles show the location of longitudinal culvert in the side slope. Three transects were used to evaluate potential flow paths under the road. One thermistor cables is installed in the side slope of the embankment and two others are installed under the centre line of the road at about one hundred meters on each side of the piezometers network (not shown on figure)
