**GEOTECHNICAL INVESTIGATION**

MILE 347 TO MILE 690 MACKENZIE HIGHWAY  
WINTER - 1975

REPORT ON  
GEOTECHNICAL INVESTIGATION  
MILE 347 TO MILE 690  
MACKENZIE HIGHWAY

Submitted by R.D. Cook, P.Eng.  
Materials Engineer  
February 1, 1976

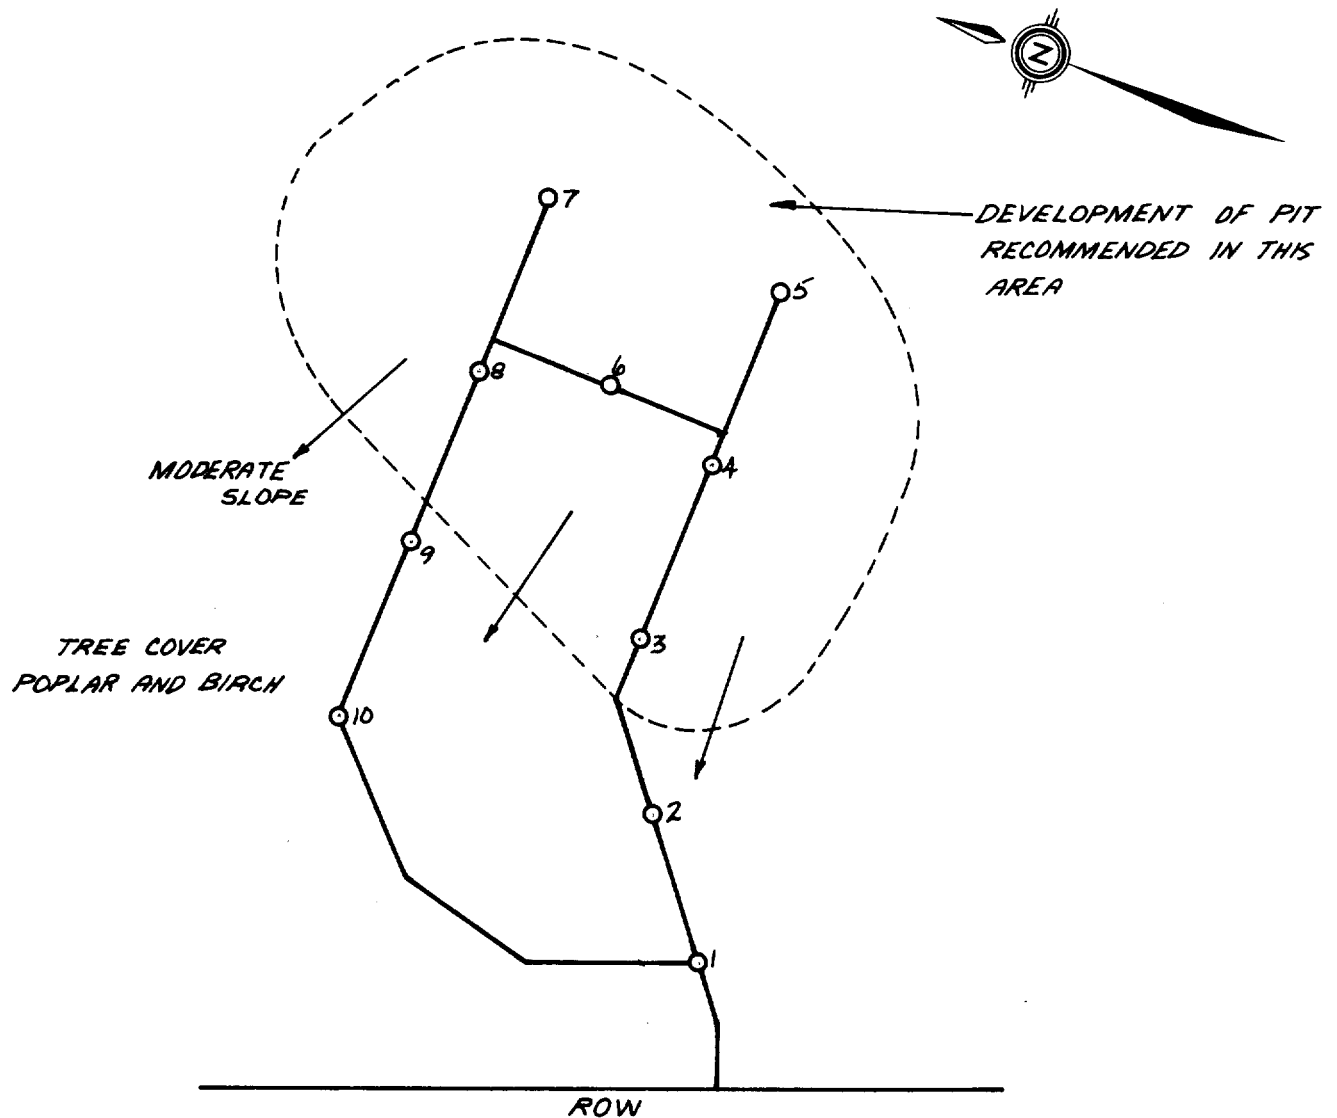
# MILE 470.9 - 1000' RT OF E

The area test drilled here extends over 1000 feet from the alluvial terrace where the right-of-way is located, to the top of the west facing valley slope. Tree cover consists largely of poplar and birch. Subsoil is medium to highly plastic silty clay. Permafrost is present on the lower portions of the slope but was difficult to detect near the top of slope due to very low ice contents. Moisture contents in the lower slope generally range between 25 and 30%. Near the top of slope, material is much dryer with moisture contents below 25%. Development of the pit area is recommended on the higher terrain (see site plan).

- SUBSOIL MEDIUM TO HIGHLY PLASTIC SILTY CLAY
- PERMAFROST PRESENT IN LOWER SLOPES - MAY NOT BE PRESENT AT TOP OF SLOPE
- MOISTURE CONTENTS  $\leq 20\%$  AND BELOW PLASTIC LIMIT NEAR TOP OF SLOPE - PIT DEVELOPMENT RECOMMENDED HERE

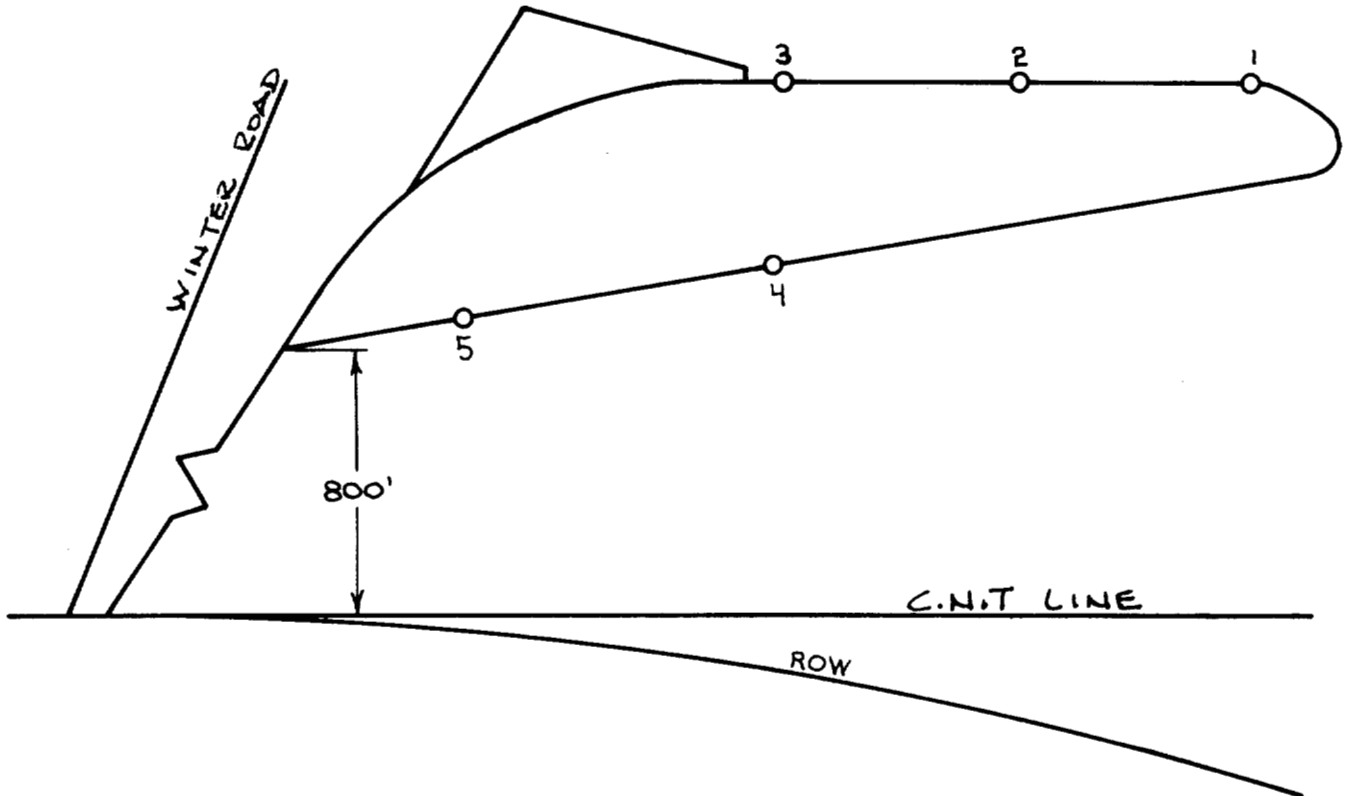
MILE 473.6-1000' RT. OF E

- SUBSOIL HIGHLY PLASTIC SILTY CLAY
- FROZEN WITH MOISTURE (ICE) CONTENTS NEAR 20%  
AND BELOW THE PLASTIC LIMIT
- STRIPPING < 2'
- GOOD BORROW SOURCE

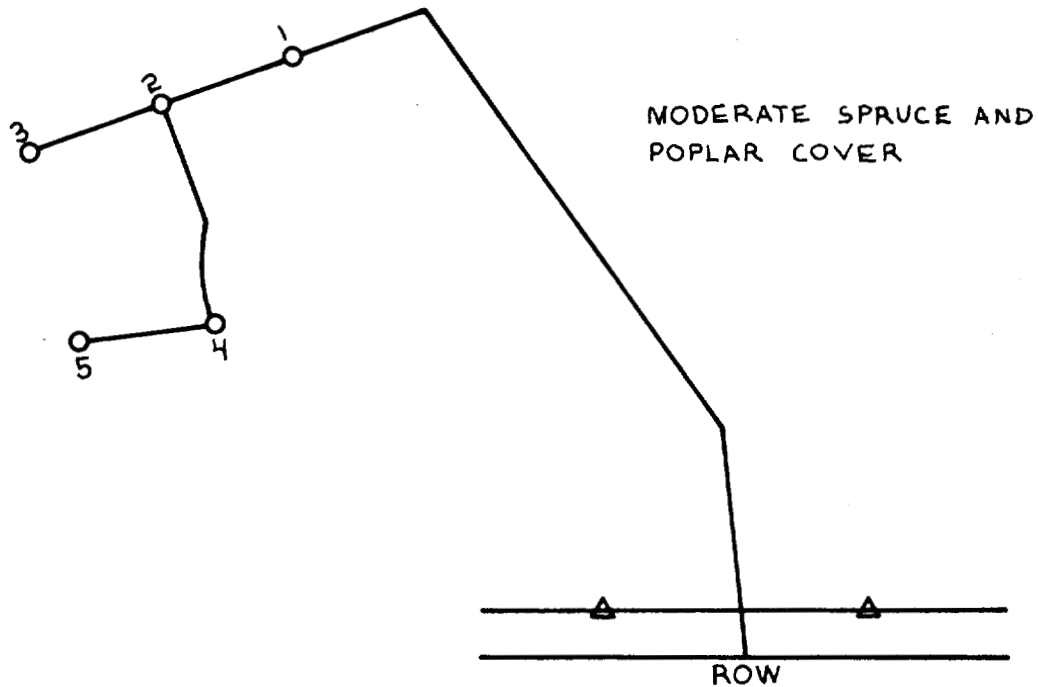
MILE 475.3-400' RT. OF E

The area test drilled here is in a moderate stand of poplar and spruce in an otherwise sparsely treed, flat, poorly drained, glaciolacustrine plain. Subsoil is highly plastic silty clay. Permafrost is present throughout and ice contents are low to moderate. Moisture contents average in the low 20's and near the plastic limit with occasional values as high as 30%. Strip-ping depths are estimated at 2-3'. This area contains usable material in an area with generally poor borrow and is recommended for development.

- SUBSOIL HIGHLY PLASTIC SILTY CLAY
- PERMAFROST THROUGHOUT WITH LOW TO MODERATE VISIBLE ICE
- MOISTURE CONTENTS ON THAWING  $\approx$  PLASTIC LIMIT WITH RANDOM WETTER ZONES
- 2-3' OF STRIPPING
- USEABLE BORROW SOURCE IN AN AREA OF GENERALLY POOR MATERIAL

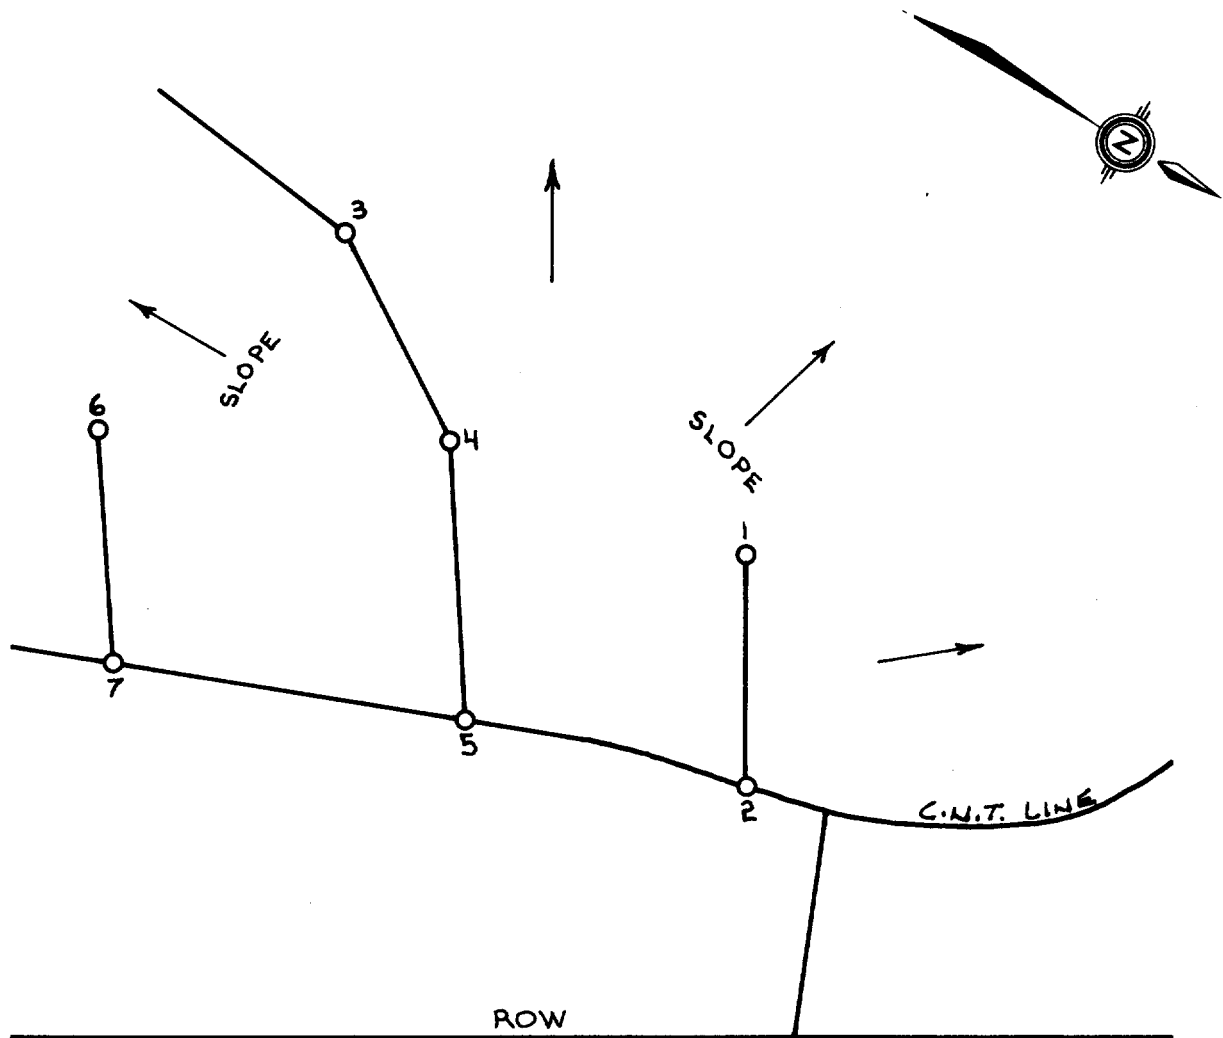
MILE 478.2-600' LT. OF 4

Borrow Pit #90 is located at the top of the valley slope adjacent to the right-of-way where the route begins descent to the crossing of Dam Creek. The pit area is well drained with slopes to the south, west and north and is treed with birch, spruce and poplar. Subsoil is highly plastic silty clay, frozen with low visible ice contents. Moisture contents on thawing average near 20% and are roughly at the plastic limit. There are occasional wet zones, however, these should not be a serious detriment in the high plastic material. Stripping depths are estimated at 2-3'. This borrow area is recommended for development.

- SUBSOIL HIGHLY PLASTIC SILTY CLAY
- FROZEN WITH LOW VISIBLE ICE AND MOISTURE CONTENTS  
≈ 20% AND THE PLASTIC LIMIT
- OCCASIONAL WET ZONES
- 2-3' OF STRIPPING
- CONSIDERED TO BE USEABLE BORROW

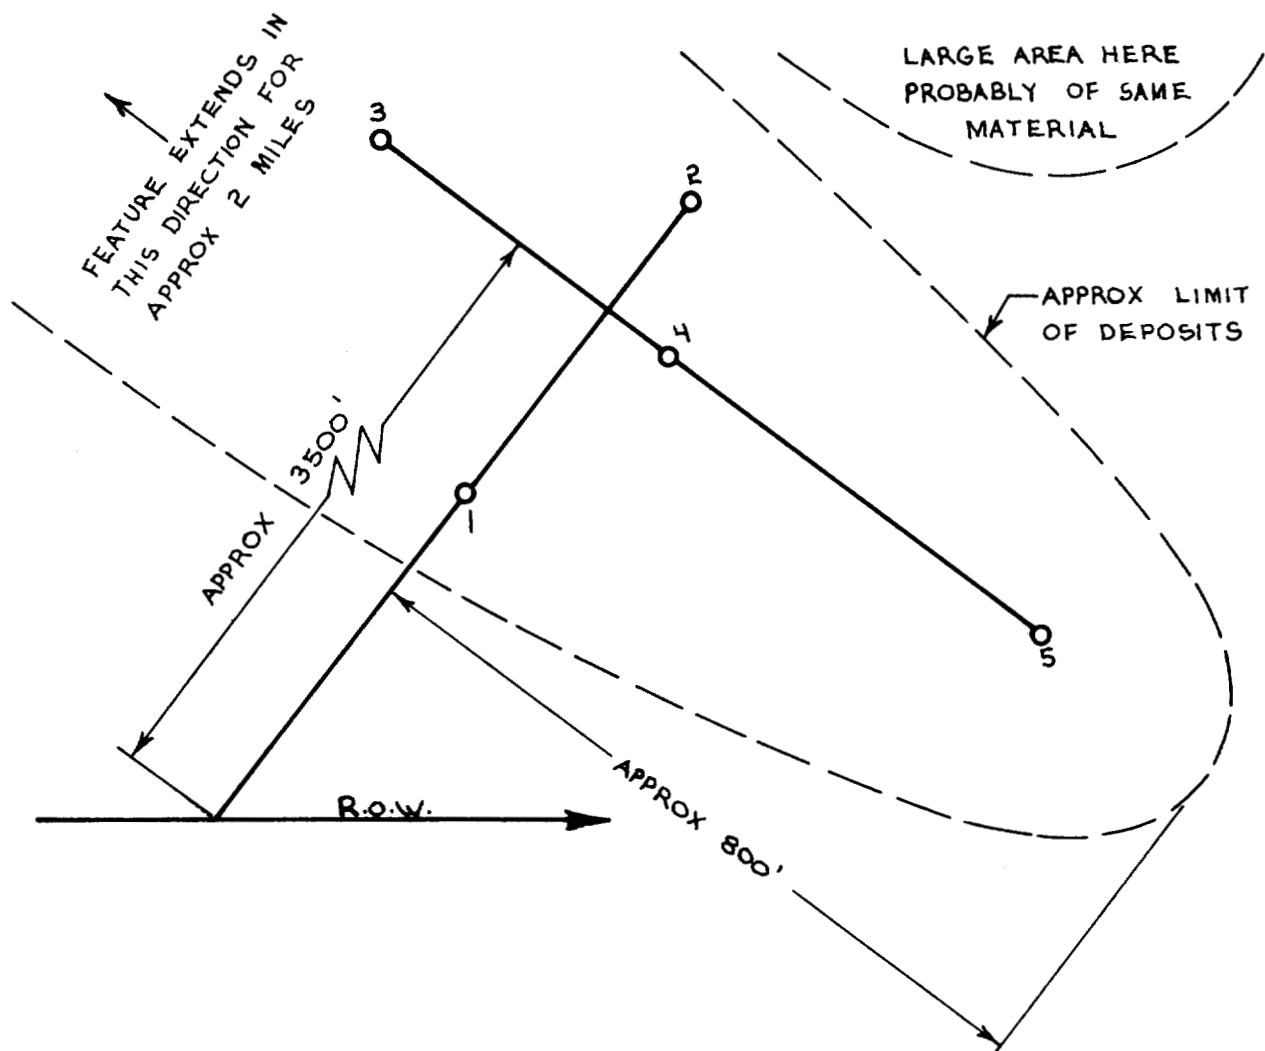
MILE 497.7 - 3500' LT. OF C

Borrow Pit 94 is on the tip of a large longitudinal segment of a glaciofluvial plain. Deposits in the area drilled vary from silty sands to gravelly sands to sandy gravels. Tree cover on the granular materials is primarily jackpine with some spruce. Permafrost is largely absent and moisture contents are very low, the majority being less than 5%. This area is an excellent borrow source. The feature on which Pit 94 is located ranges from 1000 to 2500 feet in width and is approximately 2 1/2 miles in length. This area will likely be a good source of granular surfacing materials.

- TREE COVER JACKPINE AND SPRUCE
- FLUVIAL DEPOSITS VARYING FROM SILTY SANDS TO GRAVELLY SANDS TO SANDY GRAVELS
- LITTLE OR NO PERMAFROST
- VERY LOW MOISTURE  $< 5\%$
- EXCELLENT BORROW SOURCE
- PROBABLE SOURCE OF SURFACING MATERIALS WEST & NORTH OF AREA DRILLED

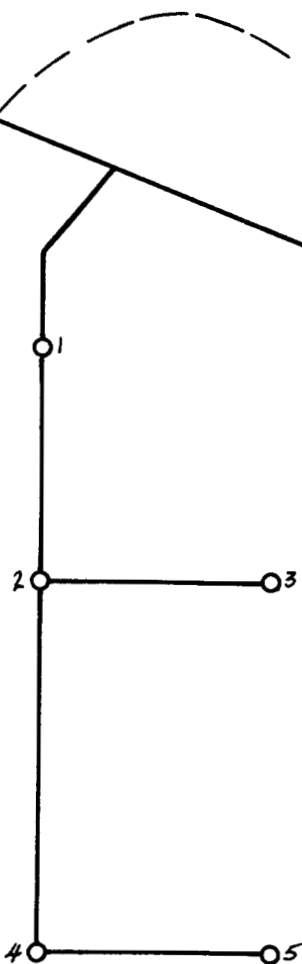
- SUBSOIL SANDY GRAVEL.
- EXCELLENT GRANULAR BORROW.
- NO PERMAFROST.
- DRY TO APPROX 13'-15' WET BELOW.
- SAME FEATURE AS B98 AND B98A ARE LOCATED ON.

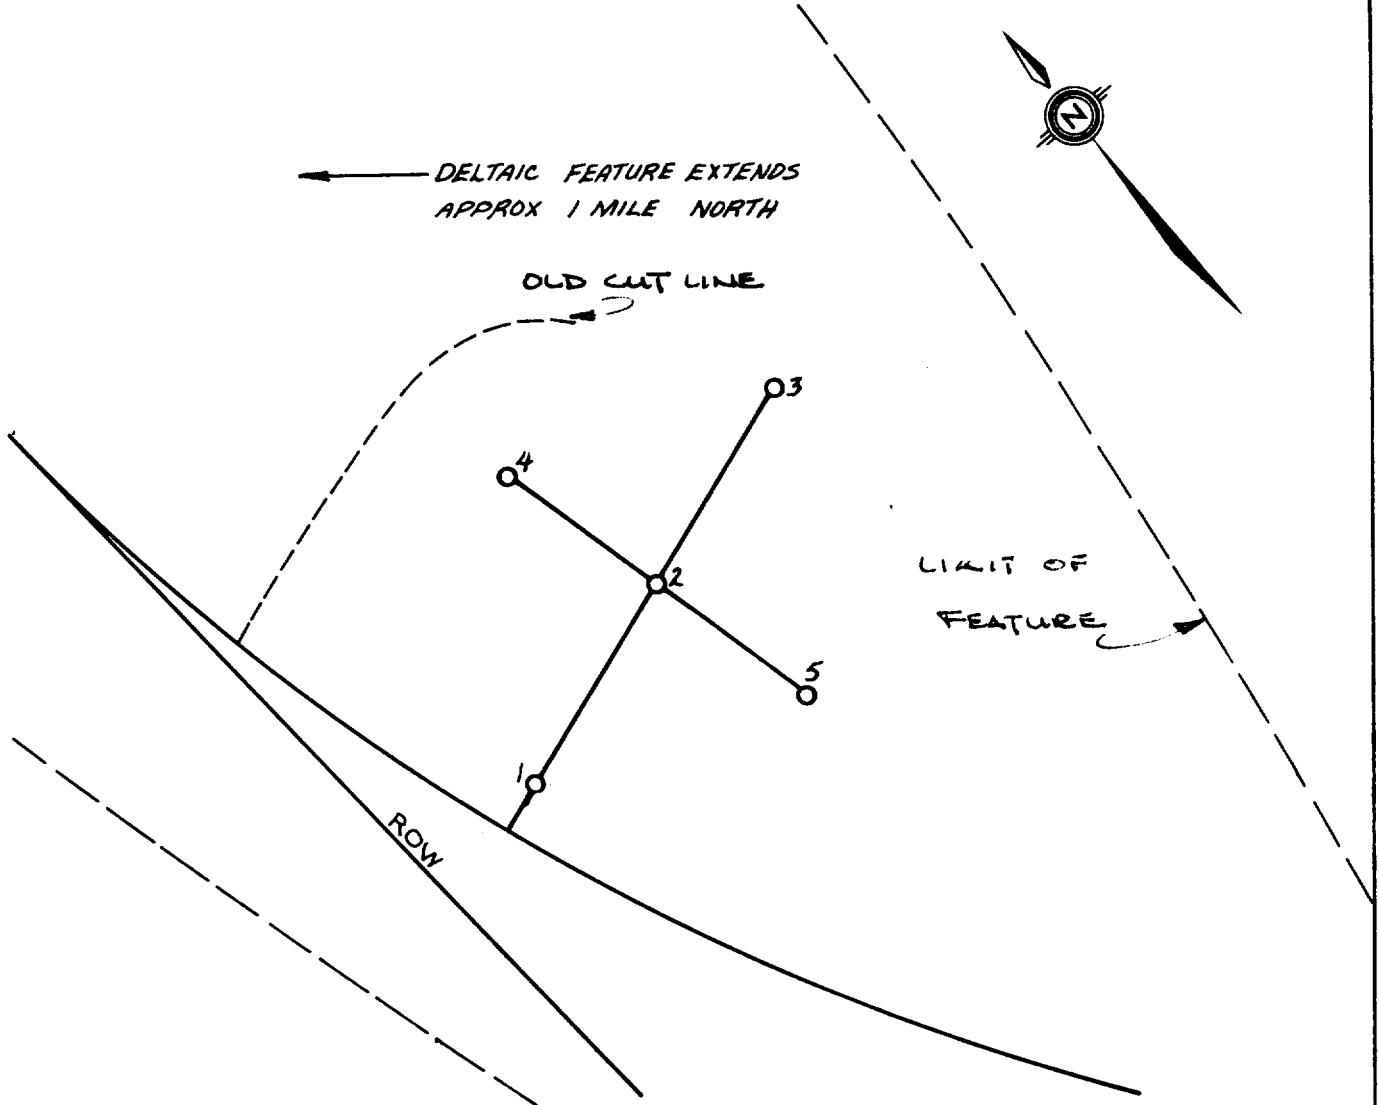
MILE 508.8 - 600' LT OF R

The area test drilled here is part of a deltaic sand deposit within a glaciolacustrine plain. The deltaic feature rises slightly above the adjacent flat plain and covers an area of approximately one mile in length and one-half mile in width. Pit No. 103 is near the south-end of the feature. Deposits consist of fine to coarse gravelly sand to the depth of 11 or 12 feet, overlying low plastic sandy silty clay with pebbles. Permafrost is expected to be absent from the site. Moisture contents are generally 10 to 12% or lower, however, there is sufficient moisture that the sandy material is wet. The right-of-way traverses the deltaic deposit to approximately Mile 509.7 and it is anticipated that similar material will be encountered anywhere along that section, thus a borrow pit can be developed wherever it is most favorable for haul economics. The material is considered to be usable borrow despite the wet zones. Strip-ping will likely be less than 2 feet.

- FEATURE IS DELTAIC DEPOSIT - SANDS TO 11-12' OVER SILTY CLAY
- LITTLE OR NO PERMAFROST
- MOISTURE CONTENTS  $\angle$  15% BUT SANDS TEND TO BE WET
- CONSIDERED TO BE USEABLE MATERIAL
- PIT CAN LIKELY BE LOCATED ANYWHERE BETWEEN MILE 508.8 AND 509.7 FOR BEST HAUL ECONOMICS - MATERIAL SHOULD BE SIMILAR.

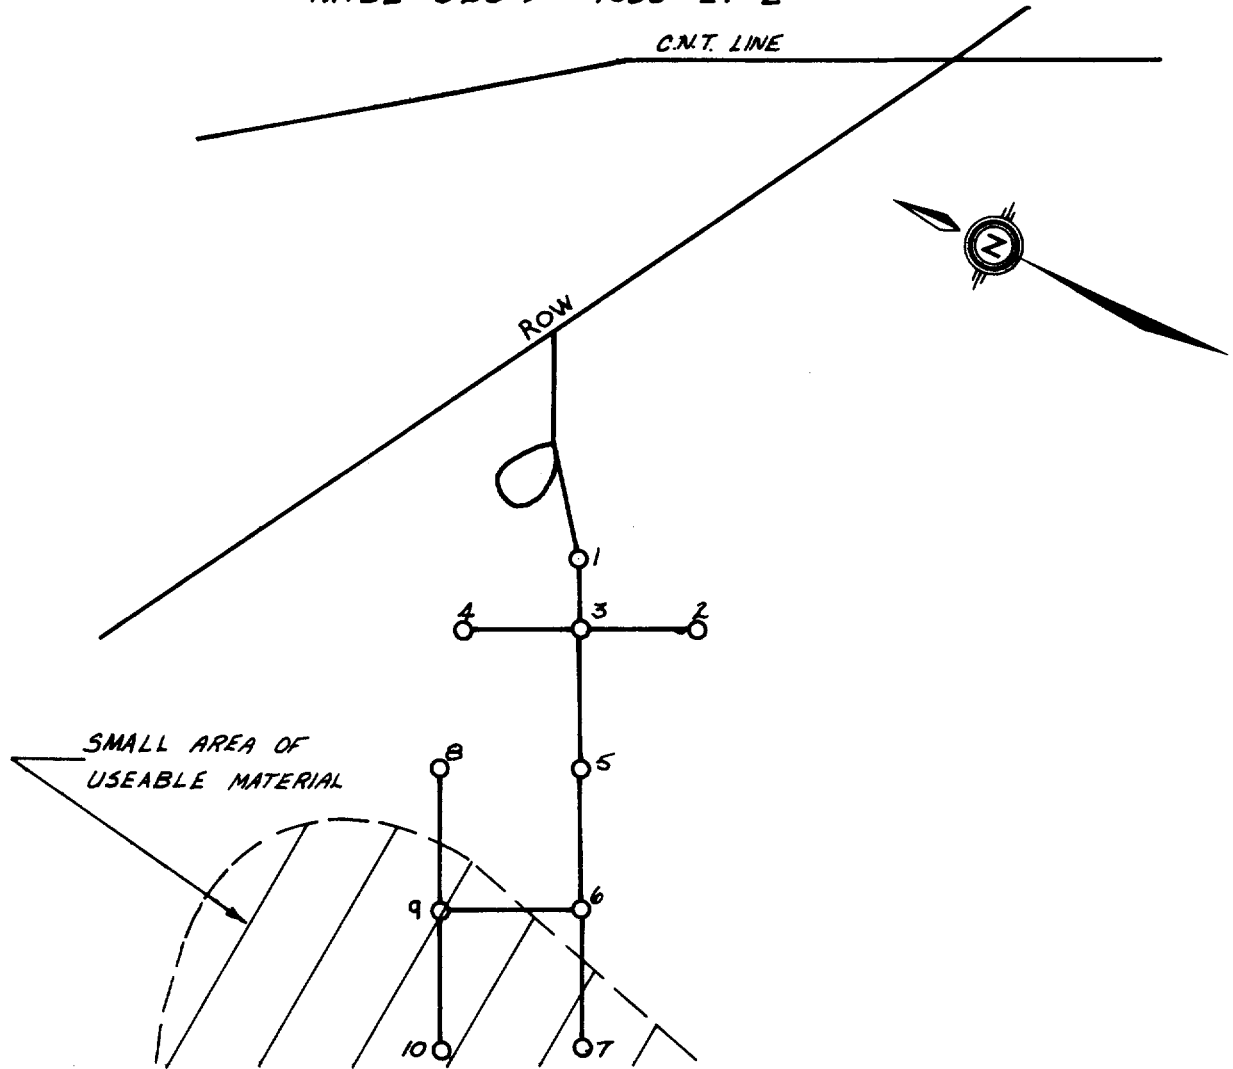
MILE 520.9 - 1000 LT 2

- SUBSOIL SILTYSANDS AND SOME SAND-GRAVELS OVER SANDY SILTY CLAY
- PERMAFROST THROUGHOUT AND MOISTURE (ICE) CONTENTS VARIABLE AND ERRATIC
- SOME USEABLE MATERIAL IN HATCHED AREA WITH 2.3' OF STRIPPING
- FURTHER DRILLING RECOMMENDED AT CONSTRUCTION.

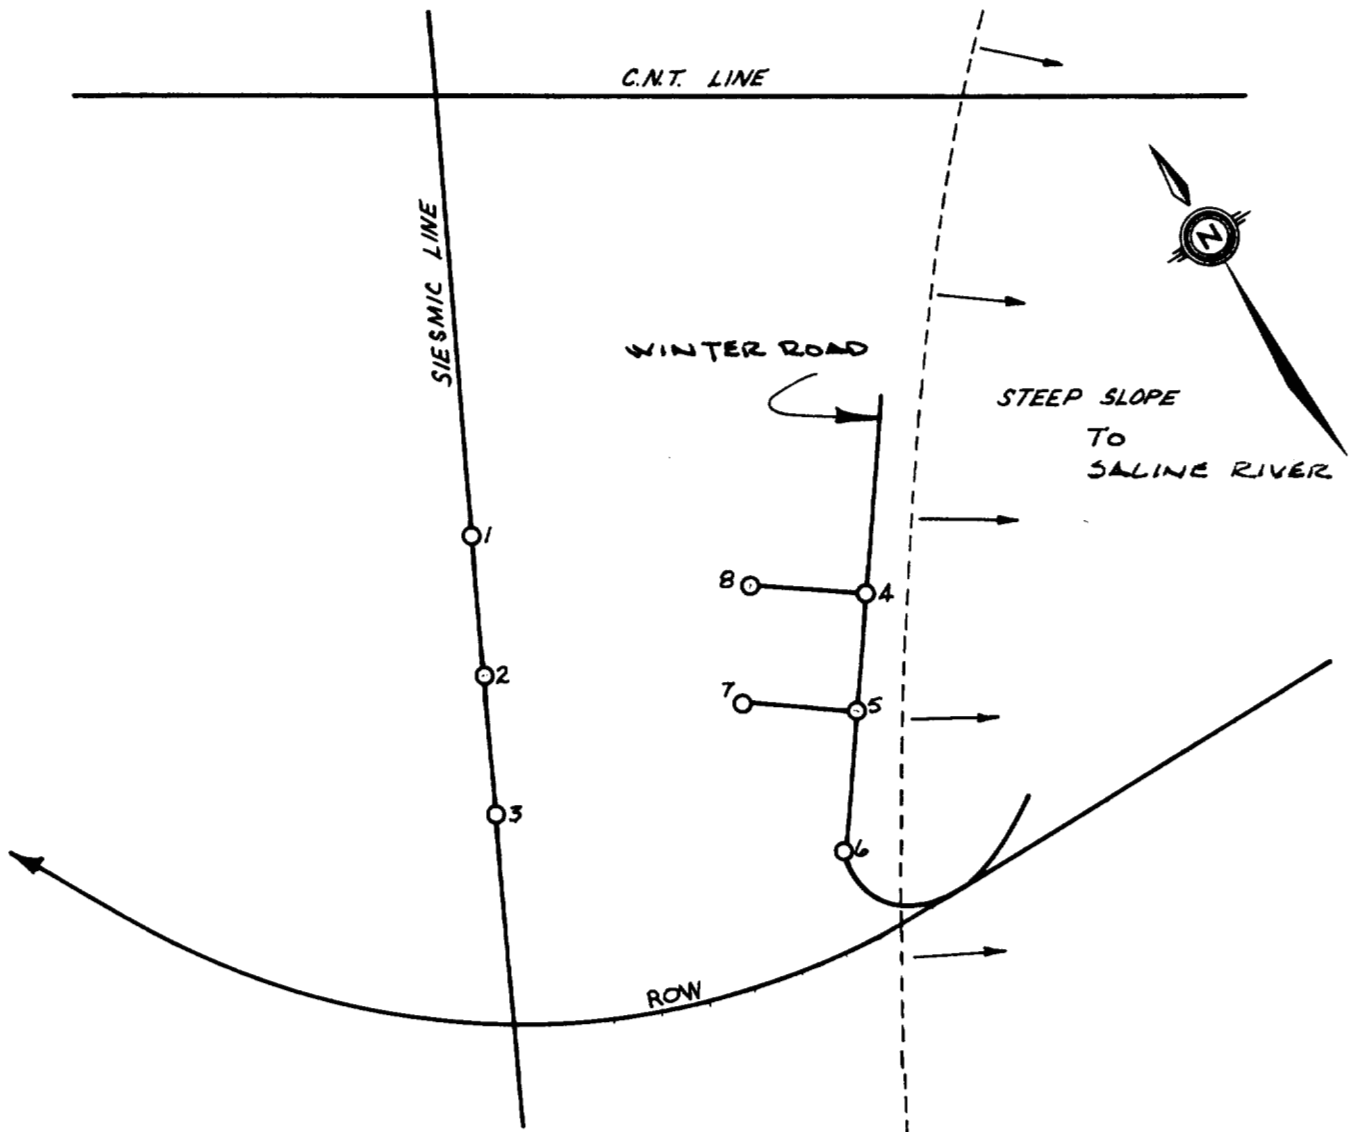
MILE 521.8 - 700' RT 2

The area test drilled here is on flat terrain above the north-western valley slope of the Saline River. The tree cover is willow and sparse birch. Subsoil is low to medium plastic sandy silty clay with pebbles - probably glacial till. Permafrost is continuous, however, visible ice is low and moisture contents on thawing are in the 15 to 18% range and near the plastic limit. Stripping should be less than 2 to 3 feet. This is considered to be a usable borrow source.

- SUBSOIL LOW TO MEDIUM PLASTIC SANDY SILTY CLAY WITH PEBBLES (TILL)
- FROZEN WITH MOISTURE (ICE) CONTENTS  $\approx$  PLASTIC LIMIT @ 15 to 18%
- USEABLE BORROW
- WILLOW AND BIRCH TREE COVER
- STRIPPING ESTIMATED @  $\angle 2.3'$

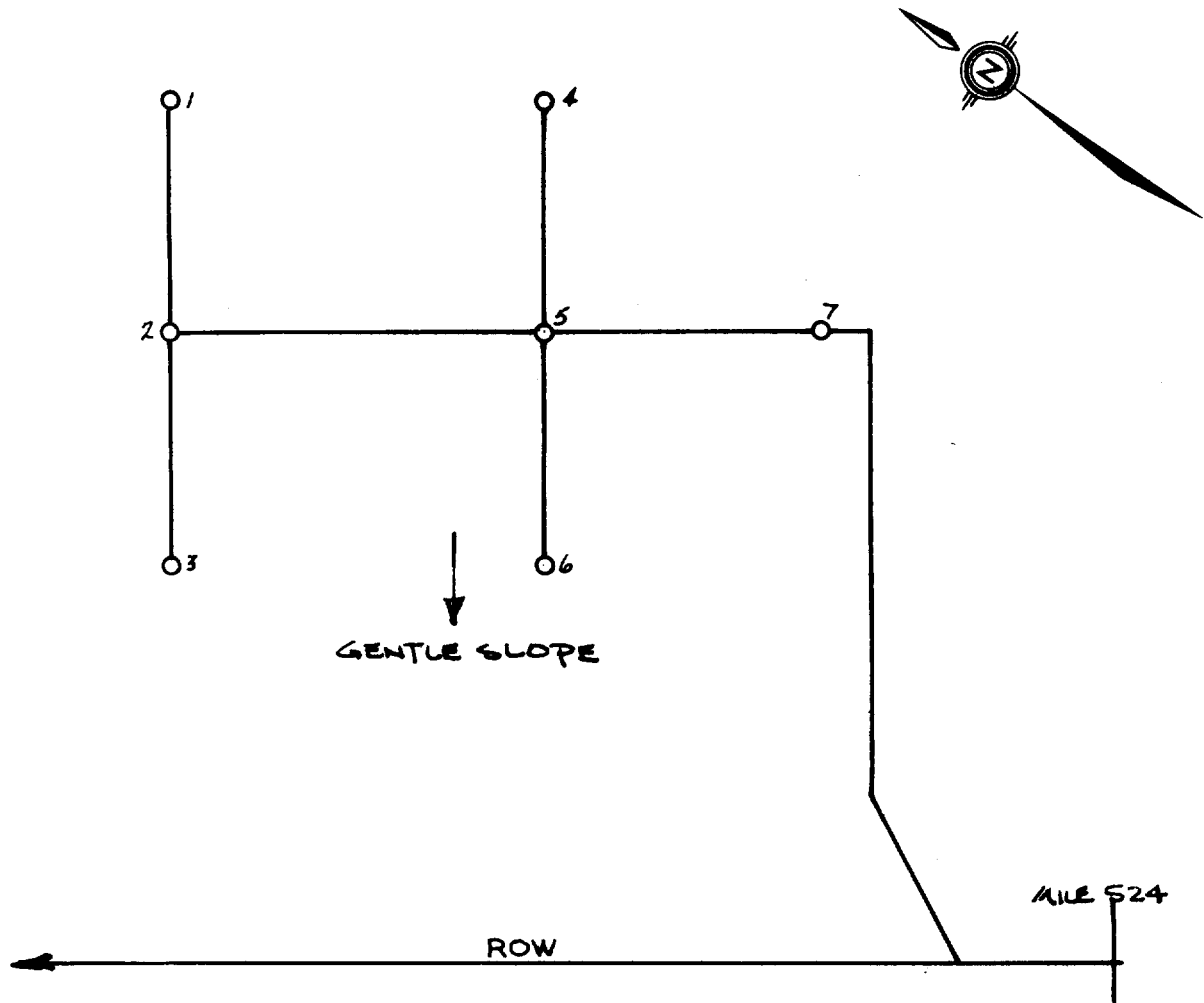
MILE 524.1 - 600' RT OF E

This pit was selected on the basis of a previous drilling program and the current drilling was for the purpose of expanding and confirming the borrow area. The feature drilled is a low till ridge. Subsoil is low to medium plastic sandy silty clay with pebbles (till). The ridge appears to be unfrozen and moisture contents vary around 10 to 12% and below the plastic limit. This is an excellent borrow source.

- FEATURE IS A LOW TILL RIDGE
- SUBSOIL UNFROZEN, LOW TO MEDIUM PLASTIC, SANDY SILT CLAY WITH PEBBLES
- MOISTURE CONTENTS - 10-12%
- 3TRIPPING  $\angle 2'$
- EXCELLENT BORROW SOURCE

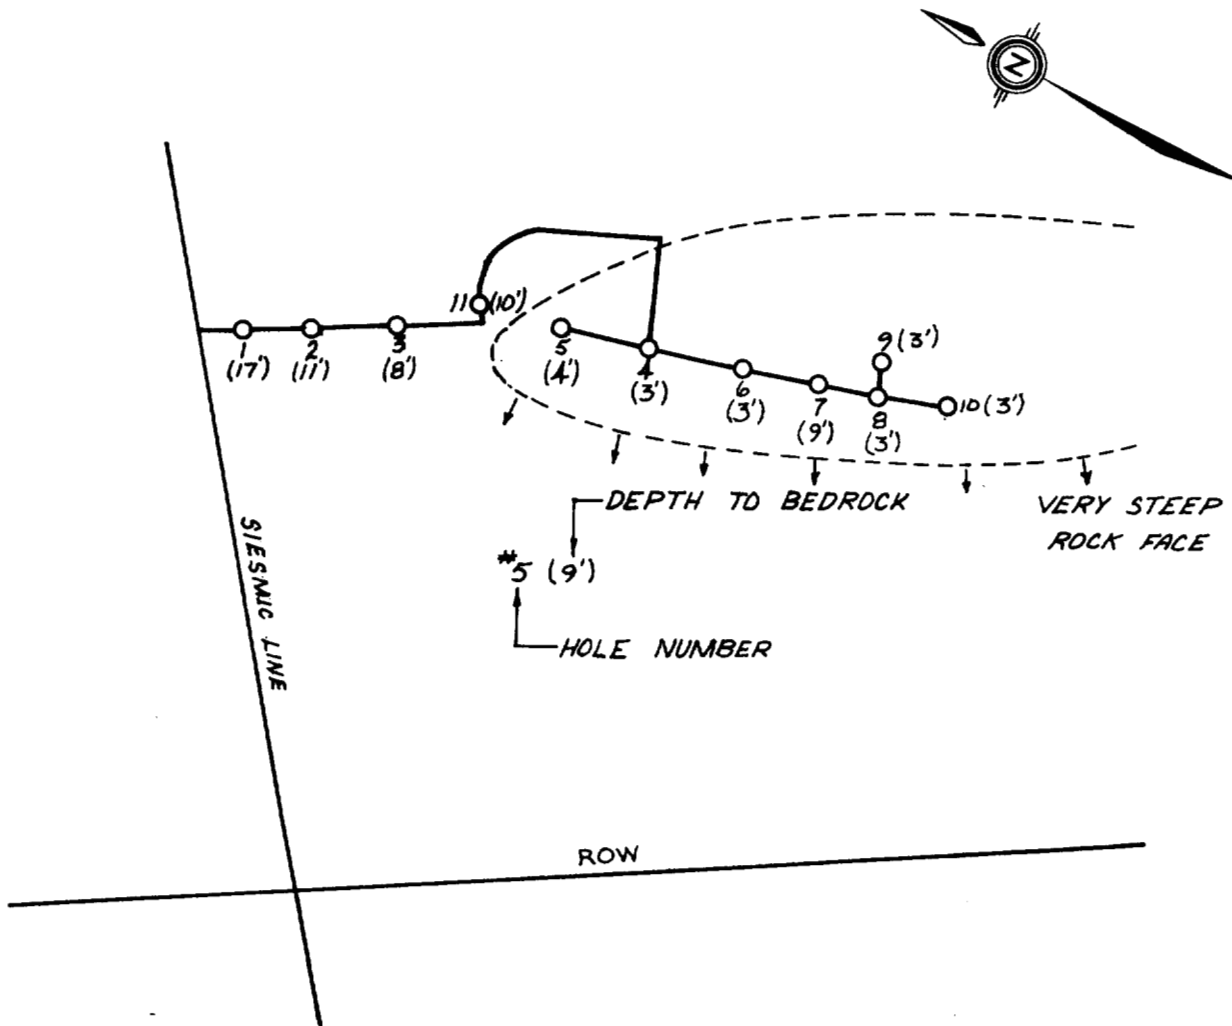
MILE 526 - 3000' RT OF E

The feature drilled here is a narrow, elongate bedrock ridge which roughly parallels the right-of-way. The ridge is sharply defined on the west with steep exposed rock faces, and access was gained on the more rounded slopes to the east. Bedrock is shales and dolomite with variable cover consisting of sandy silty clay till. The overburden till is at low moisture contents and is usable borrow. The underlying bedrock was categorized as soft by the field crews, however, it is anticipated that blasting of bedrock will be required for borrow. Depths to bedrock are shown for each hole on the site plan.

- SUBSOIL CLAY TILL OVER SHALE AND/OR DOLMITE
- CLAY TILL IS USEABLE WITH LITTLE STRIPPING < 2'
- BEDROCK IS CATEGORIZED AS SOFT BUT BLASTING IS ANTICIPATED FOR BORROW

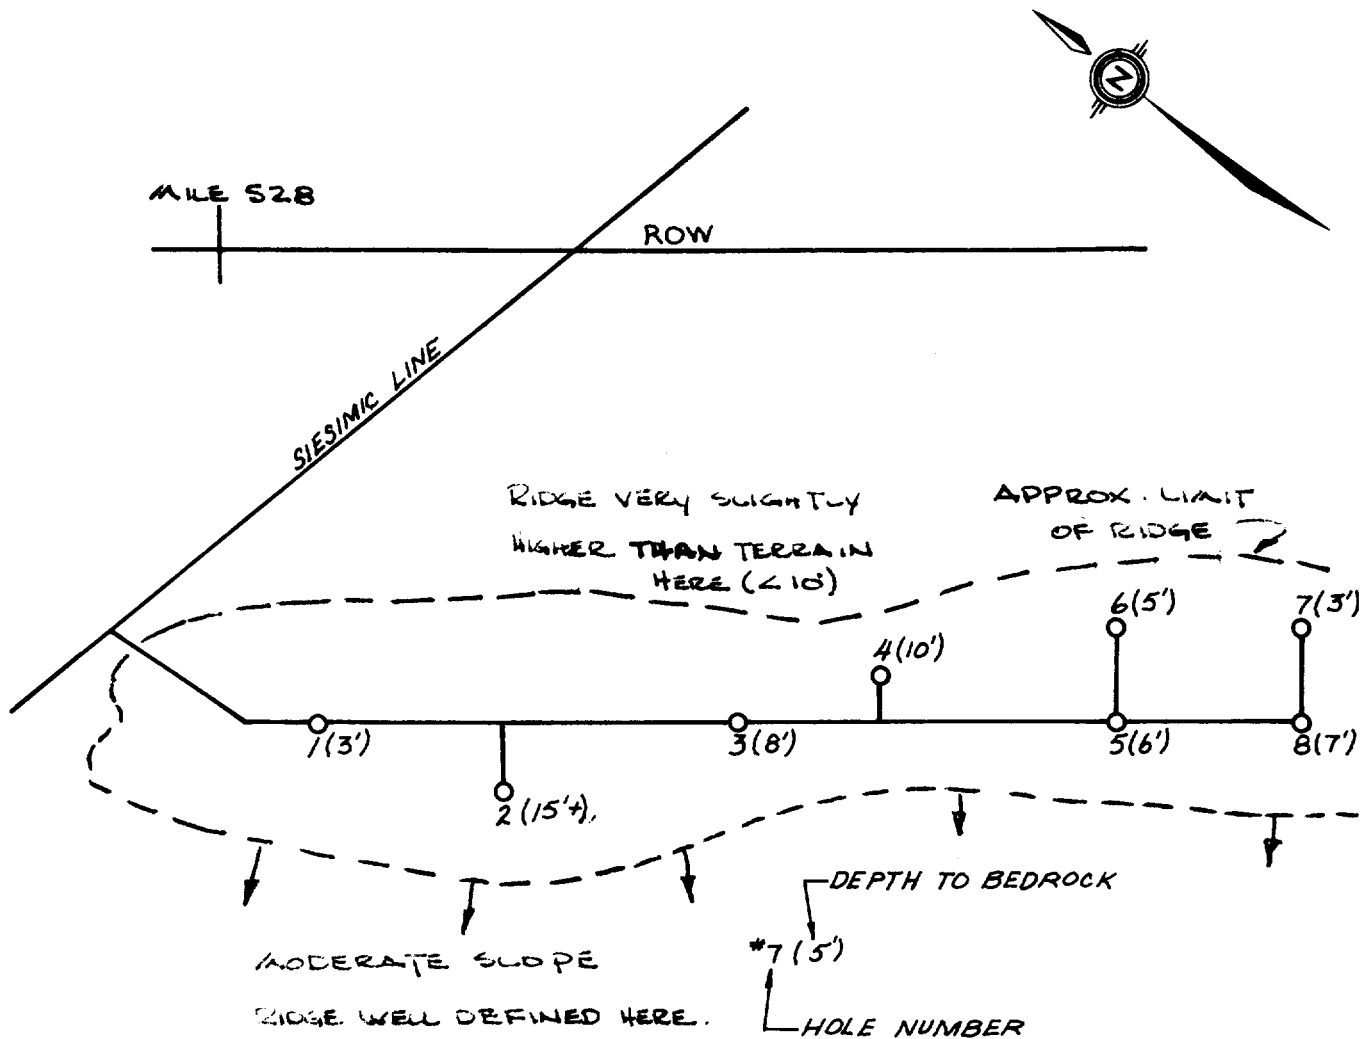
MILE 527.7-1000' LT OF E

This feature is an elongate ridge similar to Borrow Pit No. 115 but smaller and with less relief. The western edge of the ridge is defined by a moderately steep slope, whereas on the east, the level of the ridge is only slightly above the surrounding terrain. Bedrock is shales and sandstones with overburden consisting of variable thicknesses of sandy silty clay till and decomposed bedrock. The overburden is at a low moisture content and can be used with very little stripping. The bedrock is rather unusual as it appears there are relatively soft clay-like seams within the layers of shale and sandstone. It is considered quite possible that the bedrock can be ripped and blasting may not be required here. Depths to bedrock are shown for each hole on the site plan.

- GLACIAL TILL OVER SHALES AND SANDSTONES WITH CLAY SEAMS
- TILL IS USEABLE WITH LITTLE STRIPPING  $\angle 2'$
- BEDROCK WAS CATEGORIZED AS SOFT AND RIPPING MAY BE POSSIBLE

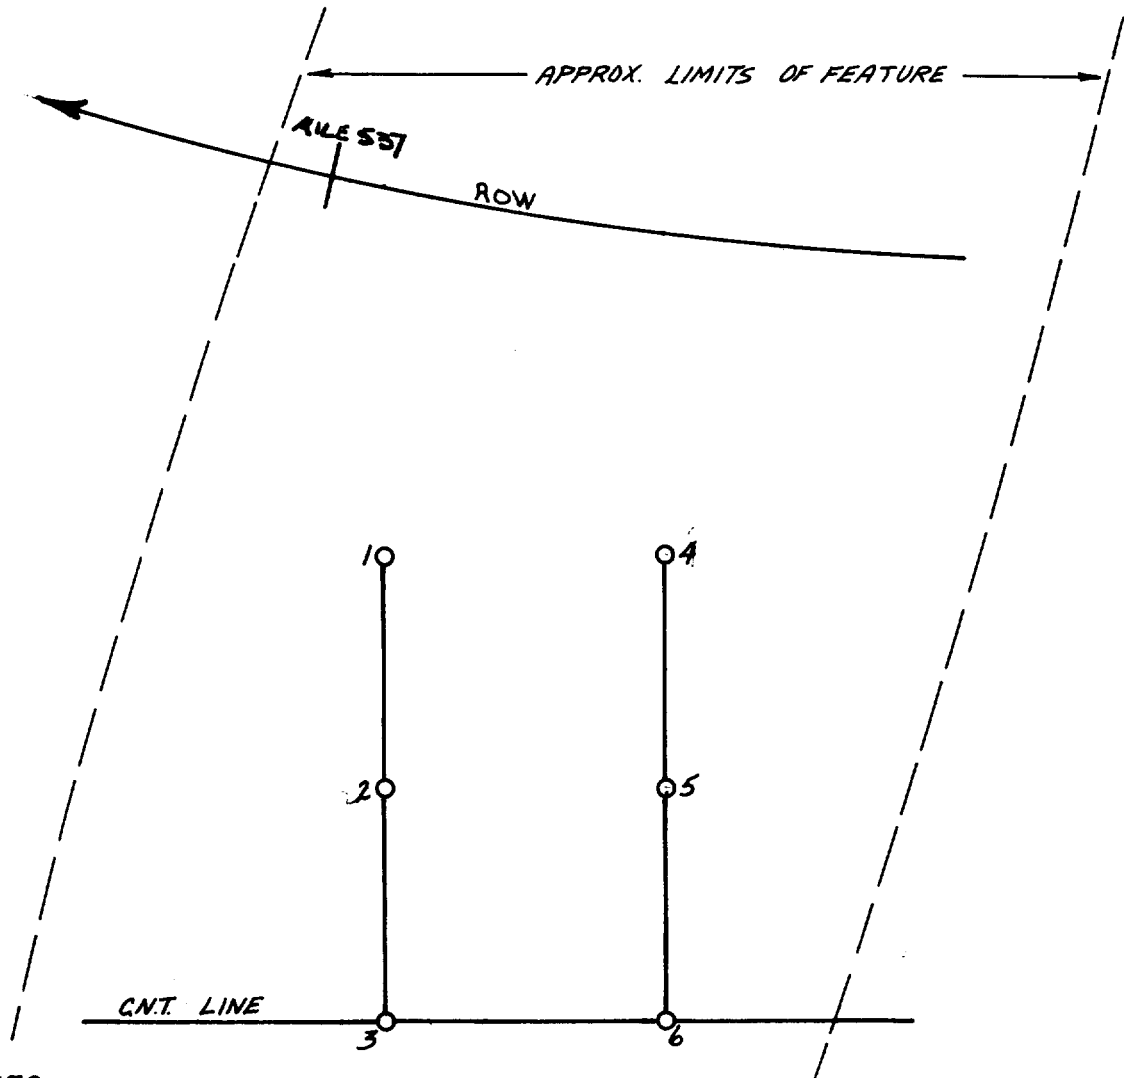
MILE 537.0 - 700' LT OF E

Borrow Pit No. 117 is located on a small fluvial deposit - probably a glacial outwash feature. This area was selected as a borrow source from previous drilling and the current drilling was carried out to confirm and expand the indicated borrow area. The feature is only slightly higher than the surrounding flat, poorly drained, terrain, but is differentiated by a more luxuriant growth of spruce and poplar to 1' diameter. Subsoil is silty and gravelly sand. Permafrost is absent and moisture contents are generally less than 5% to the depth of 15 or 20 feet. Below this level the material becomes wet and limits the depth of usable material. Strip-ping is estimated at 1 to 2 feet.

- FLUVIAL DEPOSIT OF SILTY SANDS AND GRAVELLY SANDS
- NO PERMAFROST
- MOISTURE CONTENTS  $\angle 5\%$  TO 15-20' - WET BELOW
- LOWER LIMIT OF USEABLE MATERIAL @ 15-20'
- MODERATELY HEAVY SPRUCE AND POPLAR COVER

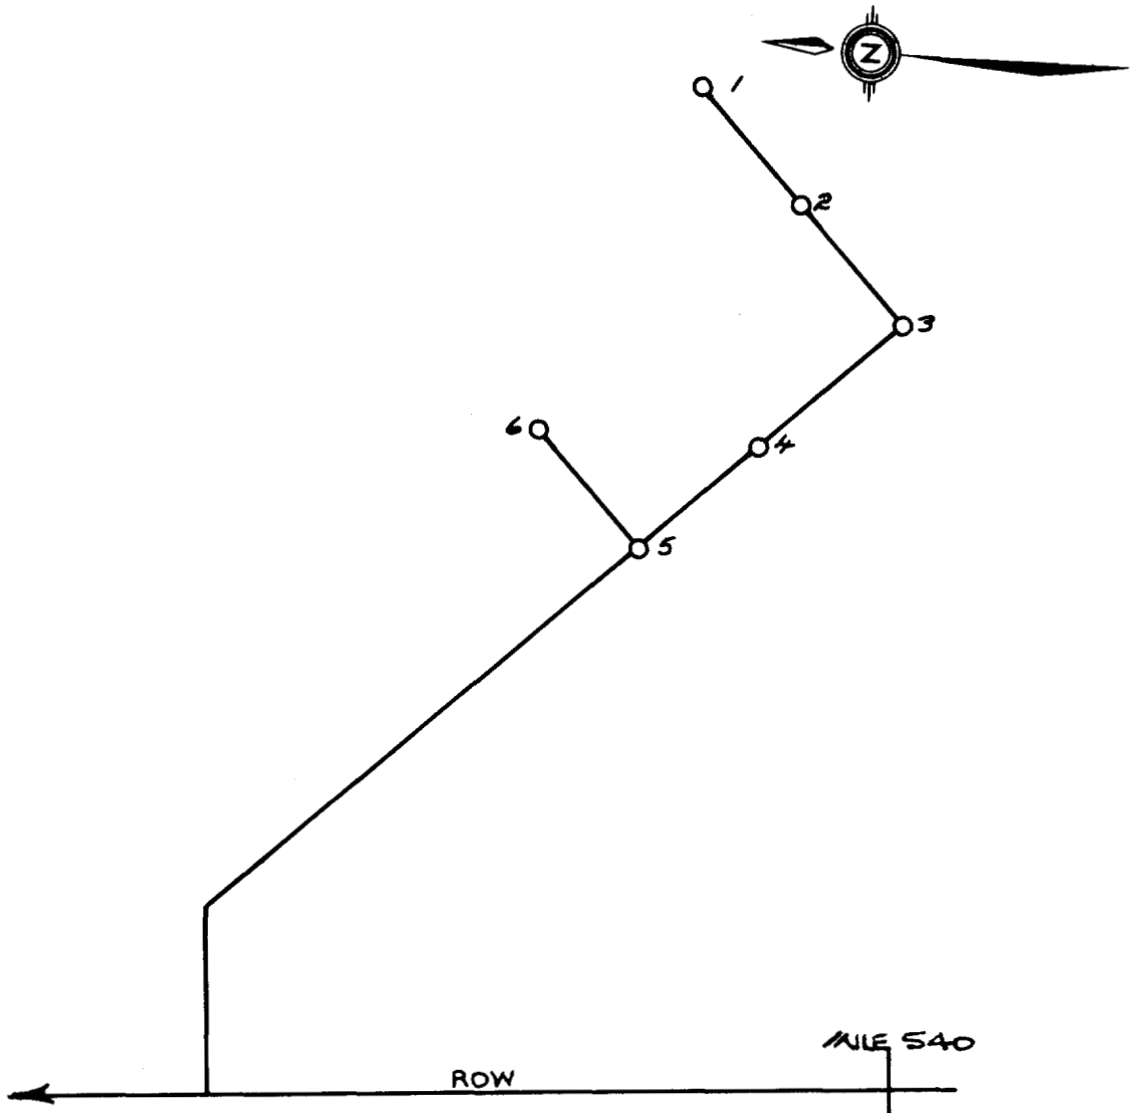
MILE 540-1 - 1000' RT OF E

In Borrow area 119 at Mile 540.1 the subsoil consists of variable thicknesses of silts, sands, and sandy gravels, over sandy silty clay till. The low plastic surface deposits tend to be wet upon thawing and stripping depths here could vary up to 5 feet. Materials below the stripping is generally usable although some high ice zones were encountered. This area is considered to contain usable borrow at depths and is probably superior to Pit No. 118 however, the stripping costs may negate against development.

- SUBSOIL IS SILTS, SANDS, AND GRAVELS OVER CLAY TILL AT VARIOUS DEPTHS
- PERMAFROST PRESENT
- STRIPPING DEPTHS TO  $\approx 5'$
- USABLE BORROW AT DEPTH
- DEVELOPMENT DEPENDENT ON HAUL ECONOMICS.

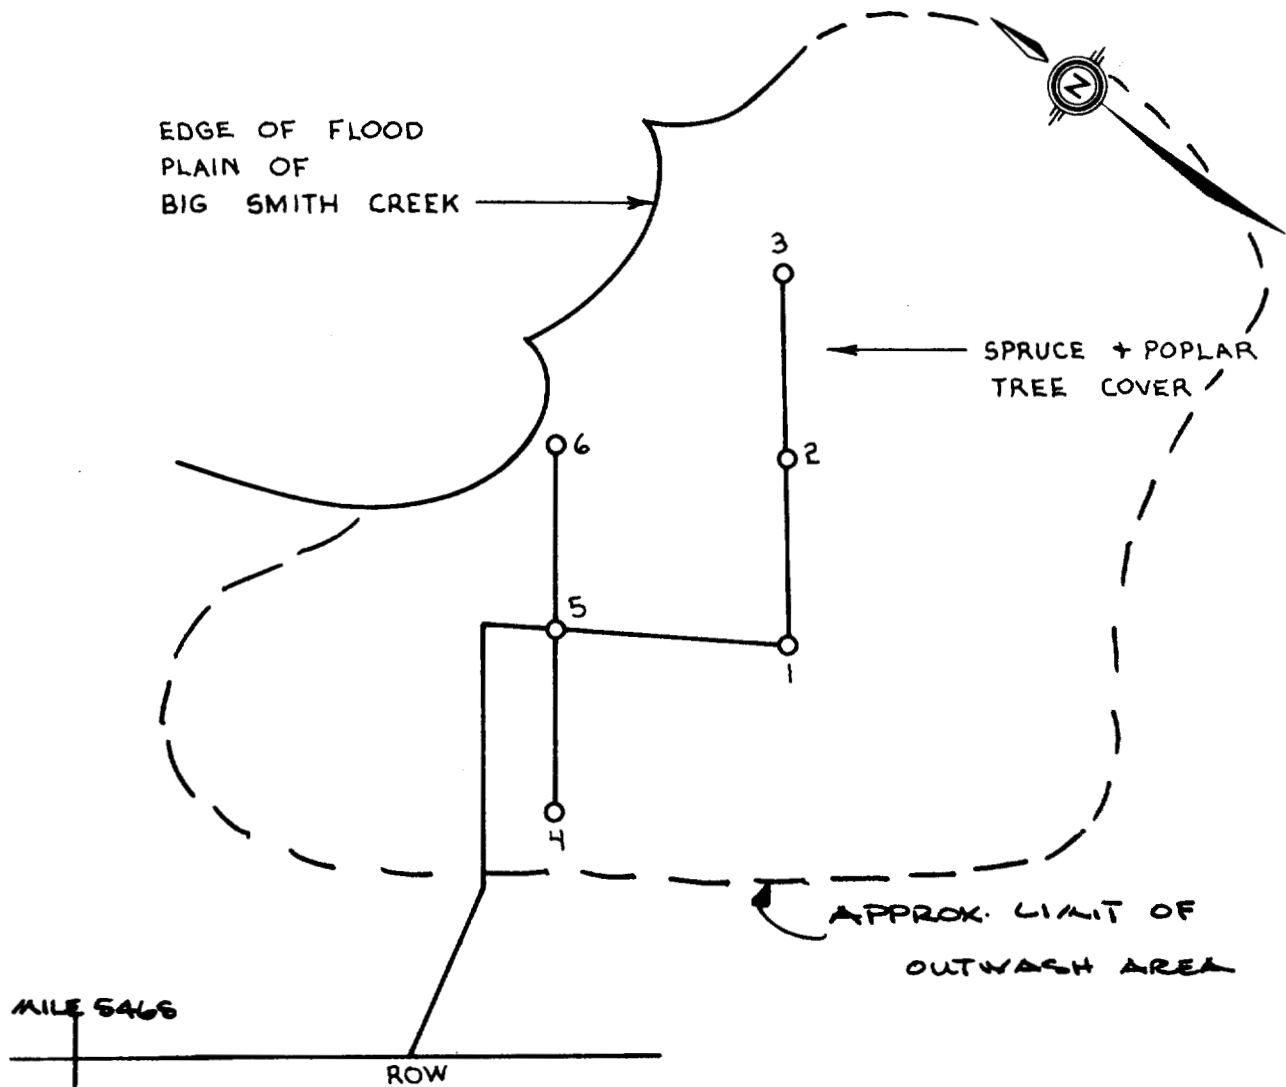
# MILE 545.85-1000' RT. OF 4

The area test drilled here was designated as a borrow area from a previous drilling program and the current program was for the purpose of expanding and confirming the borrow source. The feature in which the pit is located is thought to be an outwash delta which rises slightly above the adjacent, flat, glaciolacustrine plain. Subsoil varies from fine to coarse sand, to gravelly sand, to sandy gravel. The area would appear to be unfrozen and moisture contents are less than 10% and average around 5%. This area should provide large volumes of good borrow material as the available area should be in excess of 1000 feet x 1000 feet.

SUBSOIL SANDS, GRAVELLY SANDS + SANDY GRAVELS  
 APPEARS TO BE PERMAFROST FREE  
 MOISTURE CONTENTS < 10% - AVERAGE 5%  
 GOOD BORROW SOURCE

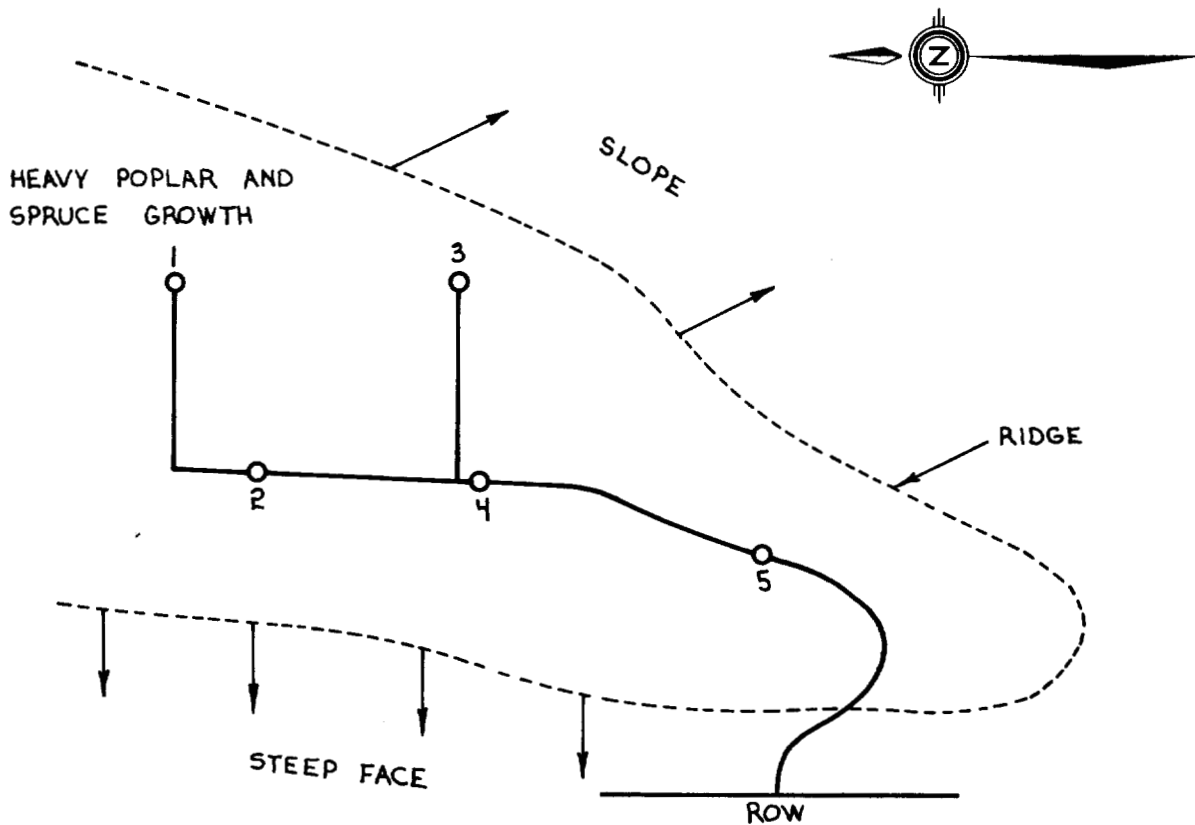
MILE 554.4-600' RT. OF E

Permafrost appears to be sporadic in Pit 131 and generally absent in Pit 132. Pit area 132 is preferred here although several large cuts in the right-of-way will likely permit a balanced design and eliminate the need for additional borrow.

- FEATURE IS IN A LARGE STABILIZED SAND DUNE
- SUBSOIL FINE, POORLY GRADED SAND
- GENERALLY UNFROZEN - MOISTURE CONTENTS NEAR 5%
- USEABLE BORROW
- RECOMMENDED IF ADDITIONAL BORROW REQUIRED IN THIS AREA
