**GEOTECHNICAL INVESTIGATION**

MILE 347 TO MILE 690 MACKENZIE HIGHWAY  
WINTER - 1975

REPORT ON  
GEOTECHNICAL INVESTIGATION  
MILE 347 TO MILE 690  
MACKENZIE HIGHWAY

Submitted by R.D. Cook, P.Eng.  
Materials Engineer  
February 1, 1976

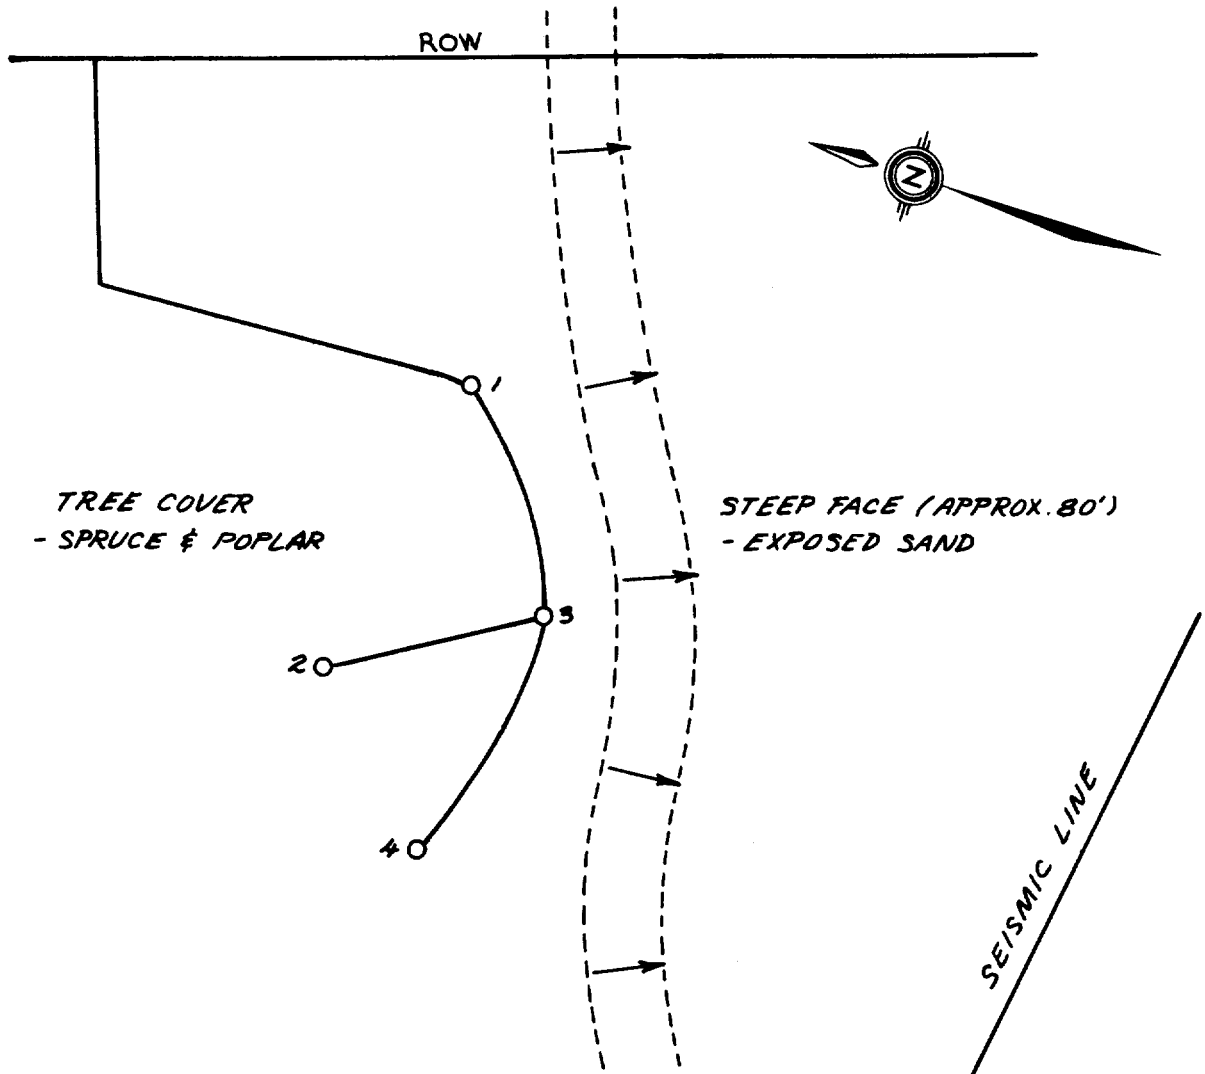
MILE 556.8 - APPROX. 350' LT E

The area test drilled here is part of a major sand dune complex located on an ancient glacial lake-bed. There is a steep face of some 80' on the south of this feature while on the north the dune has a flat profile and is coincident with the surrounding terrain. This area was previously drilled by consultants and the current program was for the purpose of confirming and expanding the area. The sand is fine, poorly graded and slightly silty. The material near the exposed face tends to be permafrost free and relatively dry, whereas back from the face, permafrost is continuous and moisture contents on thawing vary from 5% to as high as 20%. Moisture contents tend to increase with depth below the level of the active thaw zone which appears to vary from roughly 6 feet to 12 feet nearer the face. There is usable borrow here with the preferred development area along the exposed south facing slope.

- SUBSOIL IS FINE, POORLY GRADED SAND
- DRY TO LEVEL OF ACTIVE THAW ZONE
- WET BELOW ON THAWING
- DEPTH OF THAW DECREASES BACK FROM THE FACE
- PREFERRED DEVELOPMENT AREA ALONG EXPOSED FACE

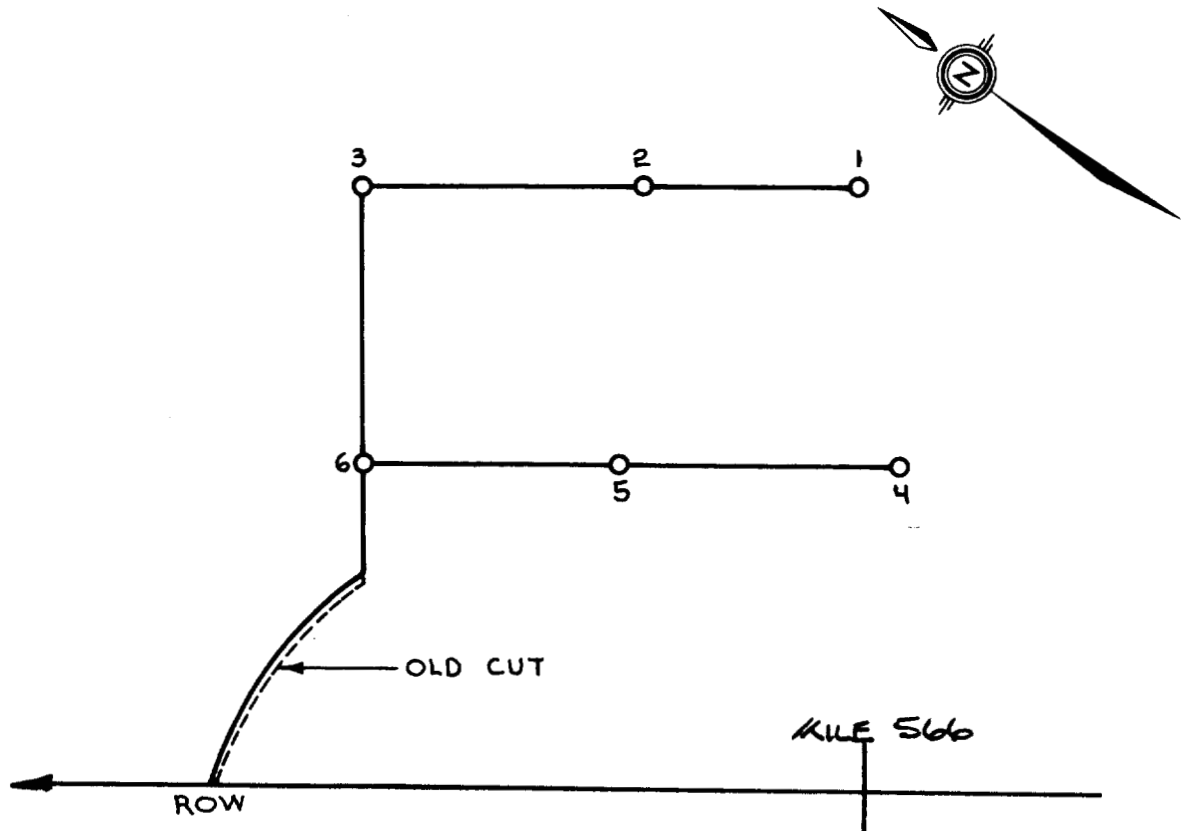
MILE 566.1-500' RT. OF E

Pit No. 135 is located on a better drained portion of a flat, poorly drained, deltaic sand plain. Tree cover is moderately dense spruce and poplar to 6" diameter. The subsoil is silty fine sand. Permafrost is continuous and moisture contents upon thawing generally range between 10 to 20% and the sand is wet or saturated when thawed. Use of this pit would require that the material be placed in a frozen condition and allowed to thaw and consolidate before capping with a trafficable material.

- SUBSOIL FROZEN, FINE, SILTY SAND
- MOISTURE CONTENTS ON THAWING 10 TO 20%
- GAND IS WET OR SATURATED WHEN THAWED
- USE OF THIS PIT WILL REQUIRE MATERIAL  
BE PLACED IN FROZEN STATE AND ALLOWED  
TO THAW AND CONSOLIDATE BEFORE CAPPING

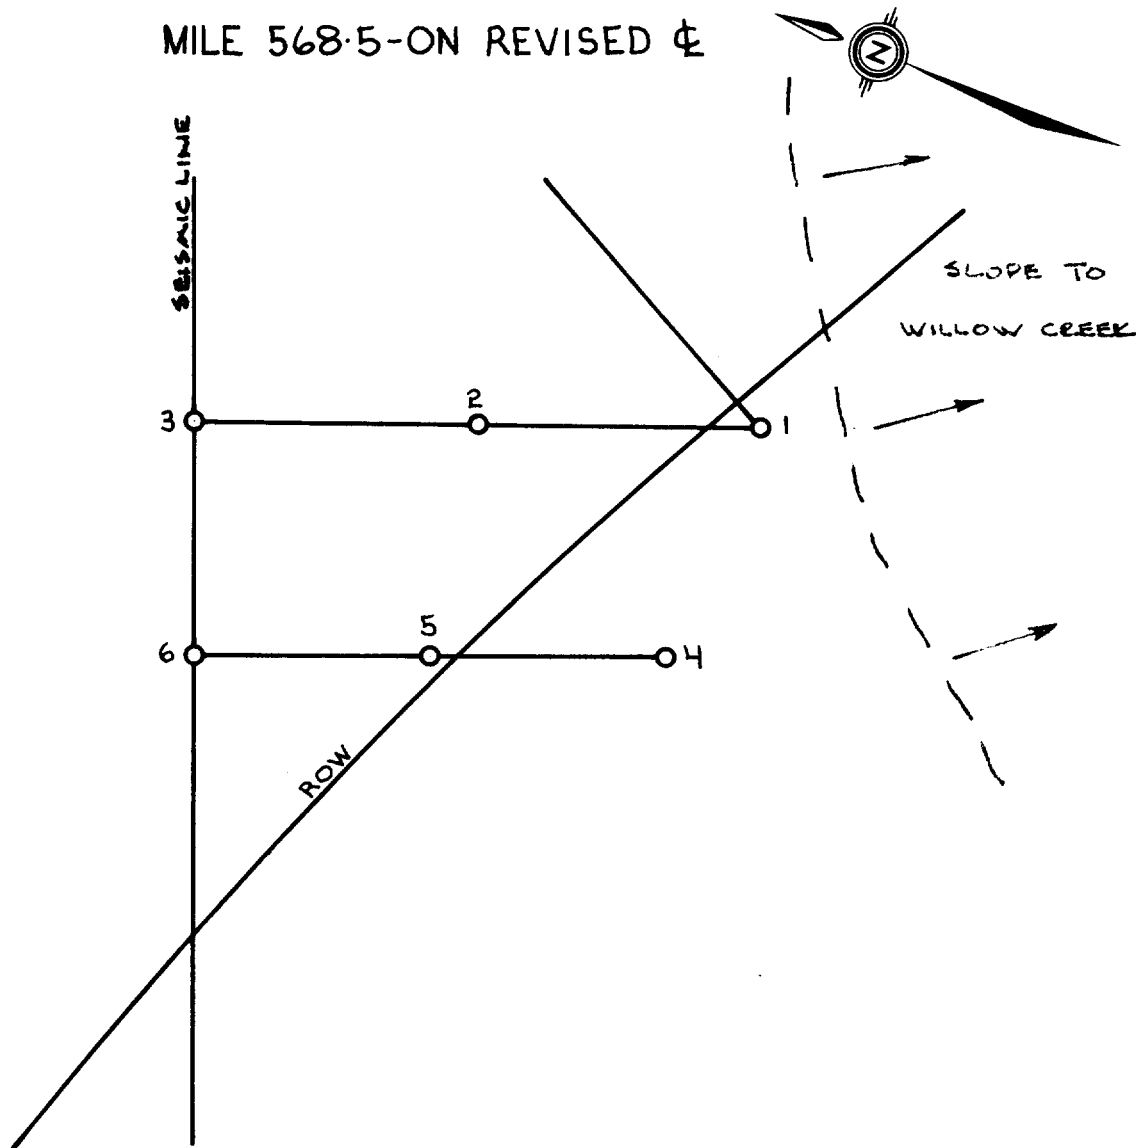
# MILE 568.5-ON REVISED &

Borrow Pit No. 136 is located above the north valley slope of the small Willow Creek Valley. Subsoil here consists of silty sands and sandy silts. Permafrost is sporadic but present over the majority of the area and most of the materials on thawing are in a wet or saturated state. There is some usable material here along the top of the valley slope, however, for the most part, the use of this pit will require that the material be placed in a frozen state and allowed to thaw and consolidate before being capped with a trafficable material.

- SUBSOIL SILTY SAND & SANDY SILTY
- PERMAFROST PRESENT OVER MAJORITY OF SITE
- MATERIAL WET OR SATURATED UPON THAWING
- SOME USEABLE MATERIAL ALONG TOP OF VALLEY SLOPE

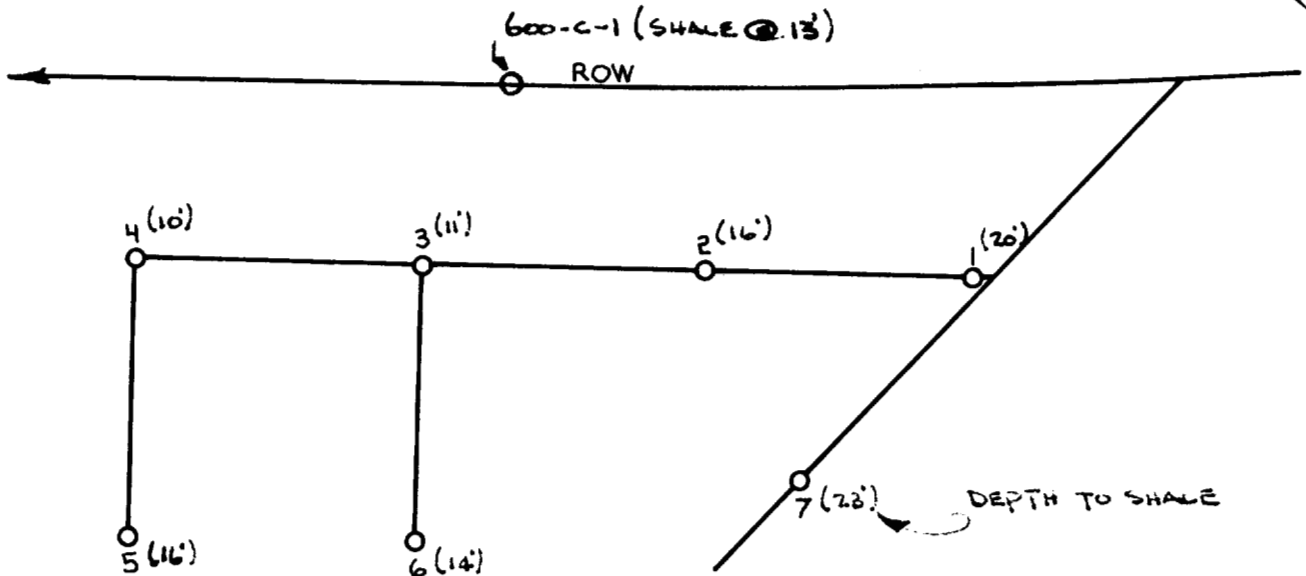
MILE 600.6-600' LT. OF E

Based upon previous drilling by consultants in this area, a borrow pit had been selected at Mile 600.3 on the right side of centerline or within approximately 1/4 mile of Borrow Pit No. 148. Subsoil in the designated pit was the same medium plastic clay till encountered in 148, however, bedrock was not encountered to a depth of 30 feet. Stripping depths between the two areas would appear to be comparable and Borrow Pit No. 148 can be considered a good alternate to the designated pit, providing there is a need or desire for shale as a construction material.

- SUBSOIL CLAY TILL OVER SHALE BEDROCK
- FROZEN - WET ON THAWING TO APPROX. 4' DAMP BELOW
- STRIPPING TO APPROX 4', 1-3' OF WHICH IS PEAT
- GOOD BORROW SOURCE

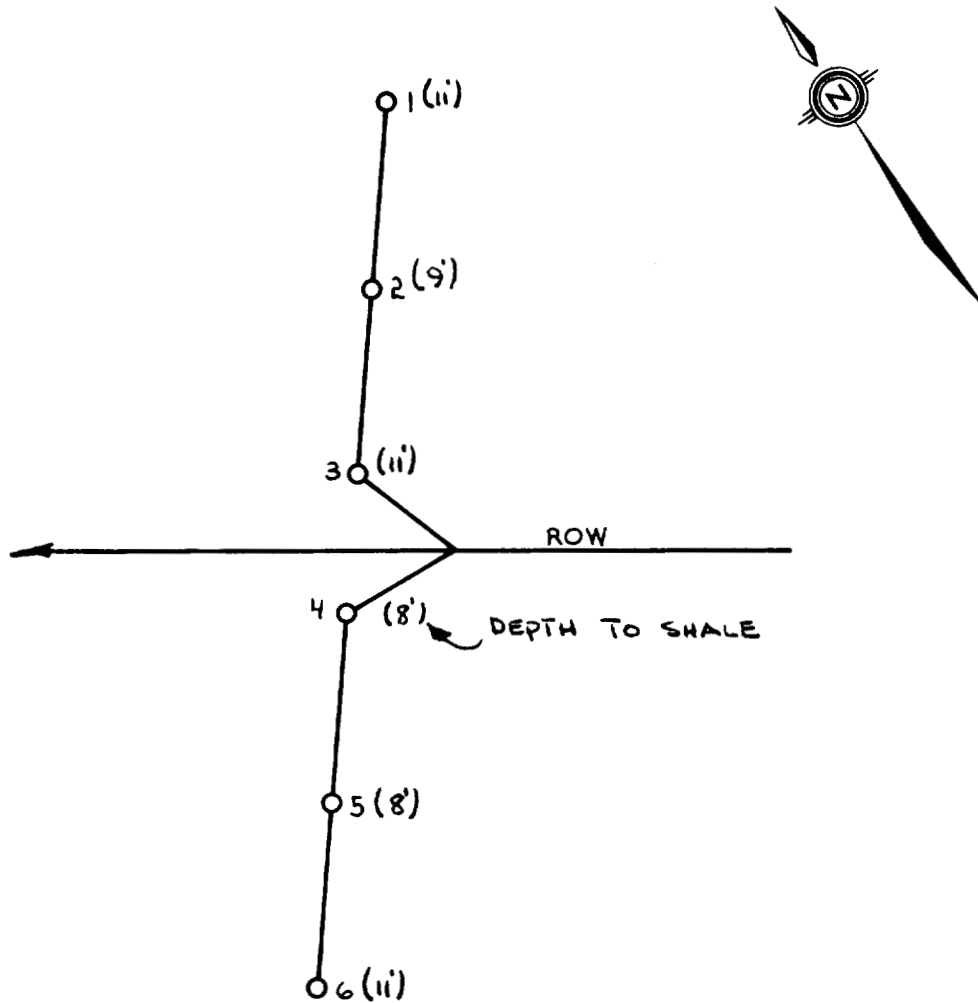
MILE 607.9-RT. & LT. OF E

These two areas were drilled in an attempt to locate shallow bedrock near the right-of-way. Subsoil is low to medium plastic sandy silty clay till over shale bedrock. Borrow Pit No. 151 at Mile 606.9 encountered shale at depths varying from 9 to 16 feet. The overburden till is usable below depths of 3 to 4 feet and much of the stripping is peat and organic soil. Borrow Pit No. 152 at 607.9 encountered shale at depths between 9 to 11 feet and the overburden till would appear to be usable below depths of 2 to 3 feet. Again much of the stripping would be peat and organic soils. Of the two areas, Borrow Pit No. 152 is preferred because of less stripping and development of Pit 152 is recommended if shale is preferred as a construction material over the clay till which is abundant in the area. The shale is described as soft by the field crews and possibly could be ripped with heavy construction equipment.

- SUBSOIL FROZEN CLAY TILL OVER SHALE
- STRIPPING ESTIMATED @ 2-3' MUCH OF WHICH IS PEAT & ORGANIC SOILS
- GOOD BORROW SOURCE

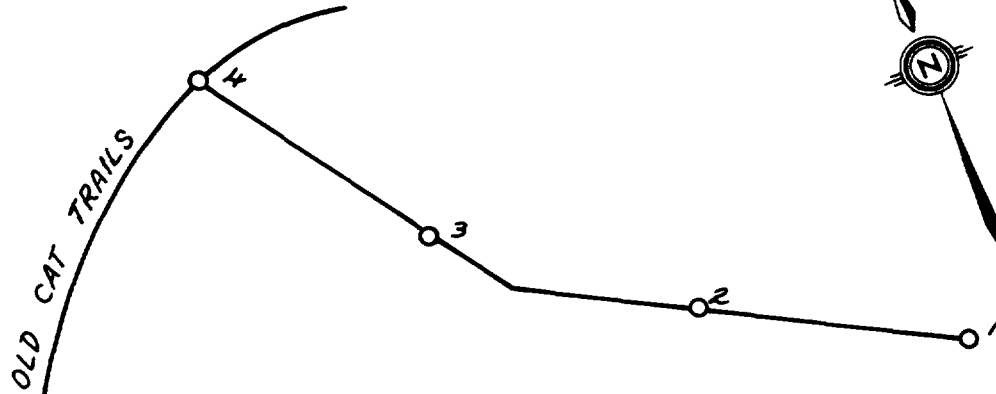
MILE 615.7 - APPROX. 1000' RT. OF E

The area test drilled here is a low beach ridge immediately south of Christina Creek. Subsoil consists of a very shallow surface layer of poorly sorted silt, sand and gravel, over low plastic sandy silty clay till. Drilling indicates permafrost is absent and moisture contents for the most part are less than 15% and slightly below the plastic limit. Stripping would appear to vary around 1 to 2 feet and although occasional wetter zones may be encountered in the upper 6 feet, it is anticipated this material could be incorporated in a fill. This area is considered to be a usable borrow source.

- SUBSOIL IS SANDY, SILTY CLAY TILL
- PERMAFROST APPEARS TO BE ABSENT
- STRIPPING ESTIMATED AT 1'-2'
- USABLE TILL BELOW AT MOISTURE CONTENTS & PLASTIC LIMIT
- GOOD BORROW SOURCE

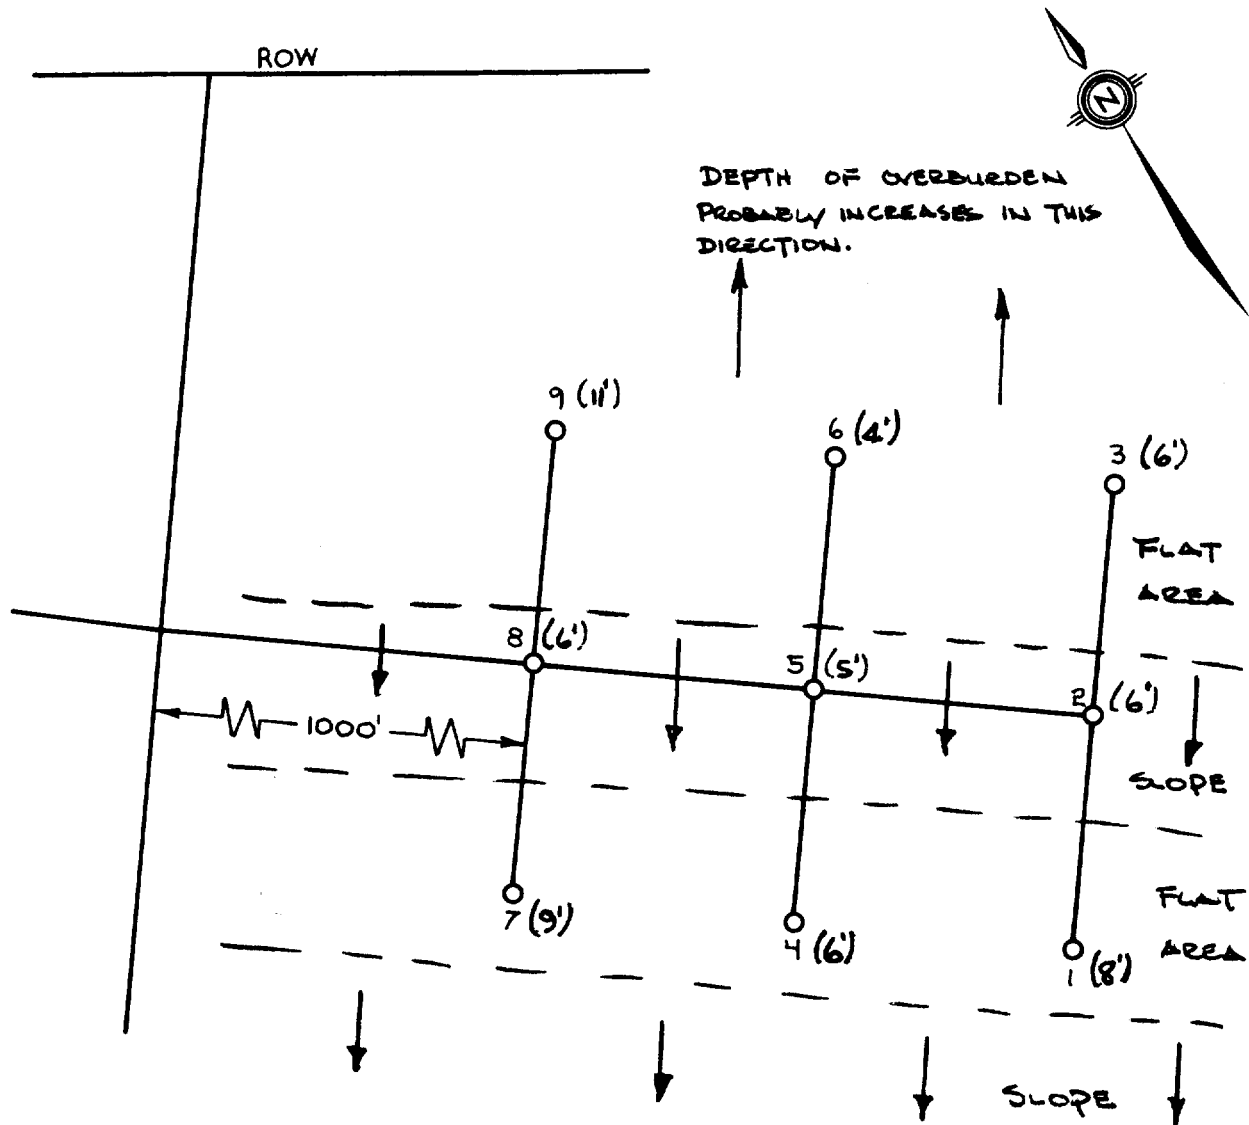
# MILE 624.7-700' LT. OF E

Test drilling here was to expand and confirm a pit that was selected on the basis of previous drilling by consultants. The feature is a bedrock controlled ridge with shallow till overburden. The ridge is elongate in the north-west south-east direction. It has a long moderate slope in the south-west direction however behind the ridge toward the right-of-way, there has been in-filling with slope wash and little relief is evident. Bedrock consisting of sandstones, shales, and possibly limestone was encountered at variable depths. Overburdened is primarily low plastic sandy silty clay till with some areas of sandy silt. Stripping depths could vary from 2 to possibly 5 feet. The bedrock is generally hard and a quarry operation will be required. Depths to bedrock in the area drilled could vary from 4 to 11 feet and average around 6 feet (see site plan).

- BEDROCK SHALES, SANDSTONES AND LIMESTONE
- OVERBURDEN PRIMARILY CLAY TILL - FROZEN
- STRIPPING ESTIMATED @ 1-2'
- QUARRY OPERATION REQUIRED

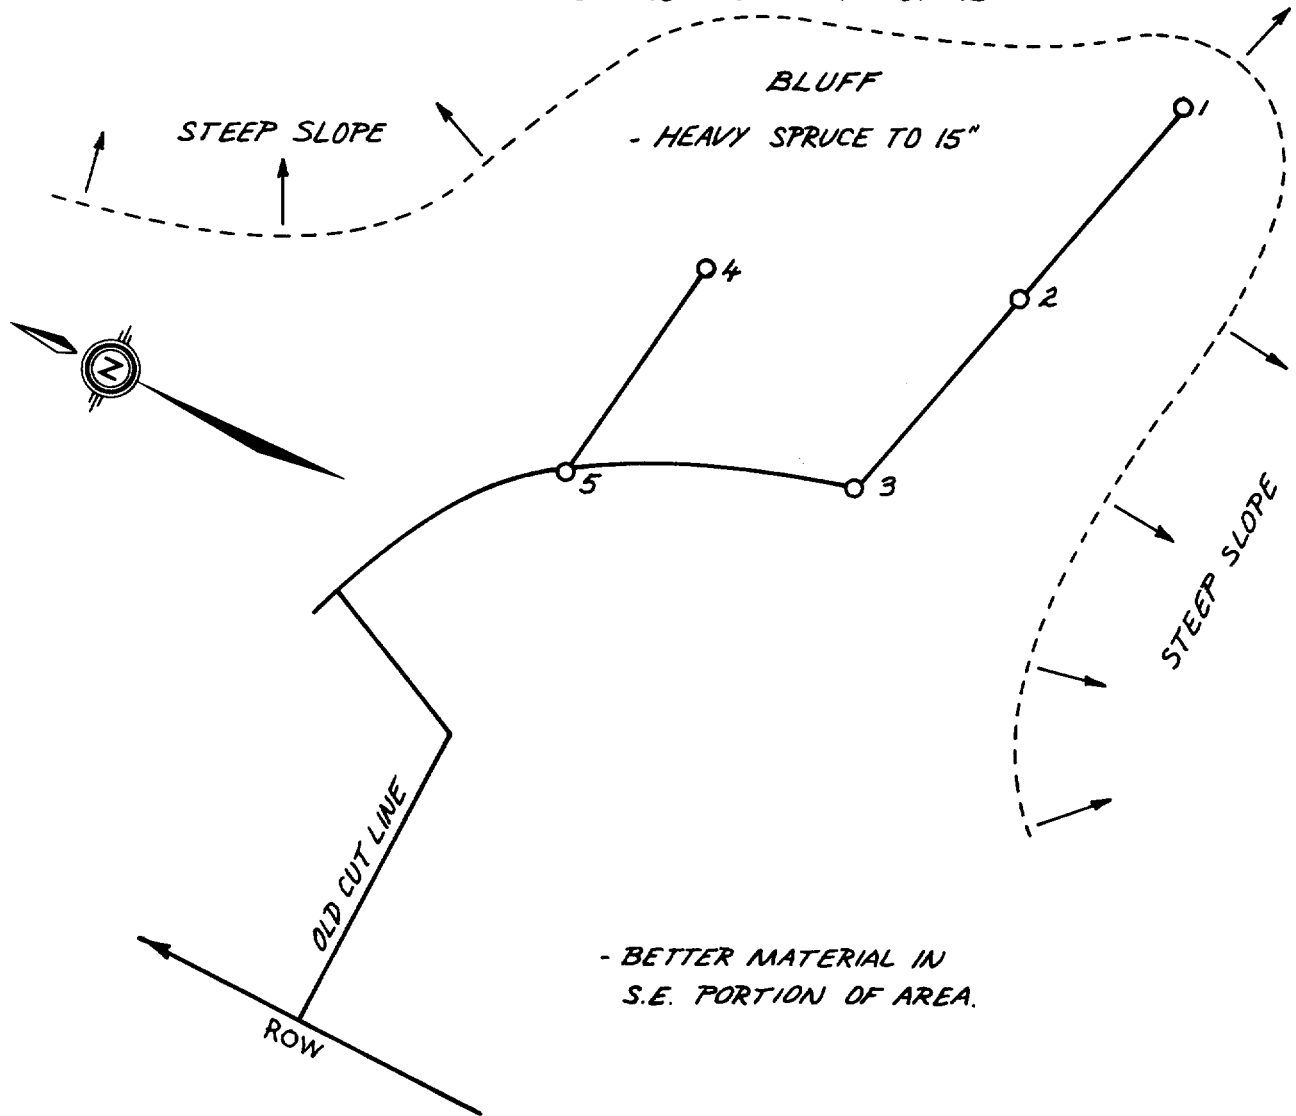
MILE 649.2 - 650' RT. OF E

Borrow Pit No. 155 is located immediately adjacent to the north bank of Oscar Creek on what is thought to be a remnant of an old glaciofluvial delta. Oscar Creek is entrenched at present in the delta and the flood plain of the Creek is well below the level of the Borrow Pit. Deposits are poorly sorted silty sands, gravelly sands and sandy gravels with some clay content. Better quality materials are located in the south-east portion of the area drilled. Permafrost would appear to be sporadic and moisture contents on thawing are variable.

This is considered to be a usable borrow source although thawing, draining and stabilizing of the material will be required after placement.

- SUBSOIL IS SANDS, GRAVELLY SANDS, & SANDY GRAVELLS
- SPORADIC PERMAFROST
- MATERIALS DRY TO WET ON THAWING
- USABLE BORROW; SOME THAWING & DRAINING REQUIRED

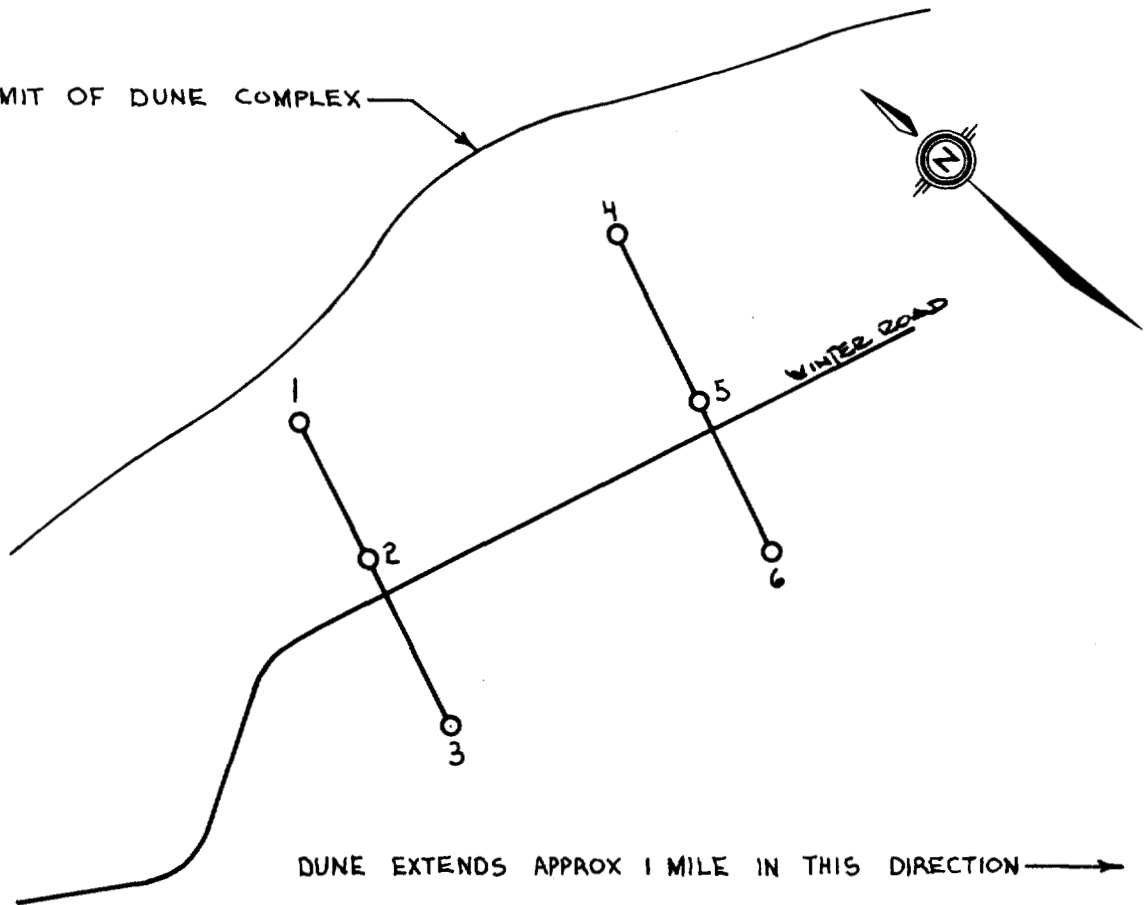
# MILE 653.2-1000' RT. OF ♢

sands with varying amounts of silt. Permafrost is generally absent and moisture contents for the most part, are less than 5%. Stripping is minimal. This is a good source of sub-grade borrow material and it is likely that a borrow pit can be developed anywhere in the sand dune between Mile 652 and 653.2.

- SUBSOIL DUNE SAND
- DRY WITH LITTLE OR NO PERMAFROST
- GOOD SOURCE OF BORROW
