PRELIMINARY BASIC ENVIRONMENTAL DATA

SHALE CREEK BRIDGE

REFERENCE MILE 332 MACKENZIE HIGHWAY

DEPARTMENT OF PUBLIC WORKS
EDMONTON, CANADA

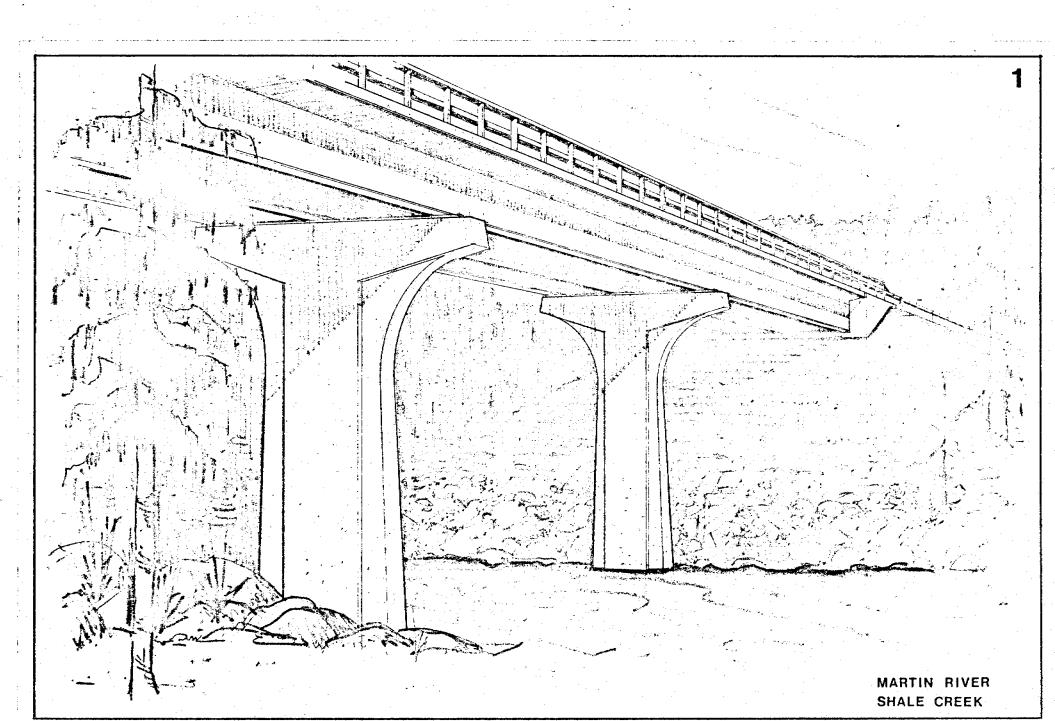
24.10.72. Shale Creek looking west. Gravel outcrops at top of bank in cut; composition of underlying material unknown, believed to be glaciolacustrine origin; colluvial slopes appear stable; surface drainage on north side must be controlled to minimize siltation; groundwater drain recommended.

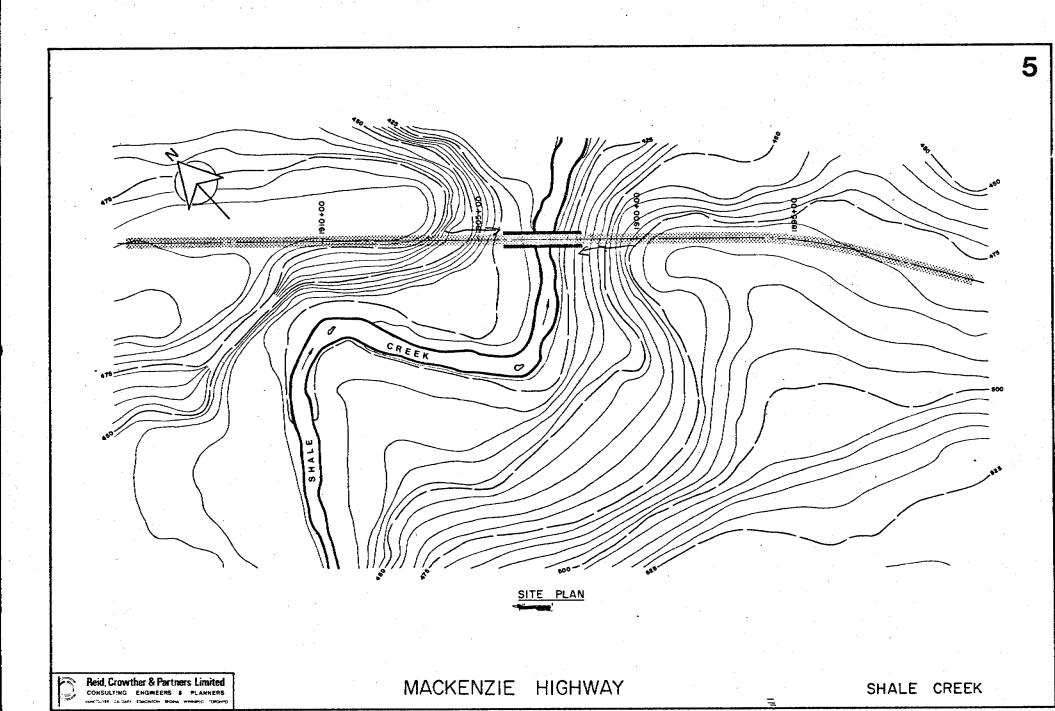
5.11.72. West slope of Shale Creek. Pebble gravel exposed in route cutbank on west side of Shale Creek. Unit appears to be quite extensive and is believed to be a glaciofluvial terrace of the Mackenzie River.
