RAPPORT FINAL

ÉTUDE D'IMPACT SUR LE MILIEU SOCIAL ET L'ENVIRONNEMENT
DE L'ÉRECTION D'UNE CLÔTURE CEINTURANT
LE COMPLEXE AÉROPORTUAIRE DE KUUJJUAO
ET DE LA CONSTRUCTION D'UNE ROUTE DONNANT ACCÈS AU "RANGE"

RAPPORT PRÉPARÉ PAR :
ROBERT LANARI
SERVICE DE LA RECHERCHE
SOCIÉTÉ MAKIVIK

SOU MIS AU MINISTÈRE DES TRANSPORTS DU CANADA

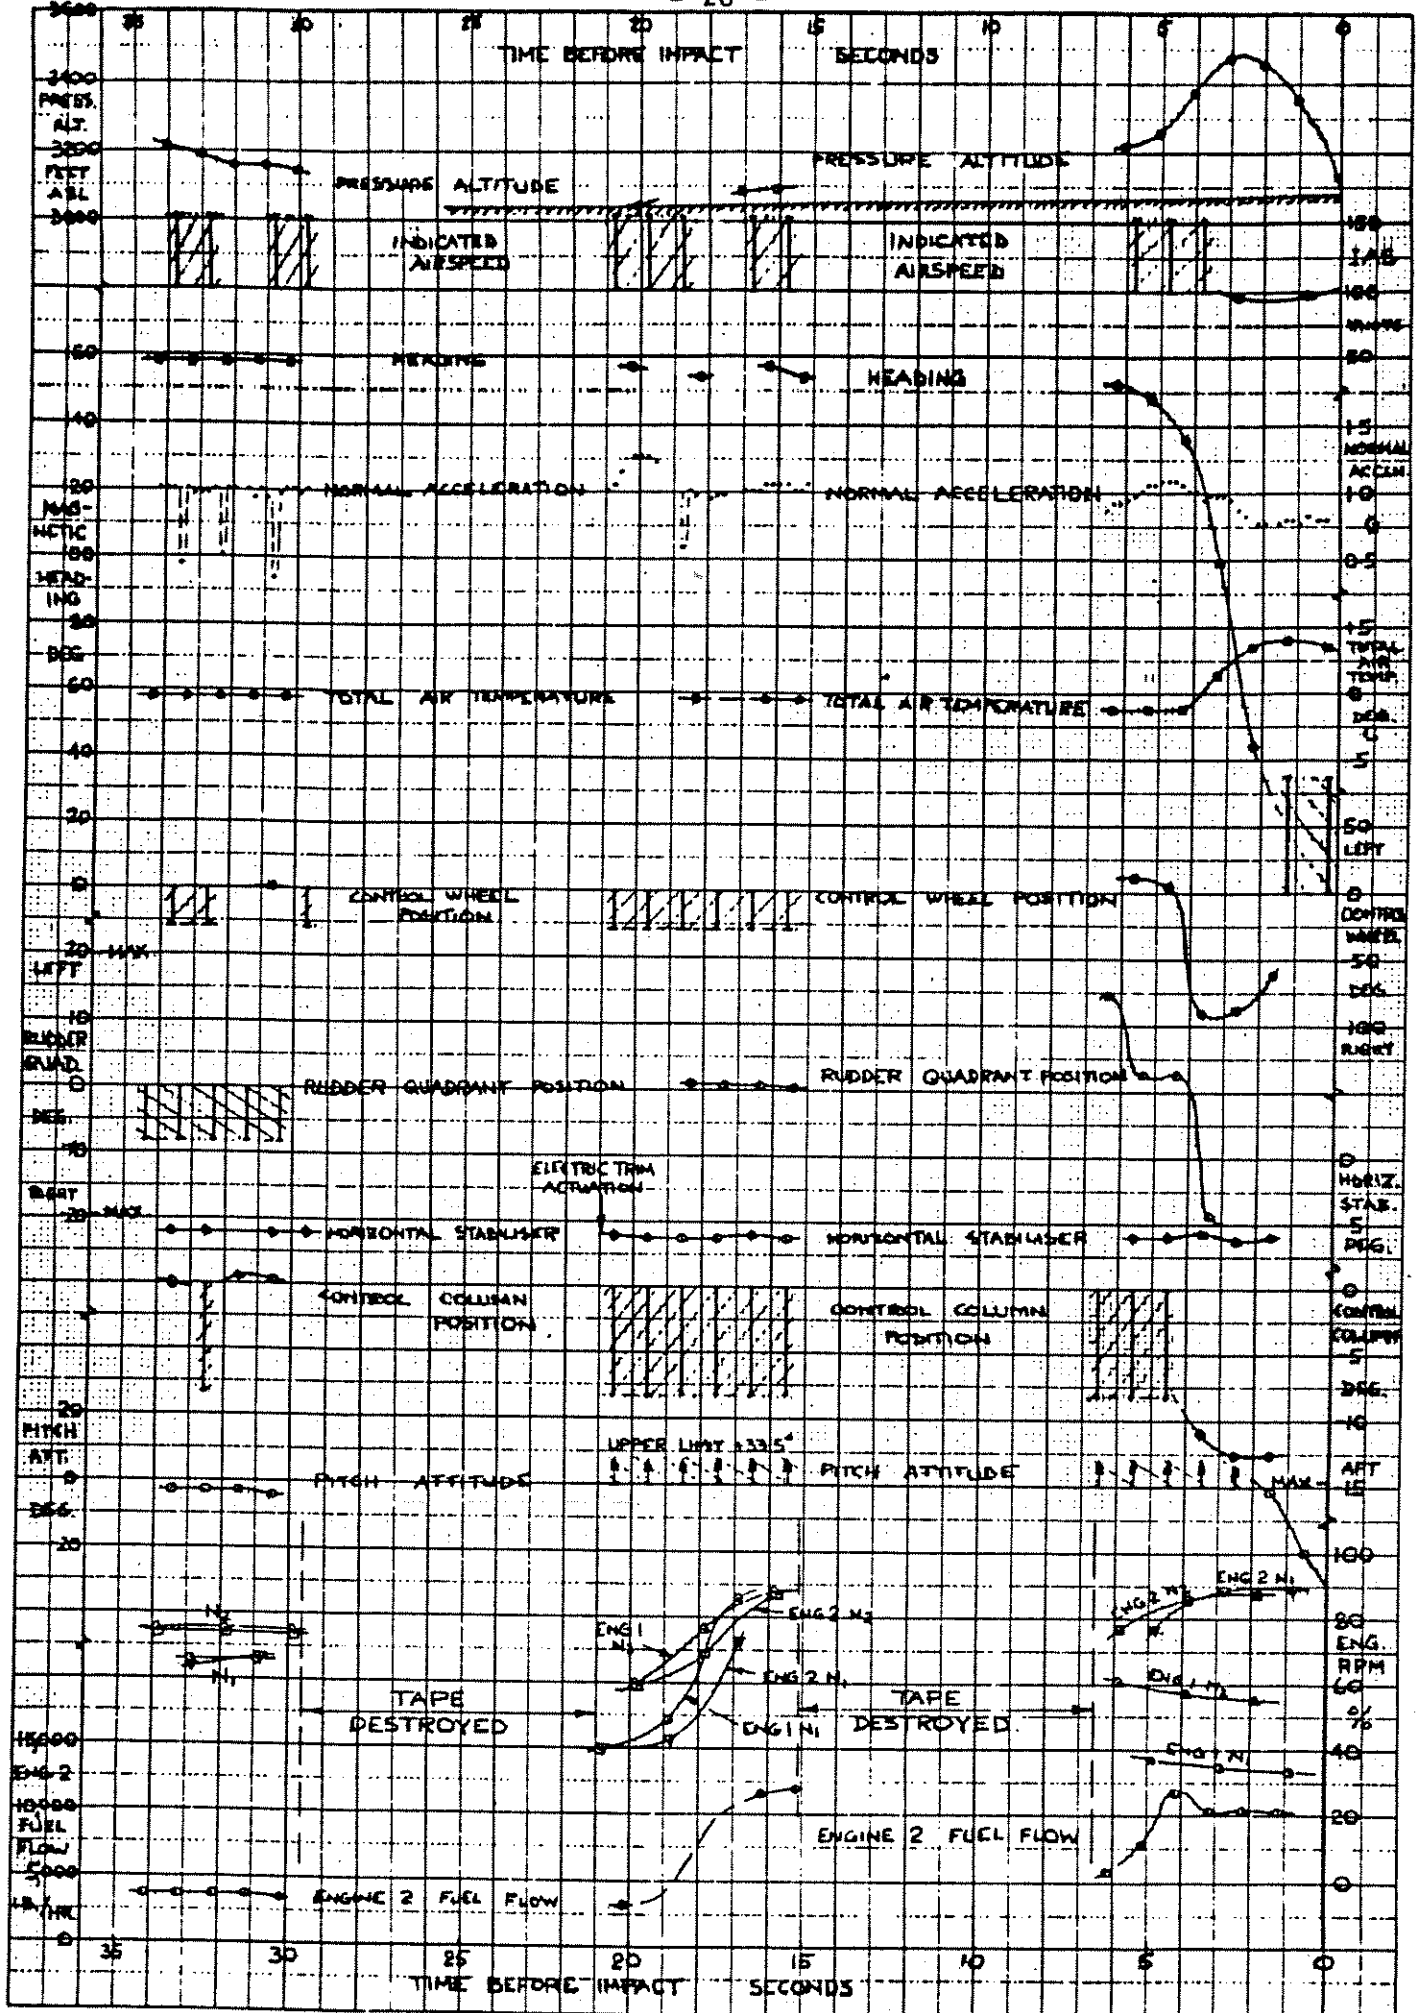
PWA BOEING 737 C-EPWC OVERSIGHT ACCIDENT CONTRIBUTING FACTORS - 11 FEB 1978 - DATA RECORDED BY...

REPORT # H80001
 AIRCRAFT ACCIDENT
 PACIFIC WESTERN AIRLINES
 BOEING 737, C-FPWC
 CRANBROOK, B.C.
 11 FEBRUARY, 1978.
