**GEOTECHNICAL INVESTIGATIONS
MACKENZIE HIGHWAY
MILE 544 to MILE 635**

DEPARTMENT OF PUBLIC WORKS OF CANADA

April 20, 1973

R.M. HARDY & ASSOCIATES LTD.
CONSULTING ENGINEERING & TESTING

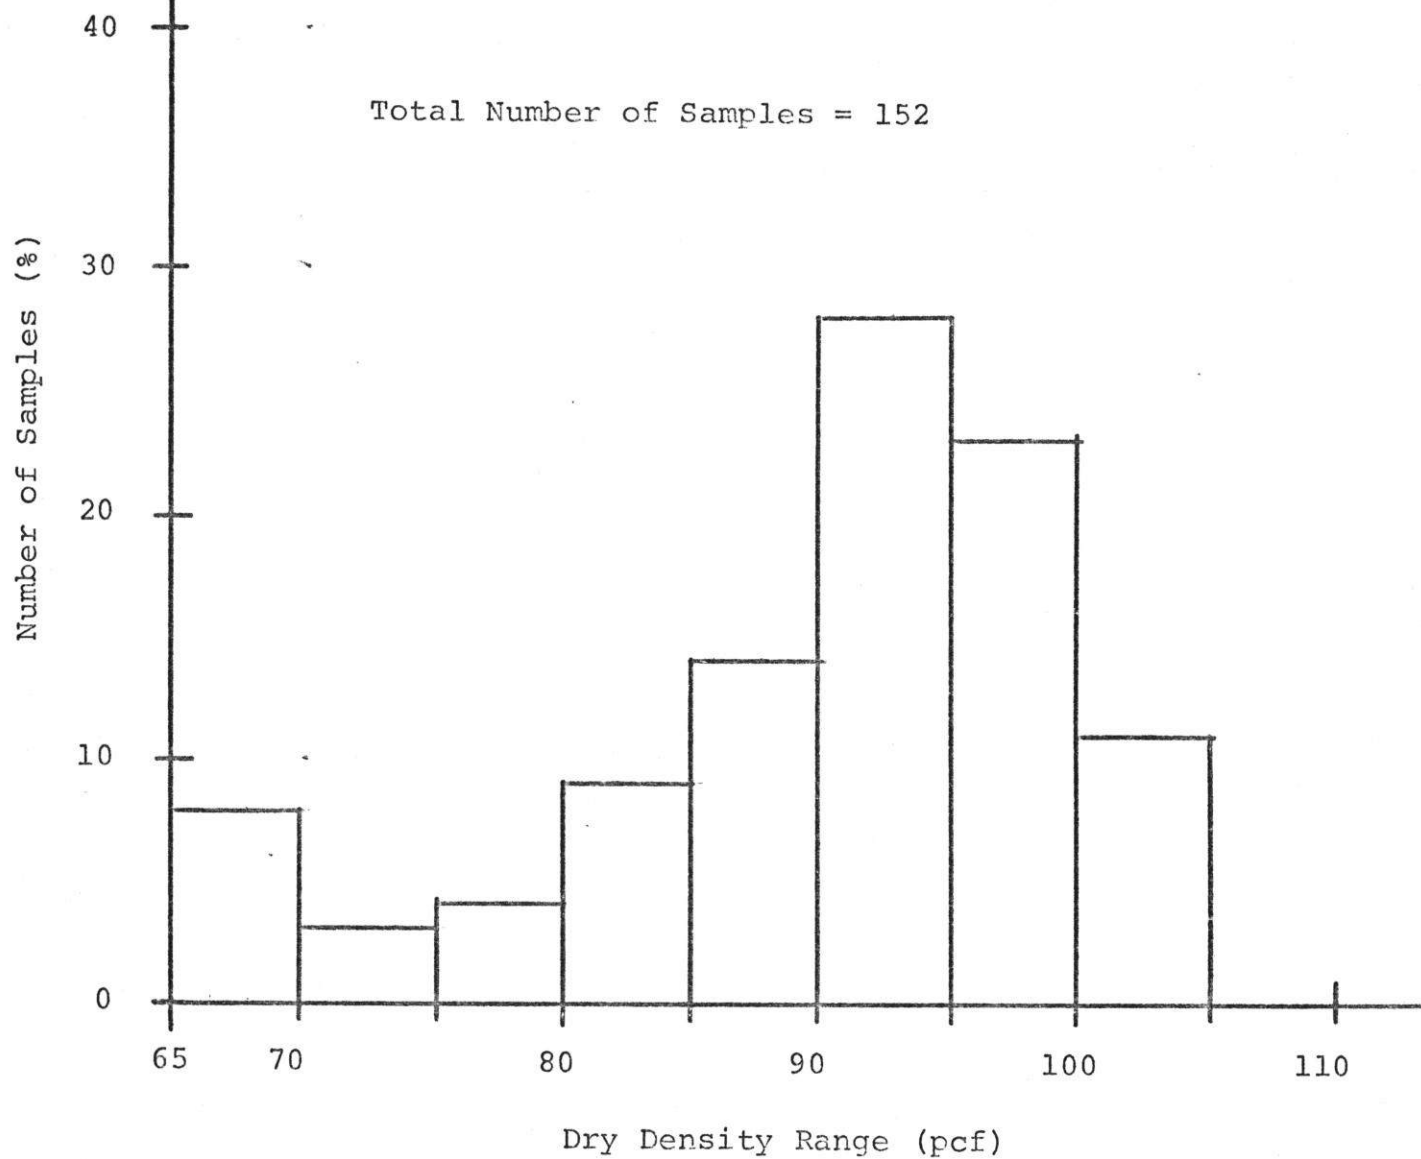
HISTOGRAM OF DRY DENSITIES

CLAY

MILE 572 - 584

8.2.3 The soils in this section are quite variable in type and density. Figures 5, 6 and 7 show the distribution of dry density versus percentage of occurrence for the three soil types, silt, clay and sand in this section. It will be observed that there is far greater variation

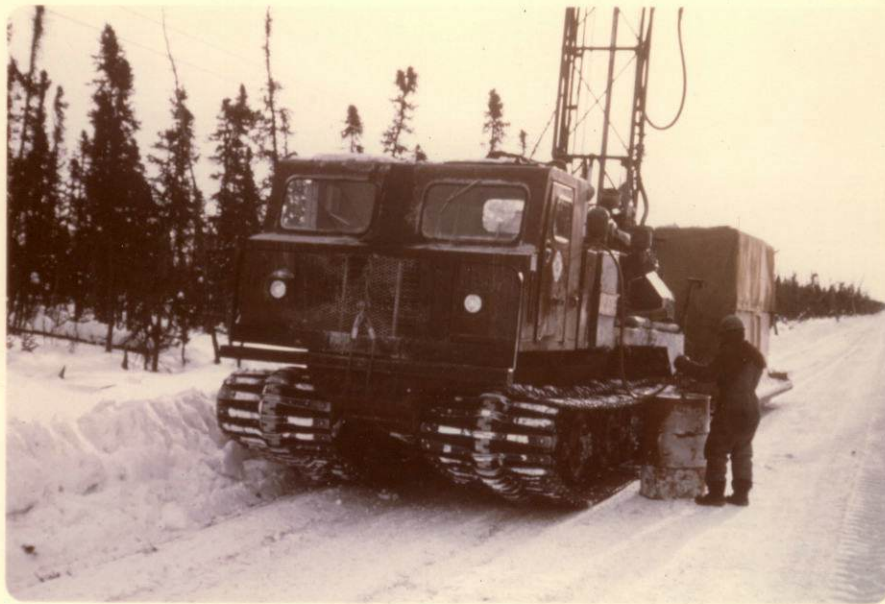
Photograph 1: Failing 1000 drill rig mounted on a Flextrac-Nodwell tractor. Note the covered "sloop" which was towed behind the drill rig. This sloop contained a work bench, writing table, extruder, propane heater and a small electric generator. An open deck at the back of the sloop was used for transporting samples and spare fuel.

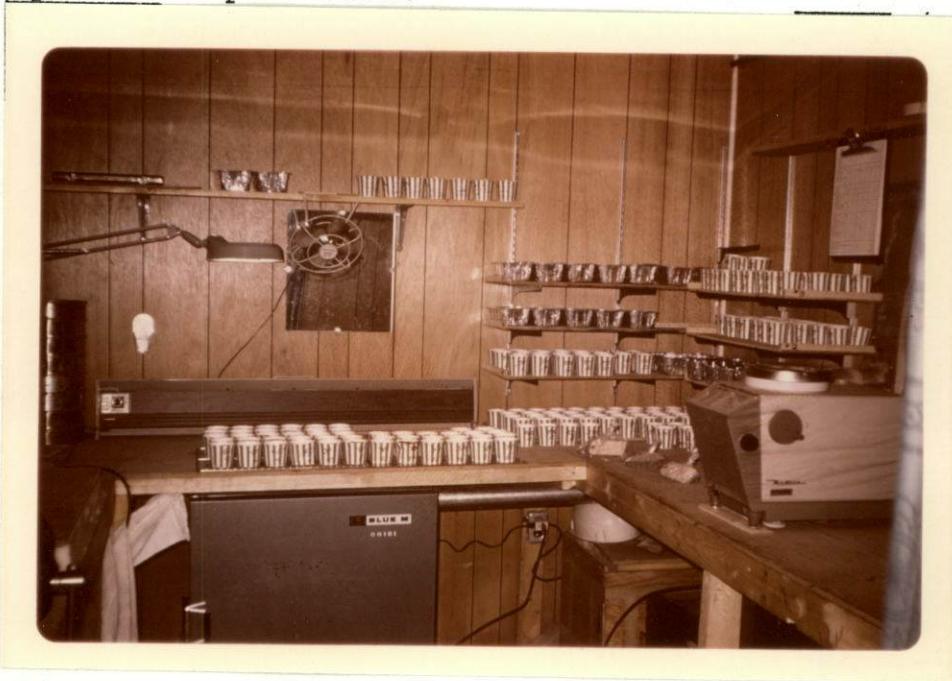
Photograph 2: The field laboratory. On the right can be seen an electronic Mettler scale. Three electric ovens were kept beneath the benches in order to conserve space. The paper cups and aluminum bread pans contain samples which are ready for drying in the oven.

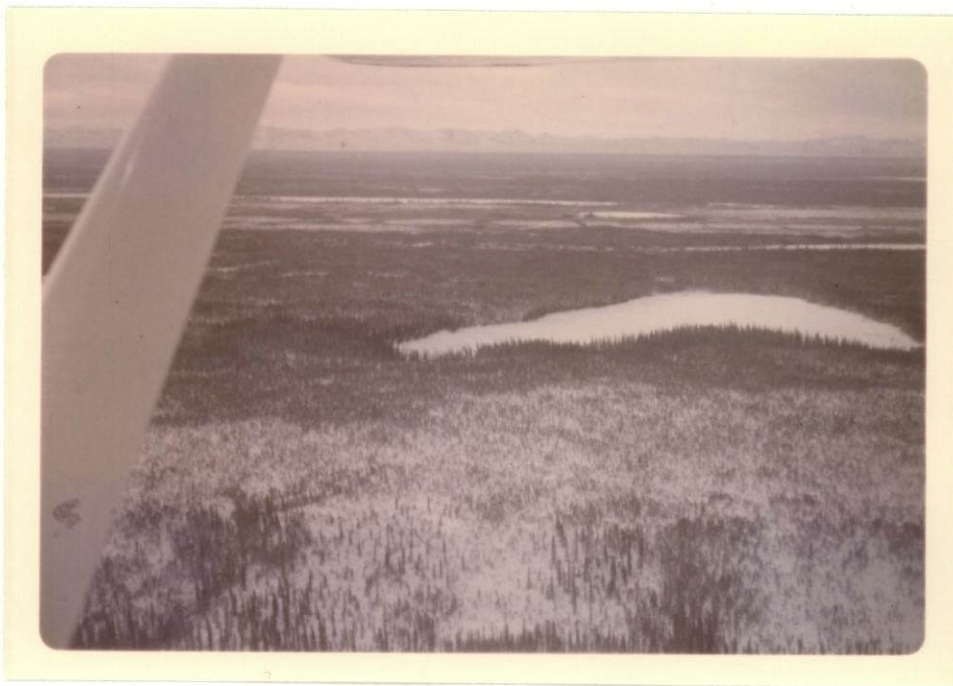
Photograph 5: Typical terrain between Norman Wells and the Great Bear River. Notice the sparse growth of spruce at the bottom of the photograph. This is quite typical of many areas in the region.

4.4.3 Photographs 5, 7, 7, 8, 9, 13, 14, 15, 16, 17 and 18 (Appendix A) show typical examples of the topography in the region.

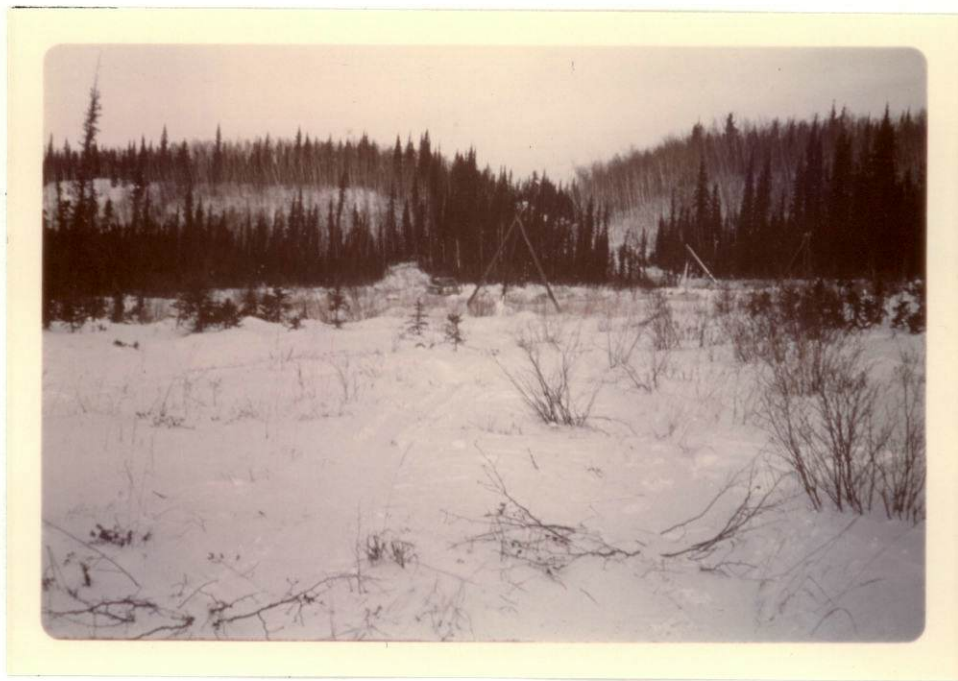
Photograph 7: Looking northerly to Test Hole 459 on the north side of the Great Bear River.

10.5.1 The alignment climbs from the Great Bear River up a ravine. The seriousness of any problems in this section will be dependent on the exact alignment of the centerline. Slopes in the ravine appear stable (no evidence of recent movement was observed). However, the slopes are as steep as 2:1 and any additional loading on top of such a slope, or additional steepening by cutting, will probably cause a problem. As far as possible, the alignment should follow the existing ravine with side hill cuts being avoided. Such an alignment may entail a poor geometric alignment of the road but we believe that this will be preferable to inviting problems with slope failures. Views of this ravine are shown on Photographs 7 and 8, Appendix A.

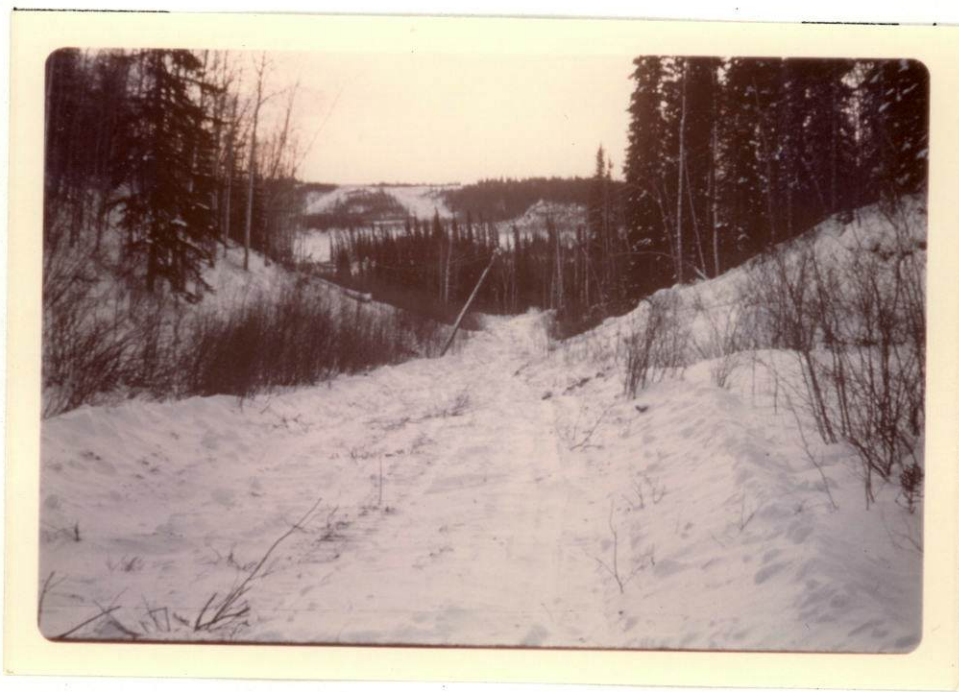
Photograph 8: Looking southerly towards Test Hole 460 at approximately mile 583.

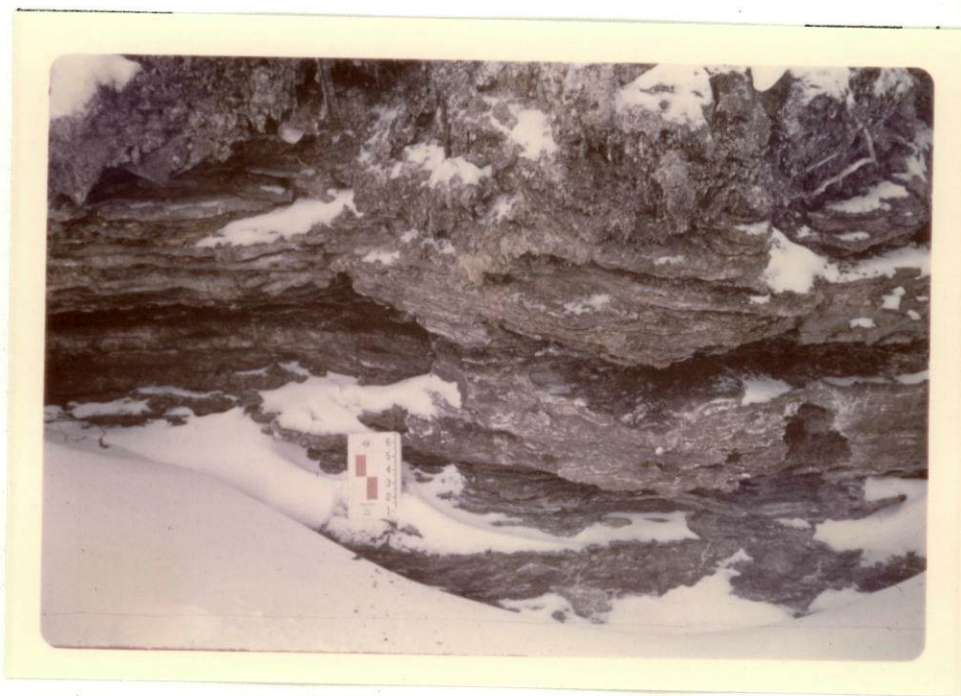
Photograph 10: Rock exposure on the flank of Bear Rock at approximately mile 587. The field book gives the scale.

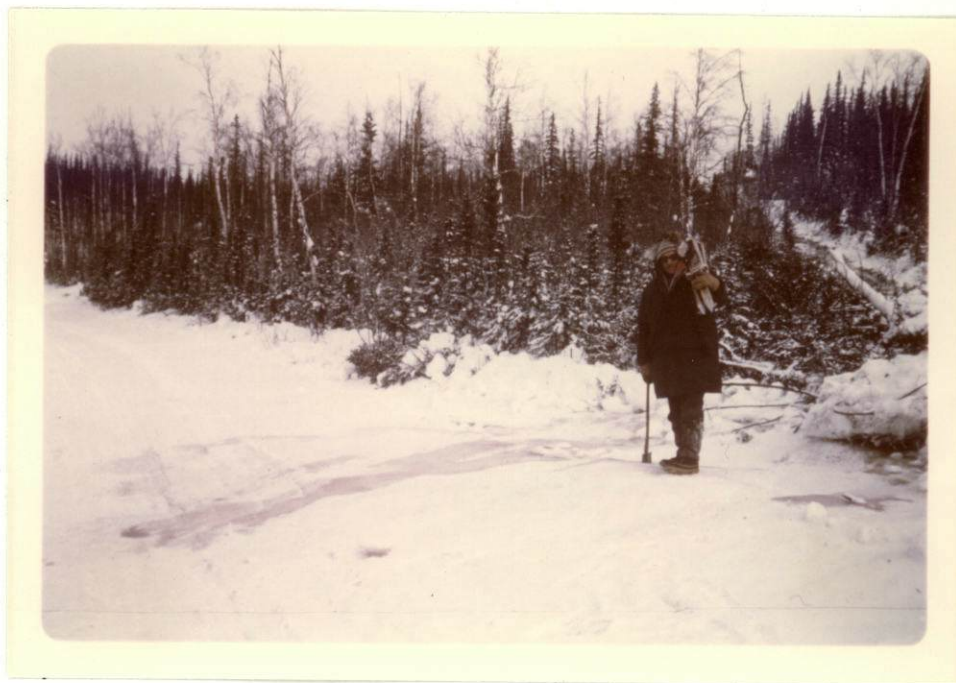
Photograph 11: Approximate location mile 591 (near Test Hole 574). Note the seepage which is causing icing on the trail. Note the stunted spruce and the swamp birch in the background. This vegetation is quite typical of the area.

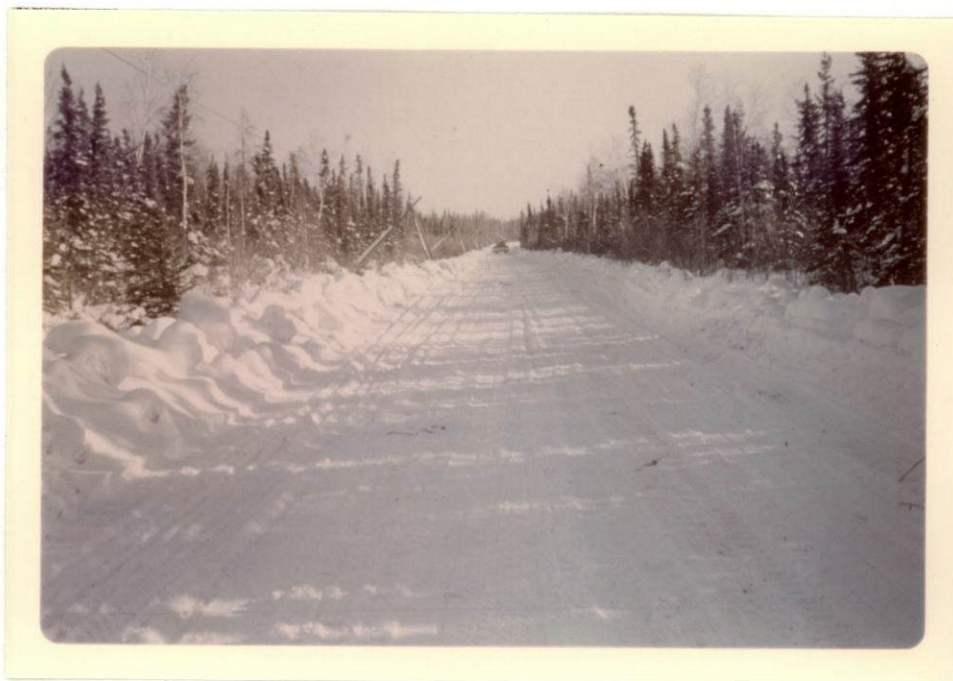
Photograph 13: Looking southerly from Test Hole 677 at approximately mile 601. The actual centerline of the road is approximately 50 feet to the right of the CNT pole line. The CNT land line was placed on large tripods in this area because of permafrost.

12.1.1 This section is generally level but is quite well drained with most of the drainage being into Jungle Ridge Creek. (See Photograph 13 for a typical view of the terrain.)

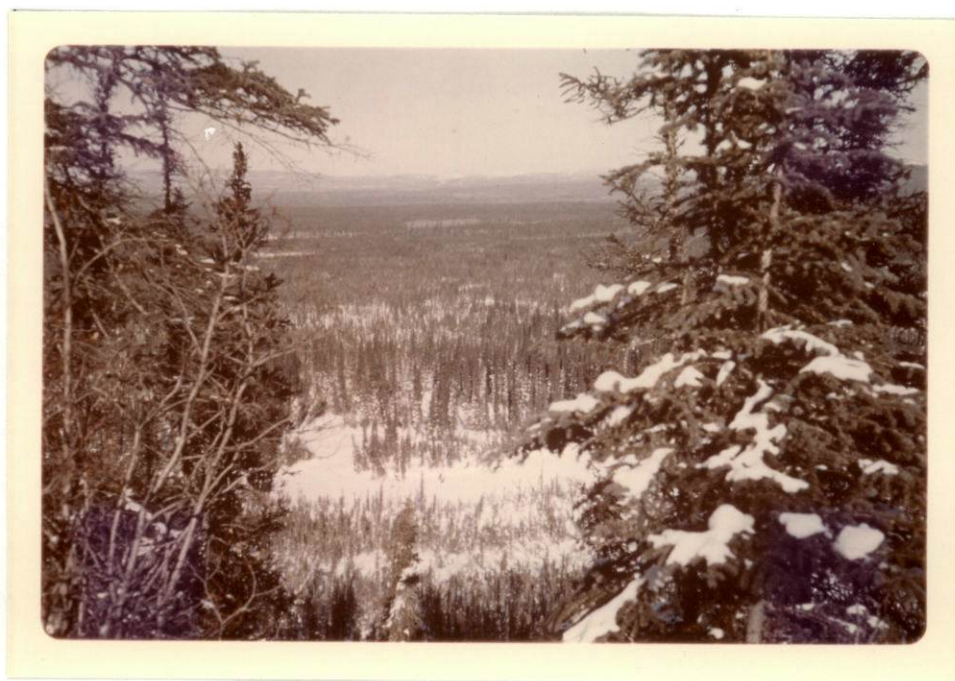
Photograph 14: View from Jungle Ridge looking easterly at approximately mile 602. Observe the flat terrain which, combined with permafrost, causes poor drainage.

11.1.1 The first two miles of this section runs through the pass to the north of Bear Rock. (See Photograph 9) Drainage is generally to the west with the main drainage channel being Jungle Ridge Creek. There is a fairly steep climb up to the pass and down on the northerly side but from thereon gradients are gentle and the topography is generally undulating. Part of this section runs along the top of Jungle Ridge. (See Photograph 14)

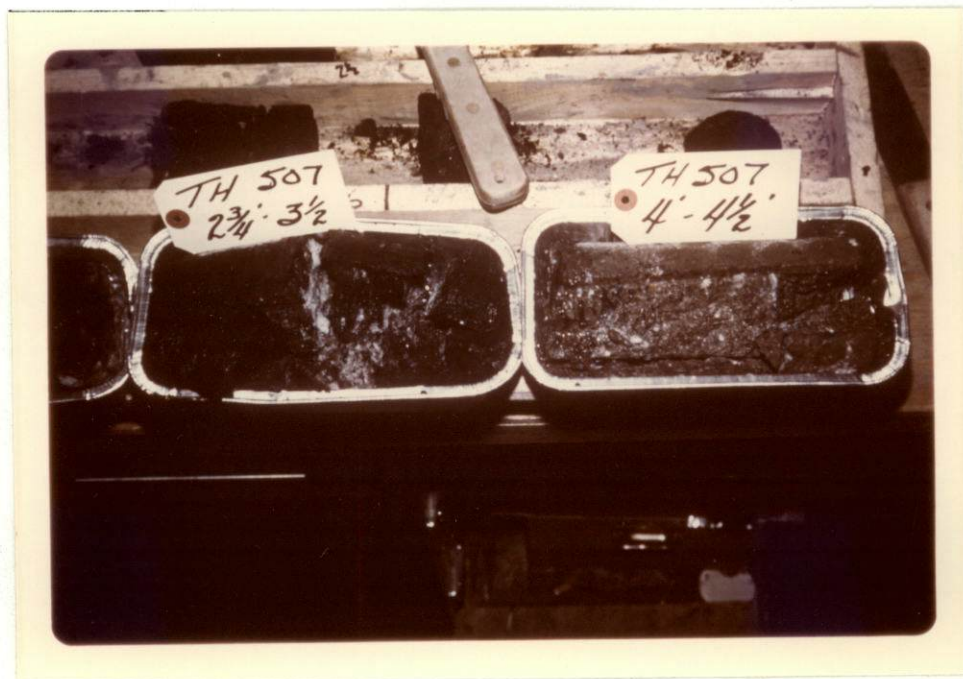
Photograph 20: Cores taken in Test Hole 507. On the left is a sample of organic clay with high ice content and on the right is a sample of clay till. In this case the clay till has a very high ice content.

almost every case, it will be necessary to select material and, particularly in the case of the upper material, to waste considerable quantities. As the soil material generally improves with depth in any pit, it may well be economical to limit the number of pits and to use longer hauls. Photographs 19, 20 and 22 show typical soil samples from this section.

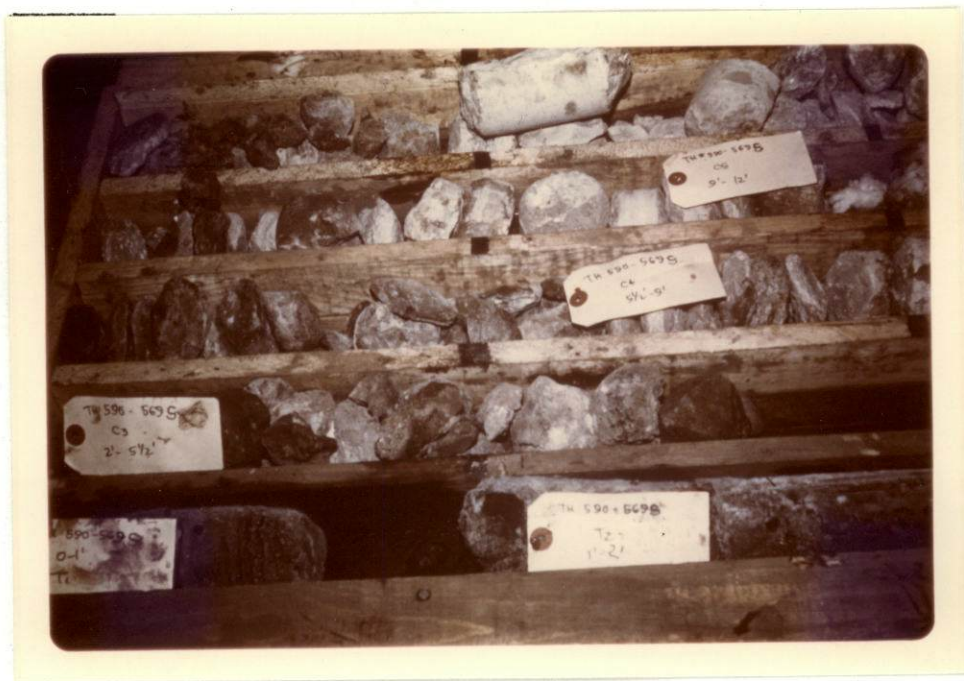
Photograph 21: Core samples from Test Hole 569. The material in the top half of the photograph is limestone.

to excavate this material in the summer. As the borrow material in the preceeding section is not so suitable for road construction, we would also advise that borrow material for that section be obtained from this section. See Photographs 21 and 23, Appendix A.

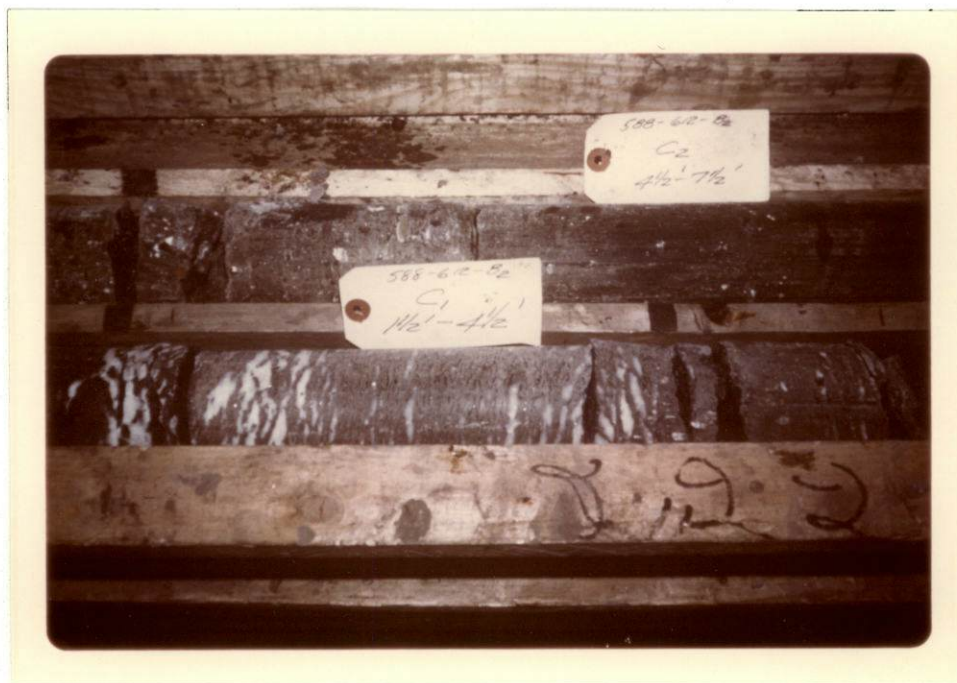
Photograph 22: Clay till cores from Test Hole 612. Observe the ice banding in the lower sample in this photograph.

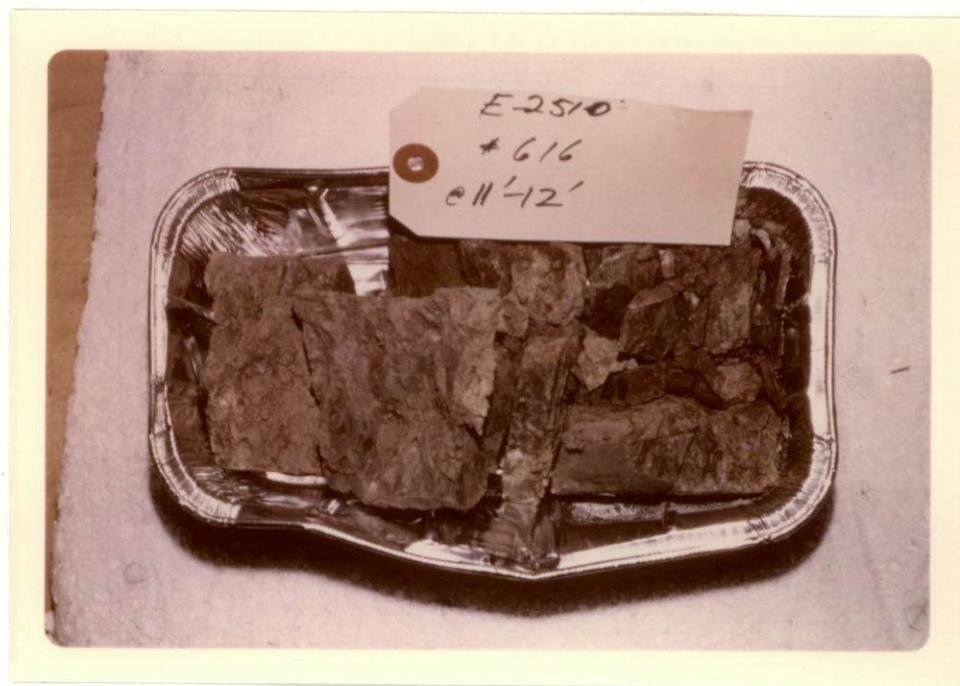
Photograph 23: A sample of clay till, sandy, from Test Hole 616 at a depth of 11 feet. The water content is about 12 percent. Note that there is no visible ice in this sample.

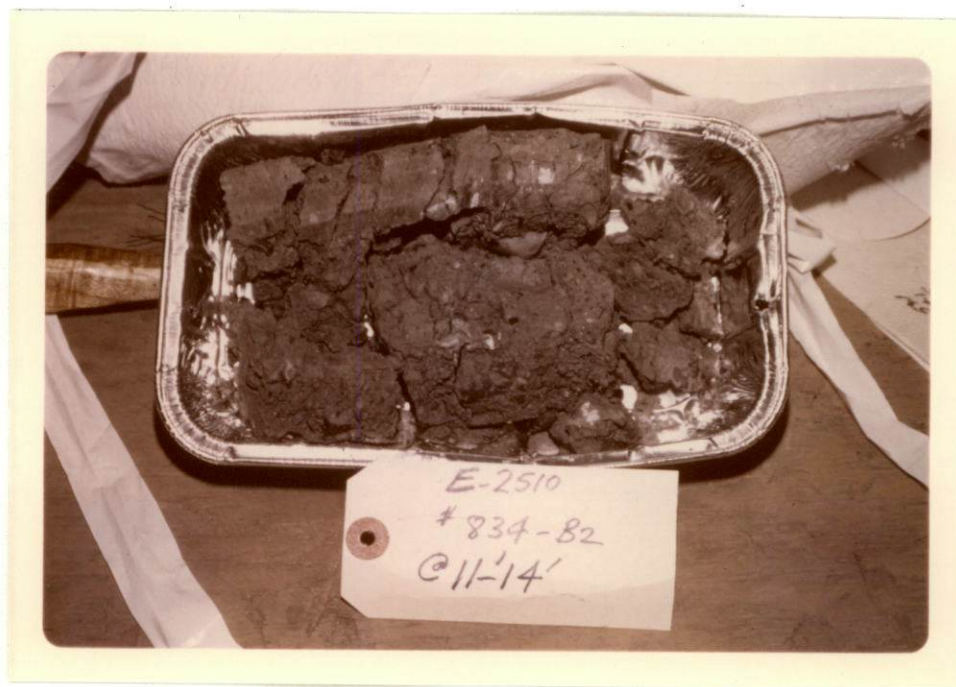
Photograph 24: A sample of clay till, silty-sandy, water content 9 percent, from Test Hole 834 at a depth of 11 to 14 feet. Note there is no visible ice in this sample.

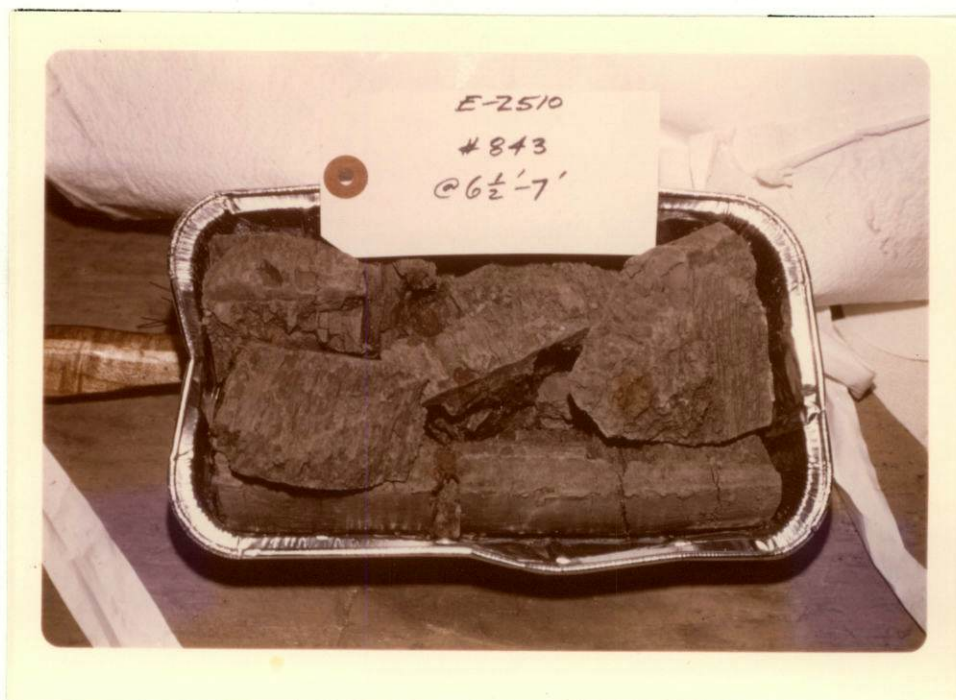
Photograph 25: A sample of clay-shale from Test Hole 843. Depth interval is 6.5 to 7 feet. This material had silt and sandstone partings. Note there is no visible ice.

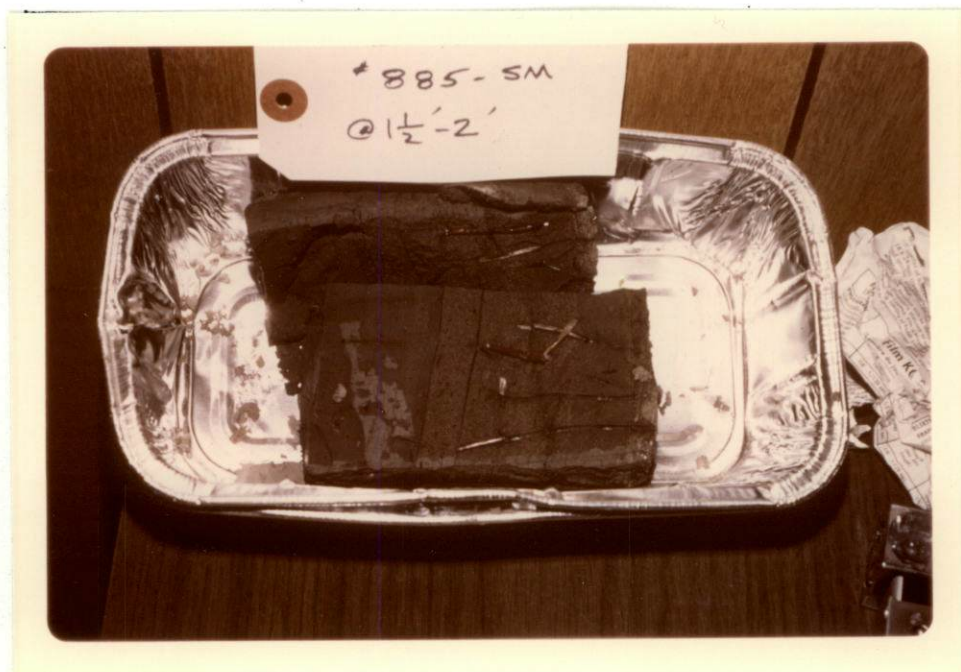
Photograph 26: A sample of organic silt from Test Hole 885 at a depth interval of 1.5 to 2.0 feet. Note the organic material.

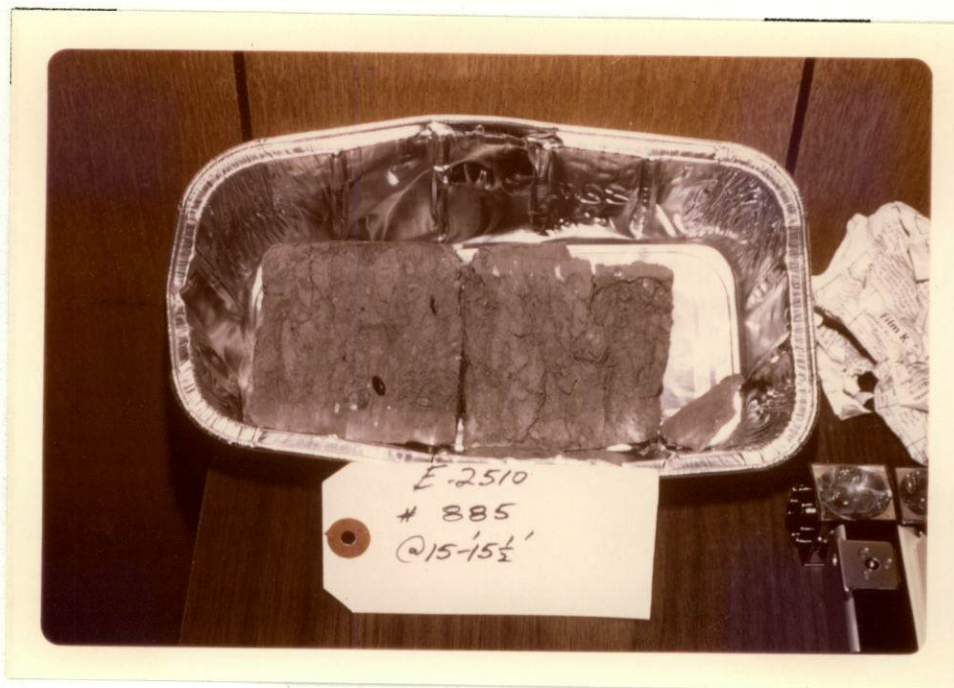
Photograph 27: A sample of clay till from Test Hole 885 at a depth interval of 15 to 15.5 feet. This material contains some pebbles. Water content was 14 percent.

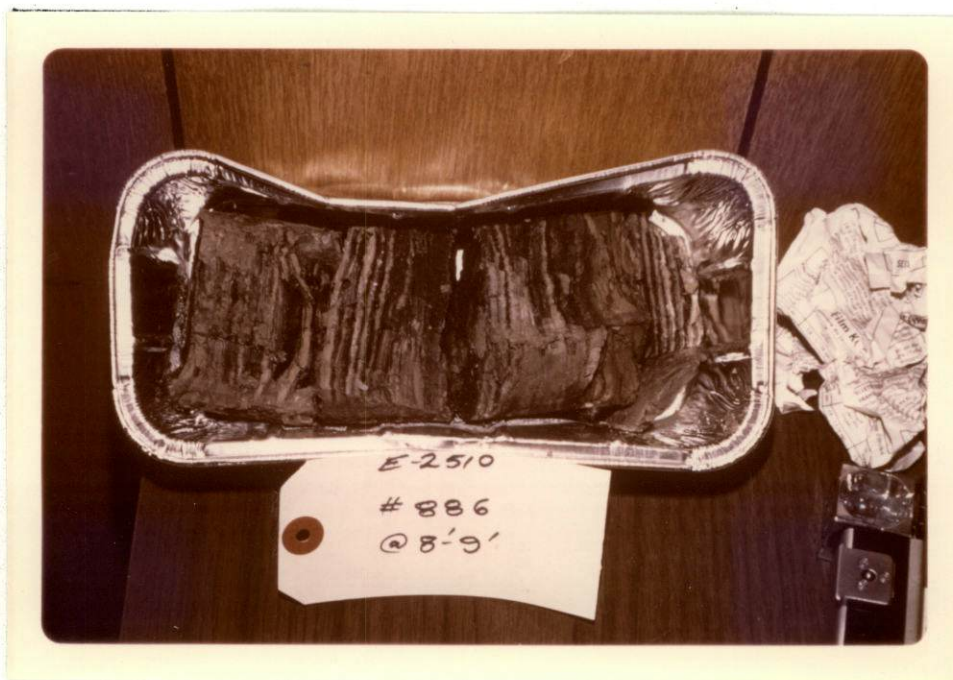
Photograph 28: A sample of varved clay from Test Hole 886. This material was laid down in still water and the light and dark bands are alternating layers of silt and clay. Water content of this material was 28 percent.

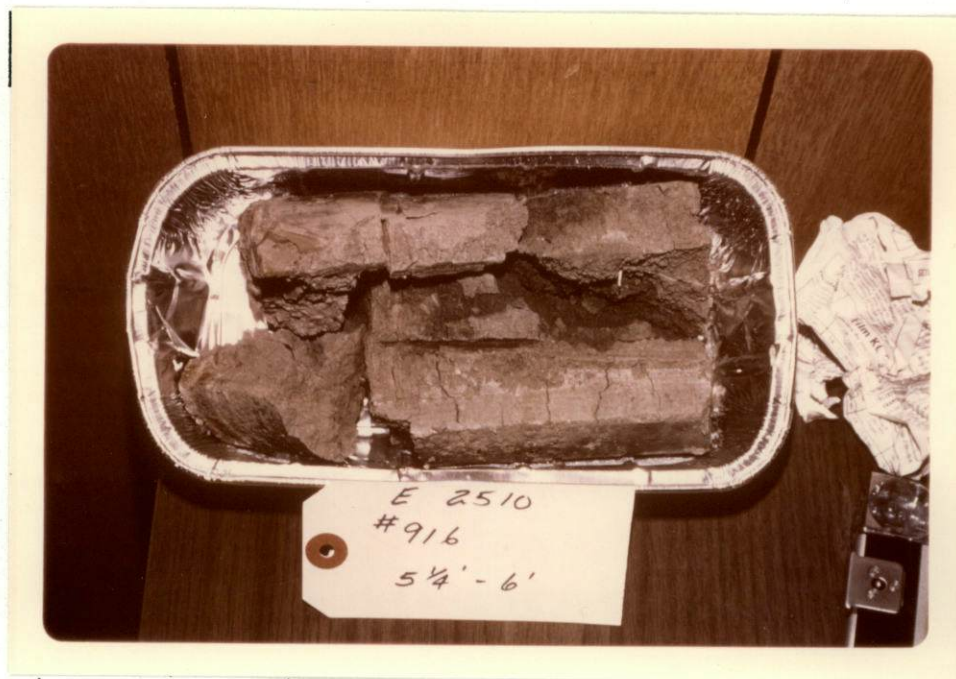
Photograph 29: A sample of silty-clay, medium plasticity, from Test Hole 916. Depth interval is 5.2 to 6.0 feet. Water content was 20 percent.

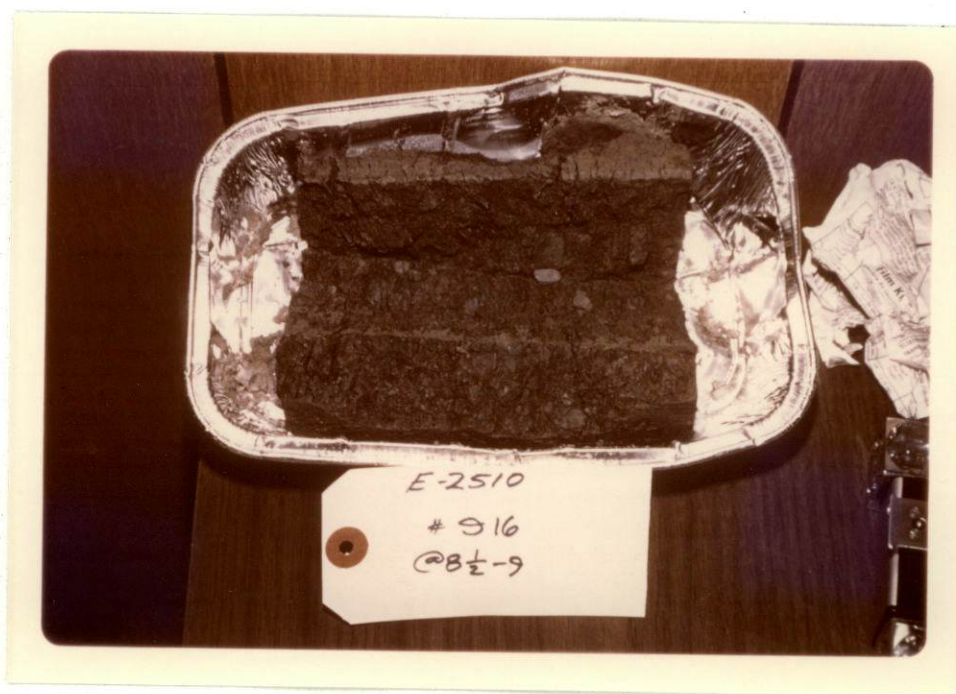
Photograph 30: A sample of silty-clay, medium plasticity, from Test Hole 916. Note the pebbles within this material. Water content was 25 percent.

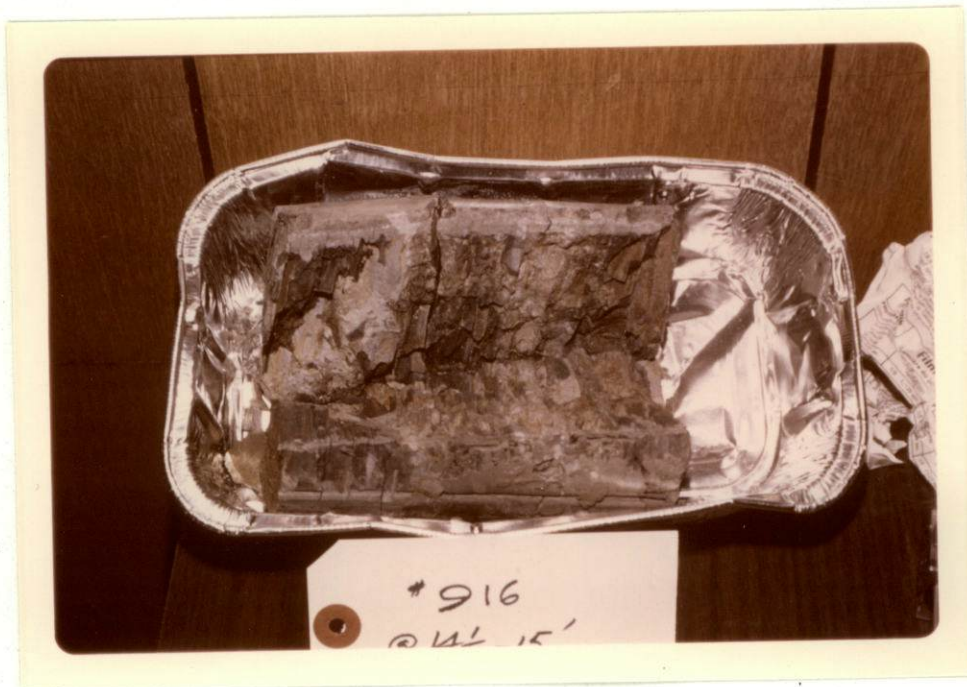
Photograph 31: A sample of weathered shale from Test Hole 916.

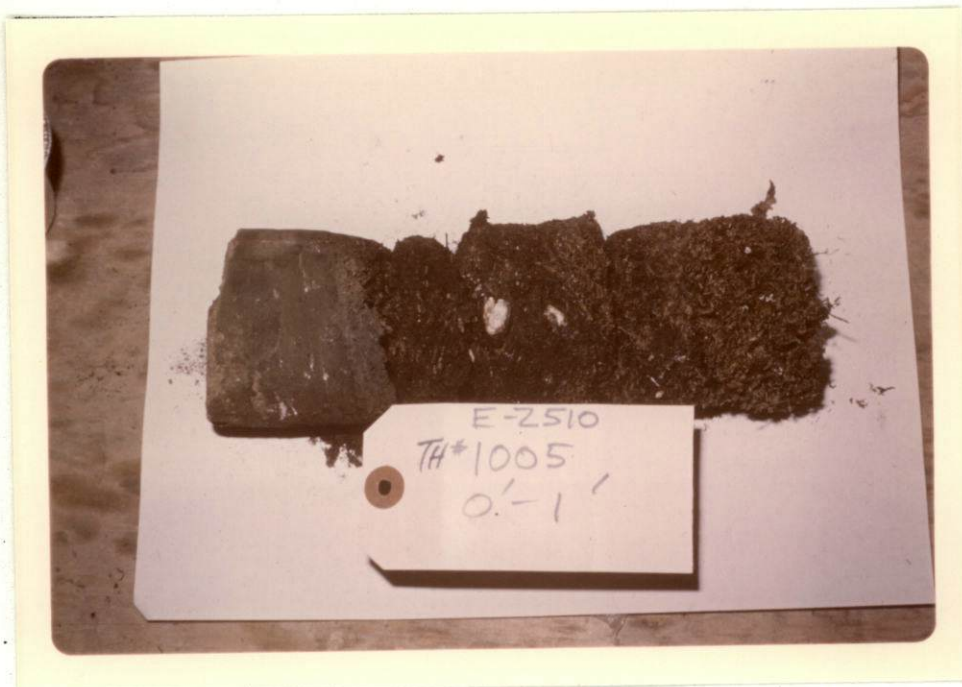
Photograph 33: A sample taken with a Shelby tube from the surface to one foot depth. The surface moss is at the right of the sample and clay is at the left. Between the moss and the clay is peat.

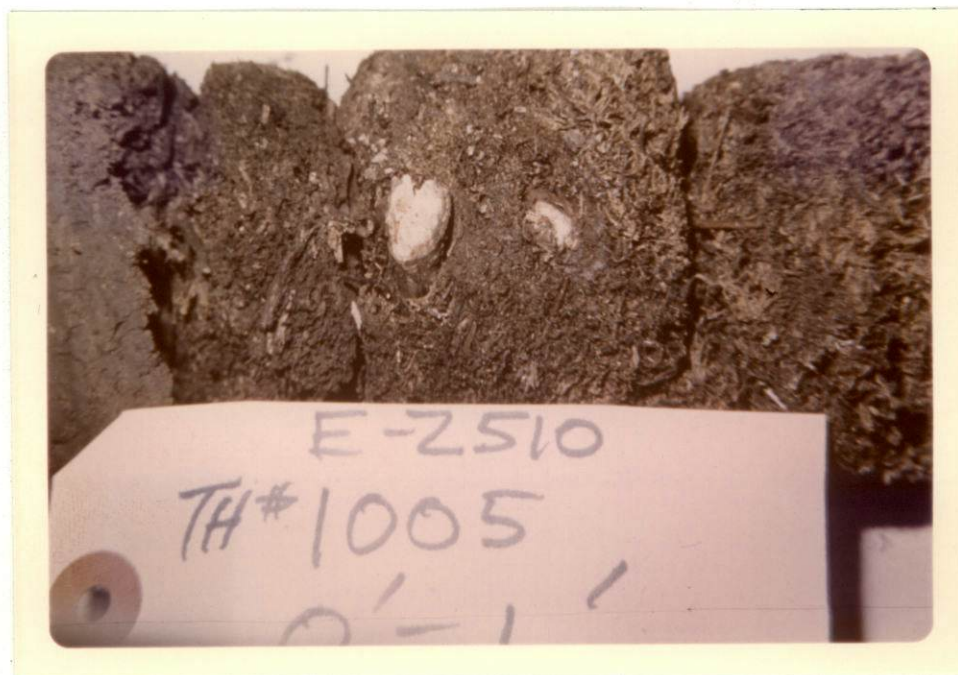
Photograph 34: A close-up of the sample shown in Photograph 33. The peat is category No. 15 using the Radforth system.

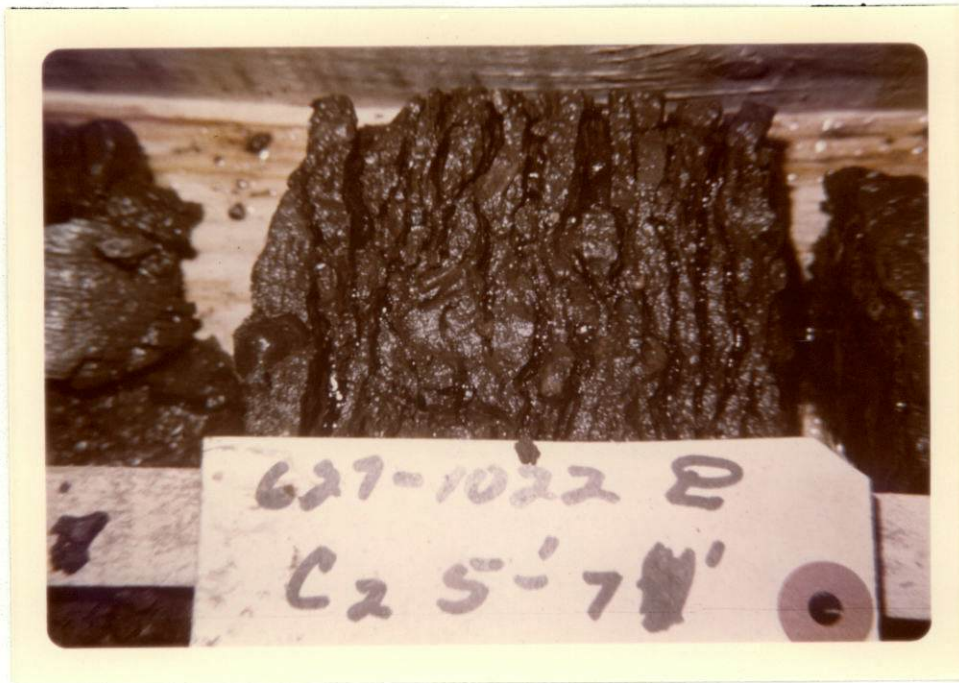
Photograph 35: A sample of clay from Test Hole 1022, depth interval 5 to 7 feet. This photograph was taken after the sample had started to thaw in the laboratory. The ice type and content was classified as Vs at 60 percent. The sample is lying on its side and the ice lenses would have been horizontal in the in situ position.

of the samples had dry densities in excess of 100 lbs./cu. ft. This histogram demonstrates the variability of dry density, and consequently ice content, within the soils in this section. (See Photographs 32, 35 and 36, Appendix A).

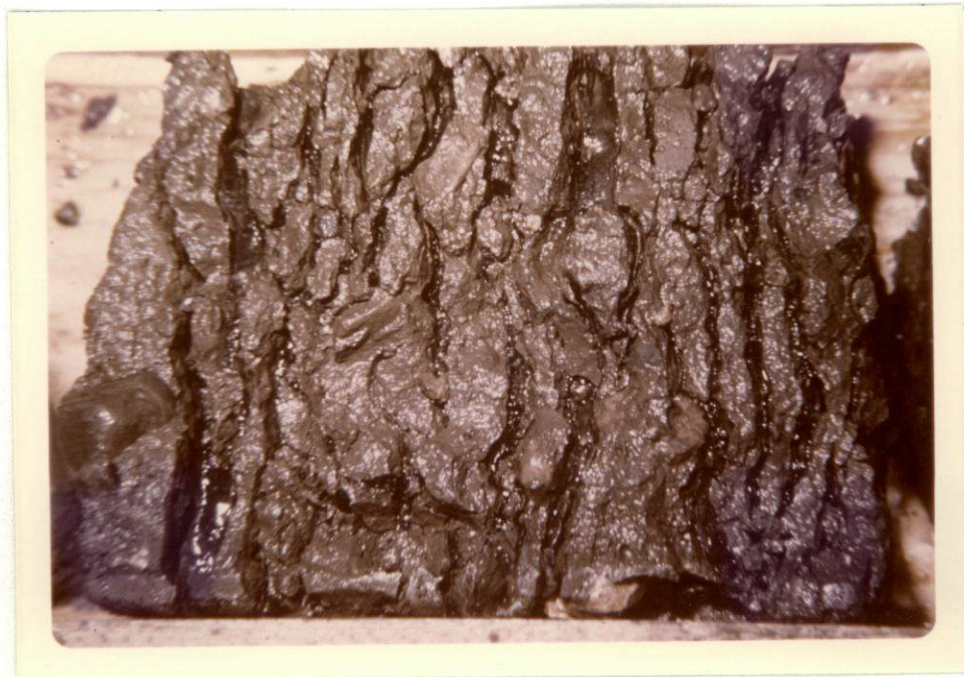
Photograph 36: A close-up of the sample shown in Photograph 35. This photograph is approximately full size. Notice the ice lenses and the pebbles within the material.
