VOLUME XI  
GEOTECHNICAL INVESTIGATION

MILE 725 TO MILE 936  
MACKENZIE HIGHWAY  
TIEDA RIVER BRIDGE - MILE 763.4

FOUNDATION INVESTIGATION

TIEDA RIVER CROSSING

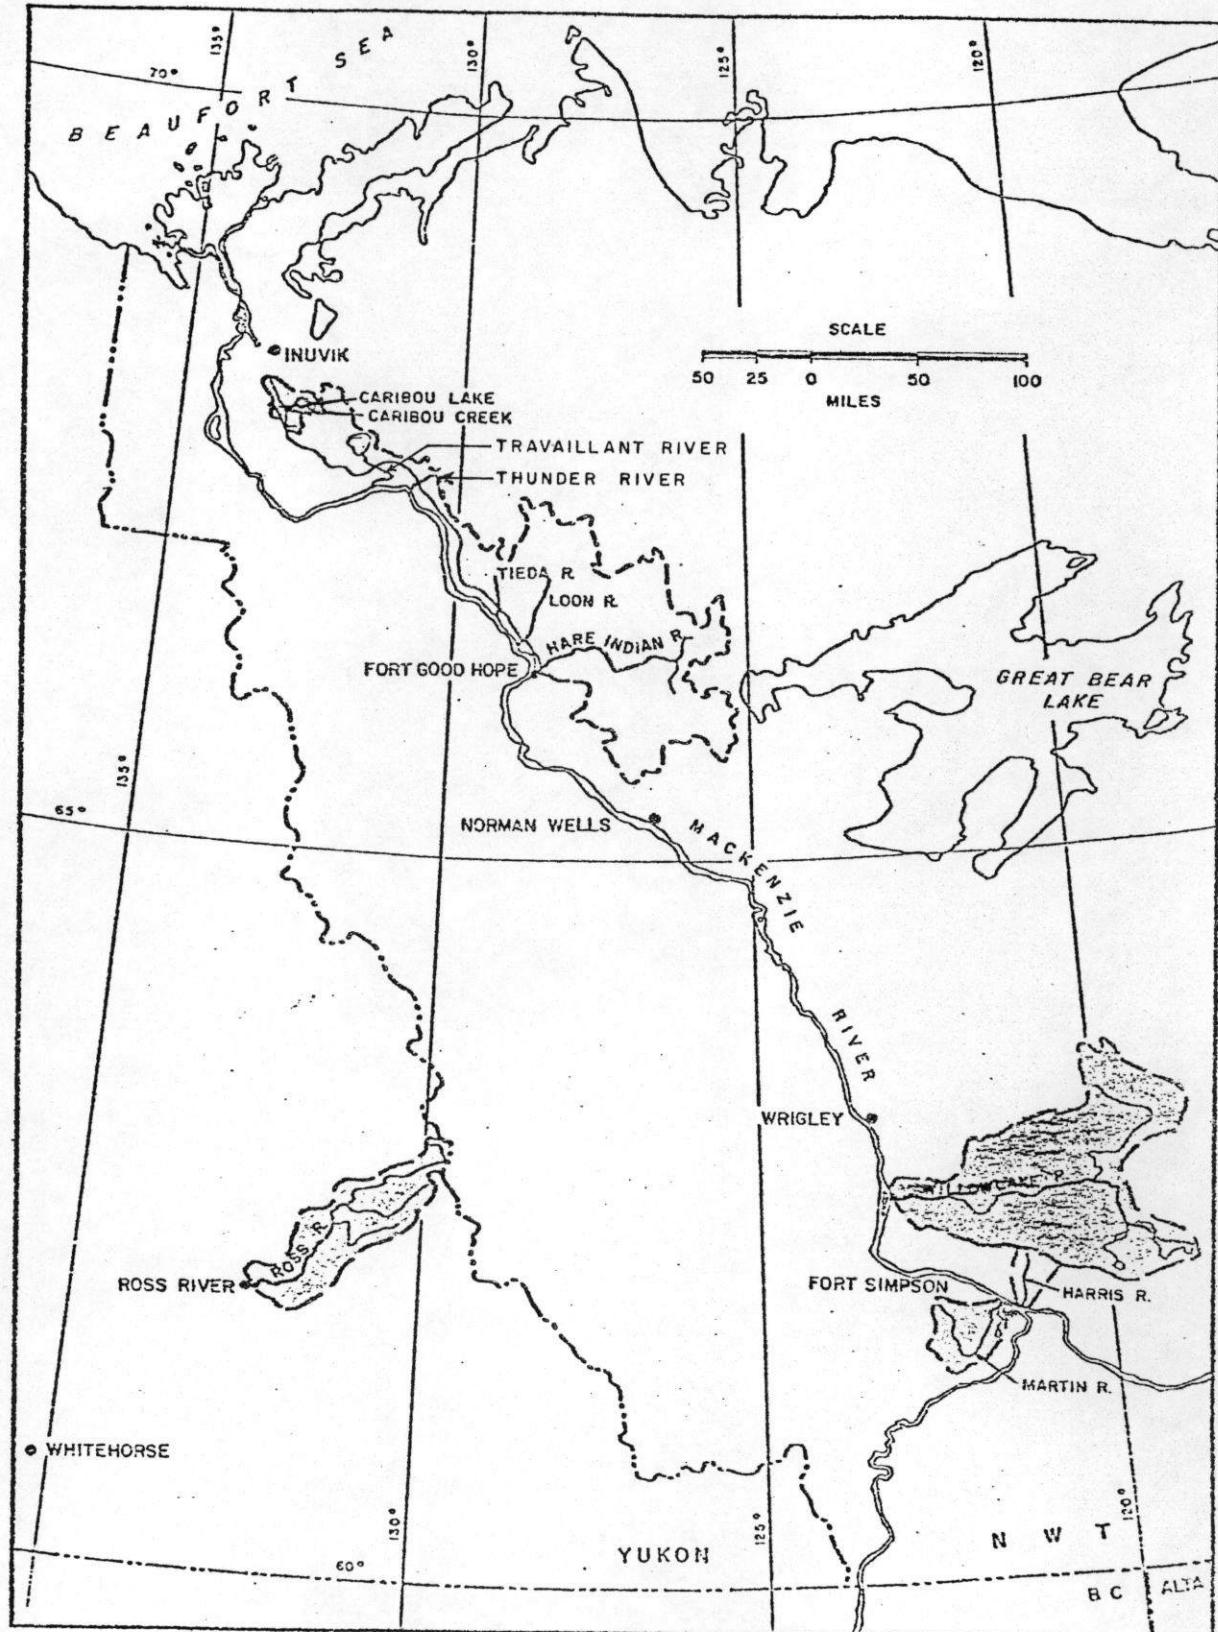
Dwg. No. A-1

#### KEY PLAN

# Tieda River

Mile 763.4

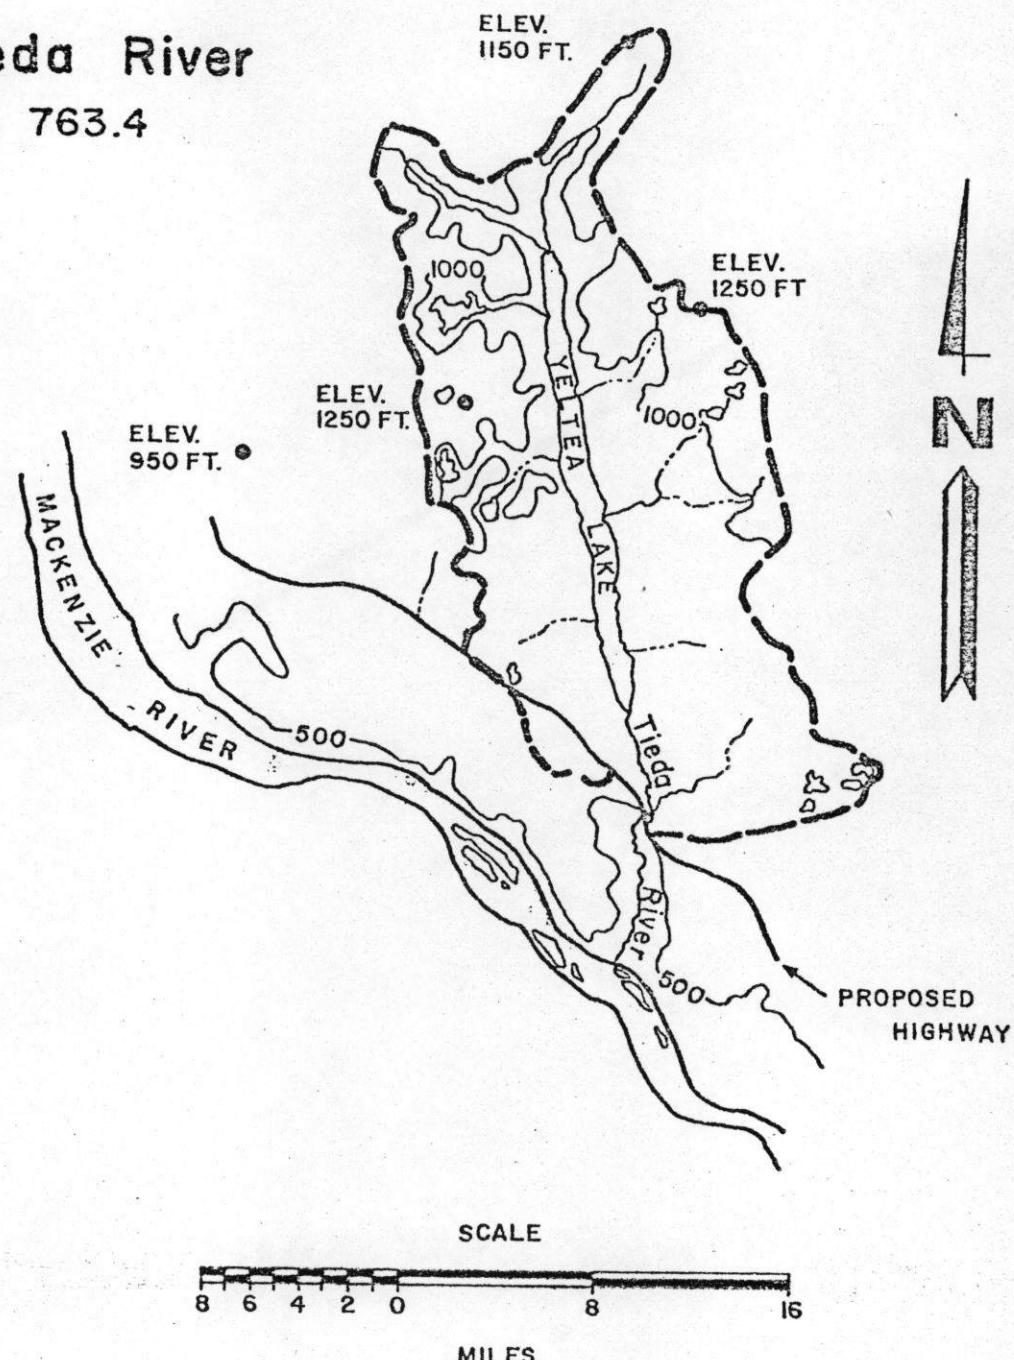
— Drainage Area to Proposed Highway Crossing 319 sq. miles

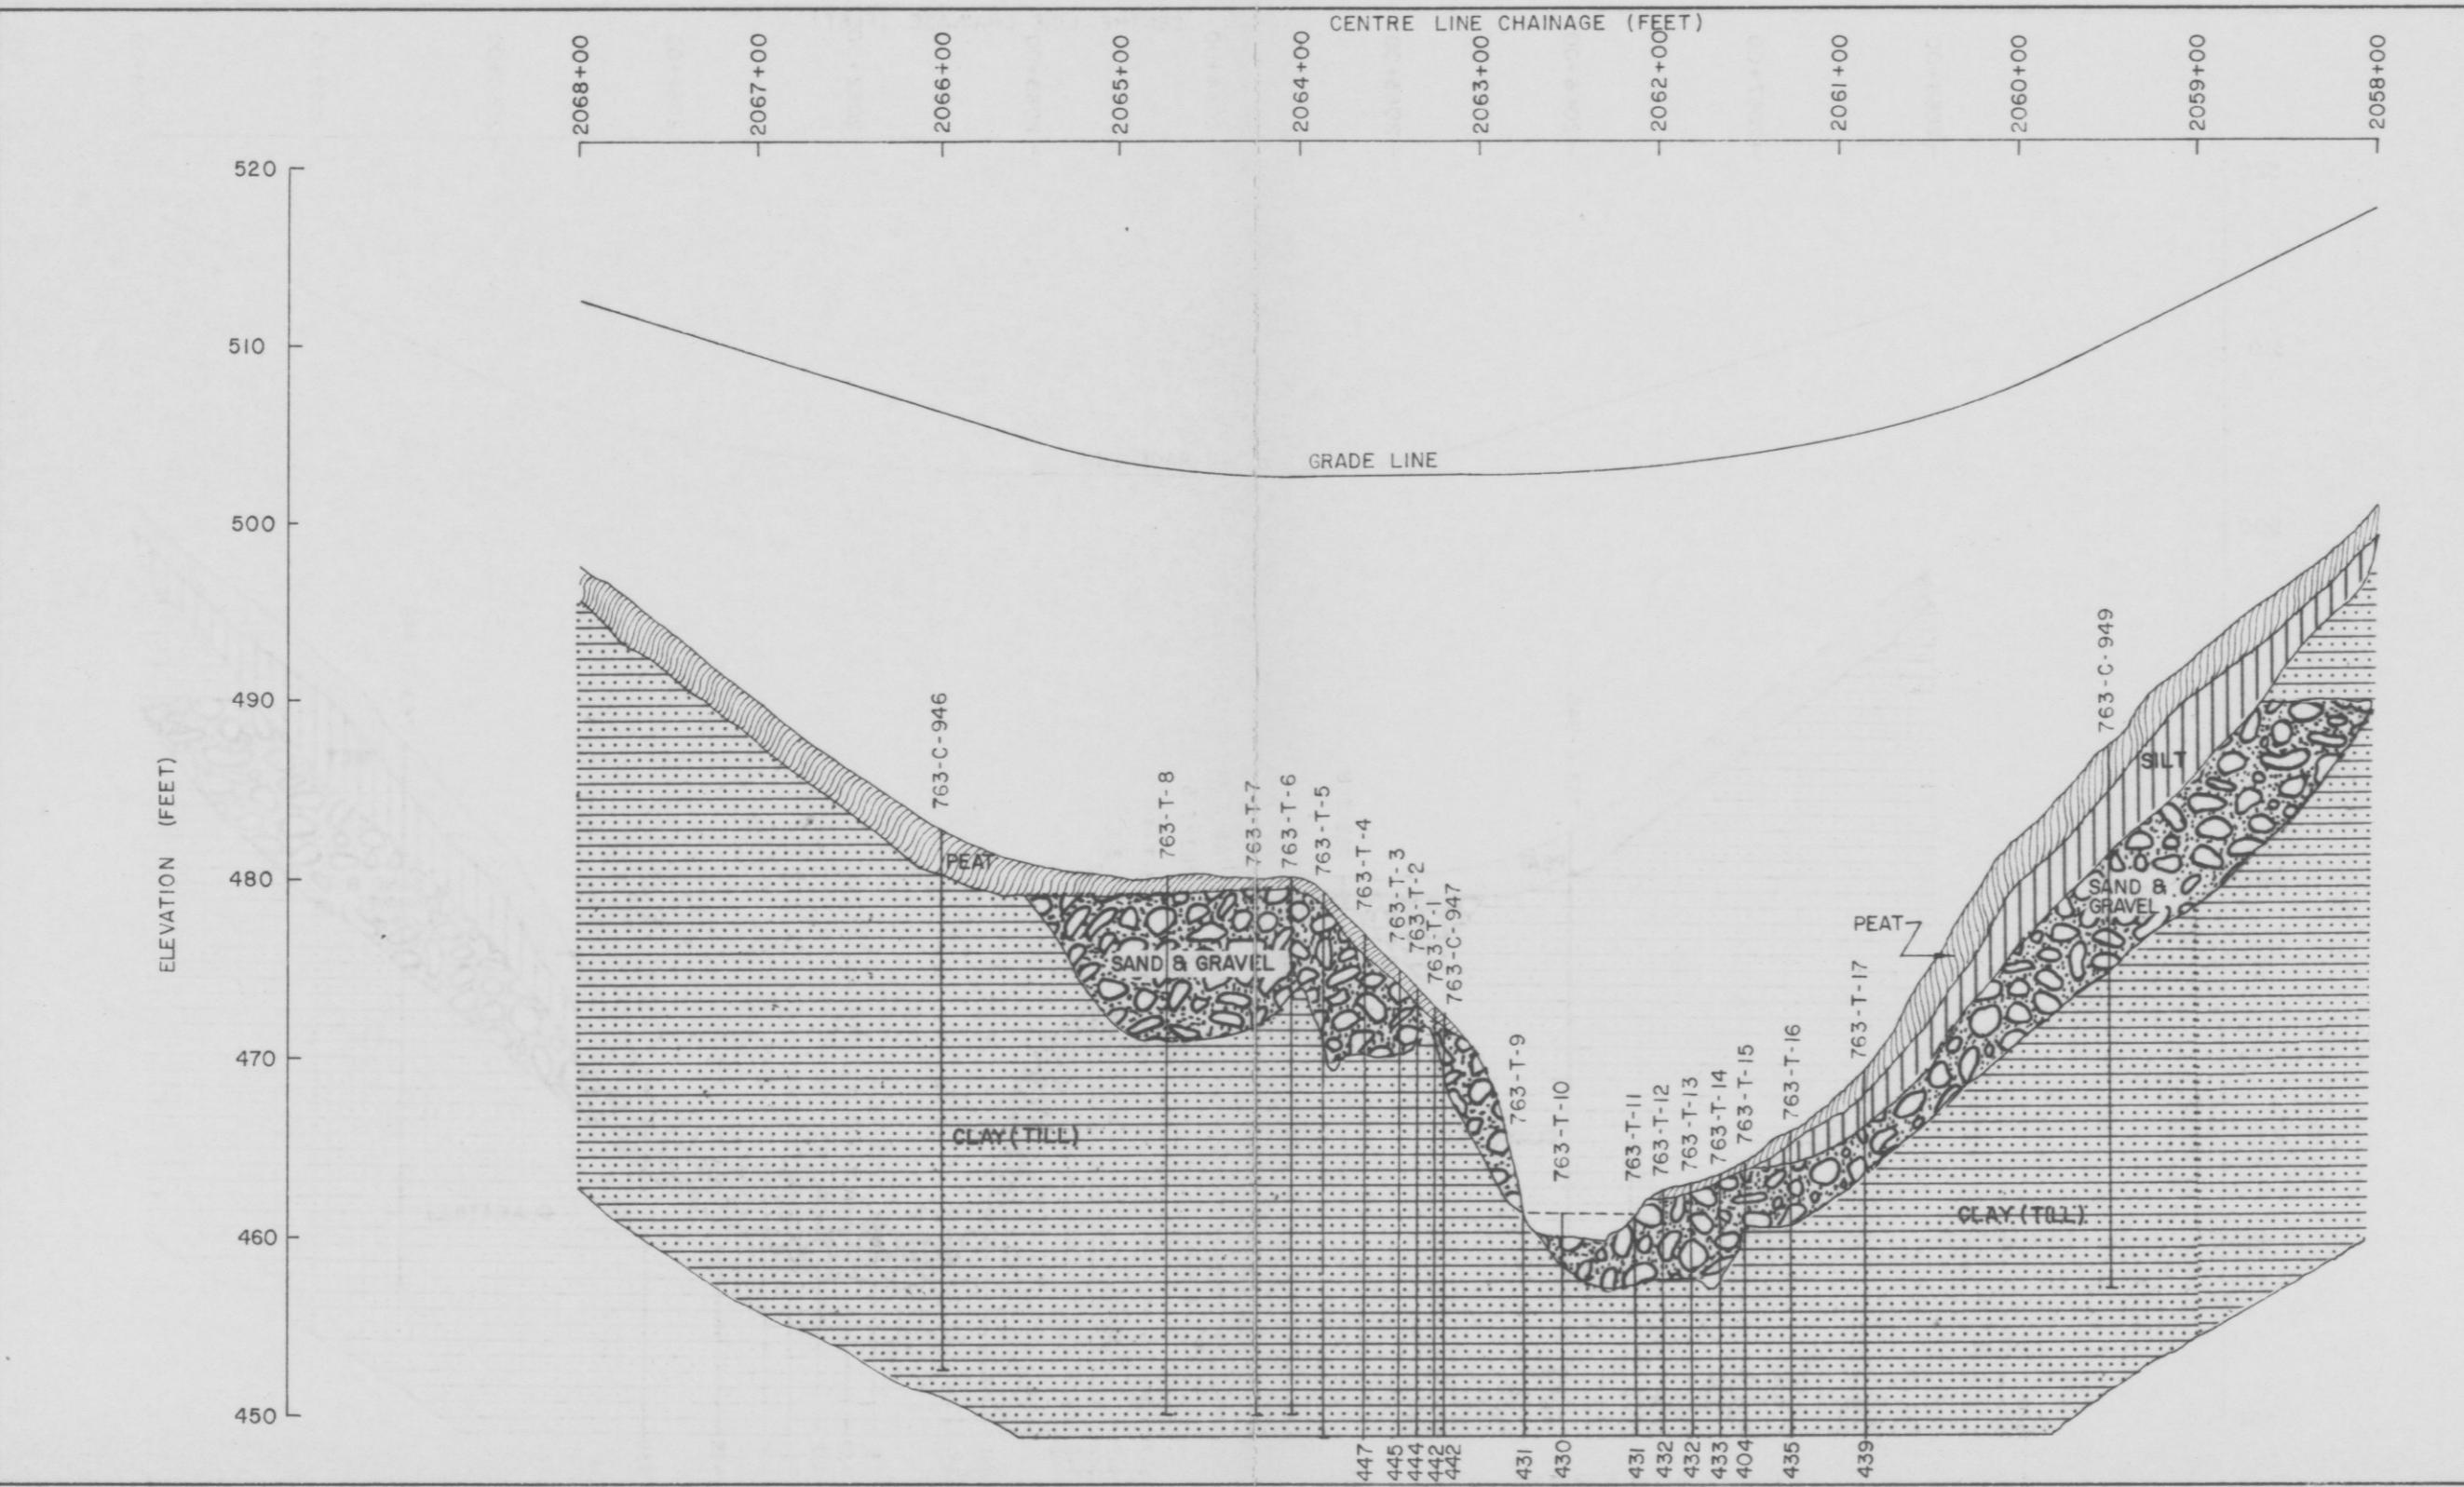
TIEDA RIVER CROSSING  
PROFILE & STRATIGRAPHY  
DWG NO A-4

NOTE: I. STRATIGRAPHY BETWEEN BOREHOLES HAS BEEN ASSUMED.

SCALE: VERT. 1"=10'  
HORIZ. 1"=100'

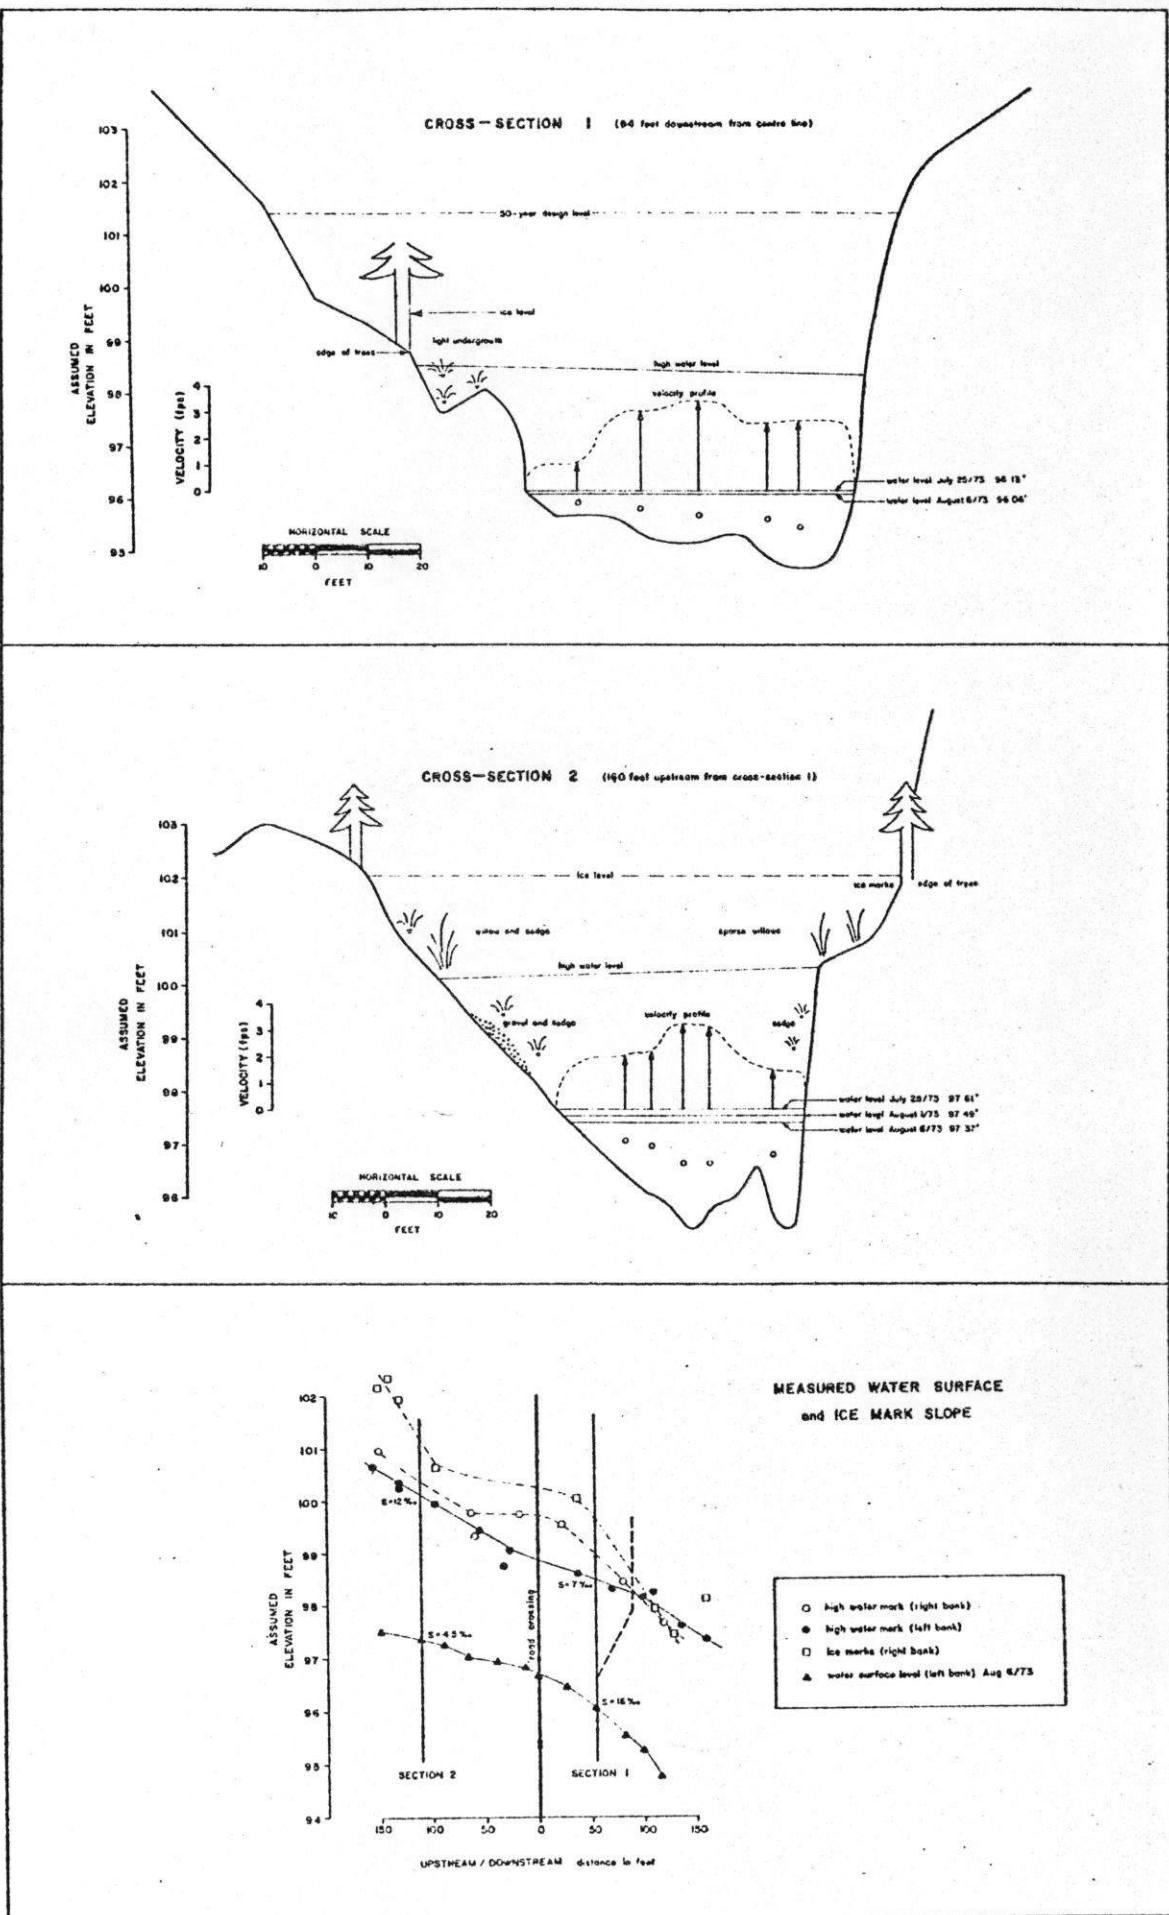
FIGURE 41 Tieda River Hydraulic Data

TIEDA RIVER BASIN  
TOTAL DRAINAGE AREA TO HWY 319 SQ MI
