Foundation Design in Talik Zone for a New School, Fort Good Hope, NT

Entzu Hsieh *AMEC Earth & Environmental, Calgary, Alberta* Dmitry Dumsky *AMEC Earth & Environmental, Calgary, Alberta* Ramesh Koirala *Public Works and Services, Government of the Northwest Territories*

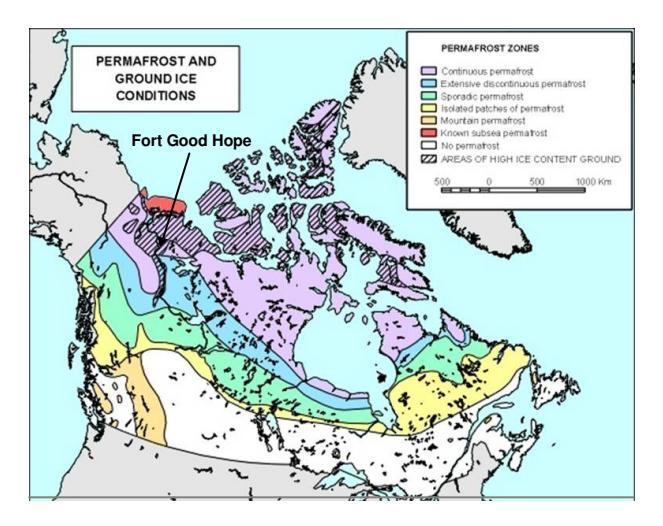
Figure 1. Location of Fort Good Hope and Permarfost Map

The community of Fort Good Hope is located within the continuous permafrost zone as shown in Figure 1 (Geological Survey of Canada). The permafrost table at the construction site was expected to be at a depth of 1 m to 2 m below the ground surface. However, the results of field investigation revealed that a talik exists on site and the permafrost table is located at depths from about 15 m to 17 m with permafrost temperatures varying from -0.1 °C to -0.6 °C. Such permafrost conditions are

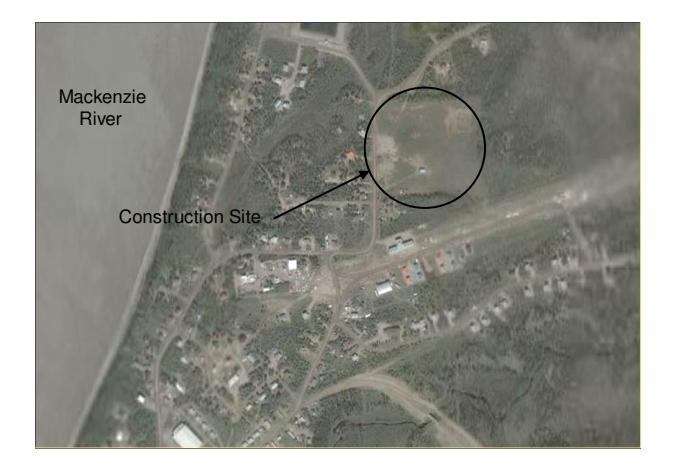
Figure 2. Location of the construction site

The new school building is situated at the southwest side of the construction site and occupies a gross area of $2,800 \text{ m}^2$. Figure 2 illustrates the location of the site in the community of Fort Good Hope.

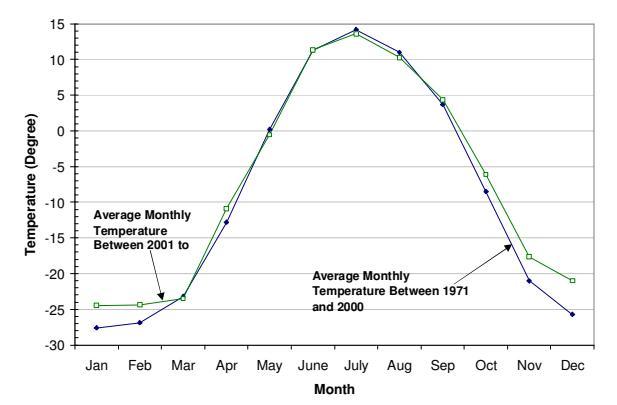
The changes of the mean monthly air temperatures for a northern portion of the Mackenzie River valley was reviewed based on data obtained from the Inuvik weather station from 1971 to 2000 and 2001 to 2008. Figure 3 below presents a comparison of the monthly air temperatures in Inuvik for the period from 1971 to 2000 and 2001 to 2008. It can be seen that there is a warming trend (about 2° C to 4° C) between September and March. Similar phenomenon was also observed in monthly air temperatures for data from Norman Wells weather station.

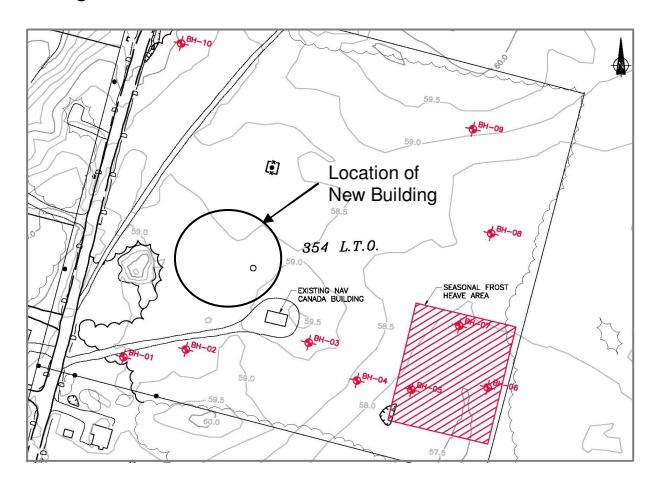
Figure 4. Locations of boreholes

The initial drilling program was carried out on February 20 and 21, 2007. A total of ten boreholes were drilled at the site to depths ranging from 5 m to 12 m using an air down hammer, track mounted drill rig. ABS thermistor conduits were installed in selected boreholes. The approximate locations of boreholes are presented in Figure 4.

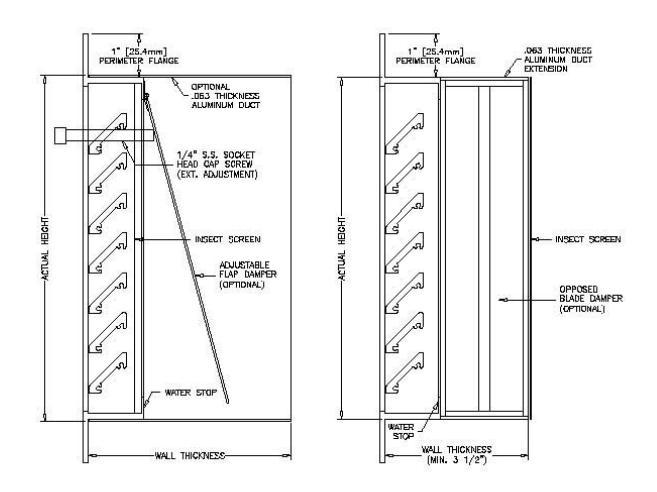
The area of the openings is a function of such parameters as the structure room temperature. dimensions of structure, floor thermal resistance, and skirt wall thermal resistance. The ambient air temperature and soil thermal parameters also have impact on the area of openings. An empirical relationship (SNiP, 1989) using the above parameters and soil temperature was used to predict the total area of openings along the skirted wall of the building. The area was estimated to be 2 m² to 4 m². The required openings were spread evenly along the six skirted walls of the building via ventilation windows. It is understood that the empirical relationship is an approximate solution and adjustable windows will be required to control the amount of circulation of cold air under the structure. On this basis, extruded aluminum brick vents with opposed blade damper, 197 mm by 1219 mm in size, were adopted for the new building. Figure 5 presents the section of the extruded aluminum brick vent. The insect screen of the vent will be removed after installation to allow better circulation. The adjustable flap damper behind the windows provides a way to adjust the area of openings, where necessary.

Figure 5. Extruded aluminum brick vent in skirted wall

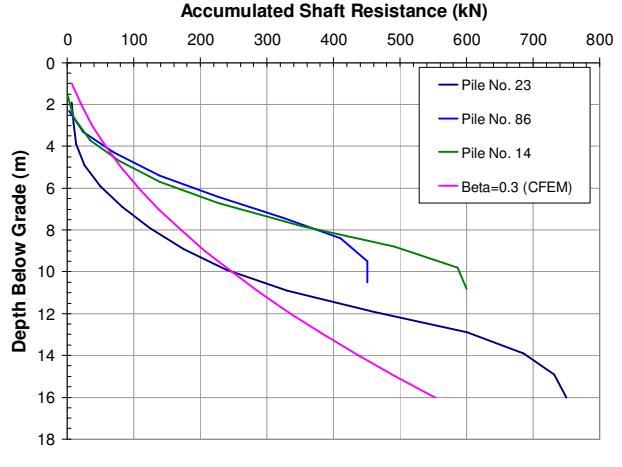
The accumulated shaft resistances along test piles obtained from CAPWAP were compared to the estimated shaft resistances using effective stress approach as assumed during the design stage. Figure 6 presents the results of comparison. It was found that the effective stress approach lies below the lower bound values derived from CAPWAP analyses when the pile length is longer than 10 m.

Figure 6. Comparison of CAPWAP analyses with effective stress approach
