GRANULAR RESOURCES MANAGEMENT STRATEGY - SOUTH SLAVE REGION VOLUME 2: APPENDICES

SUPPLY AND SERVICES CANADA (DSS FILE: 38ST.A0632-6-5023)

DEPARTMENT OF INDIAN AND NORTHERN AFFAIRS

Thurber Consultants Ltd. Calgary, Alberta

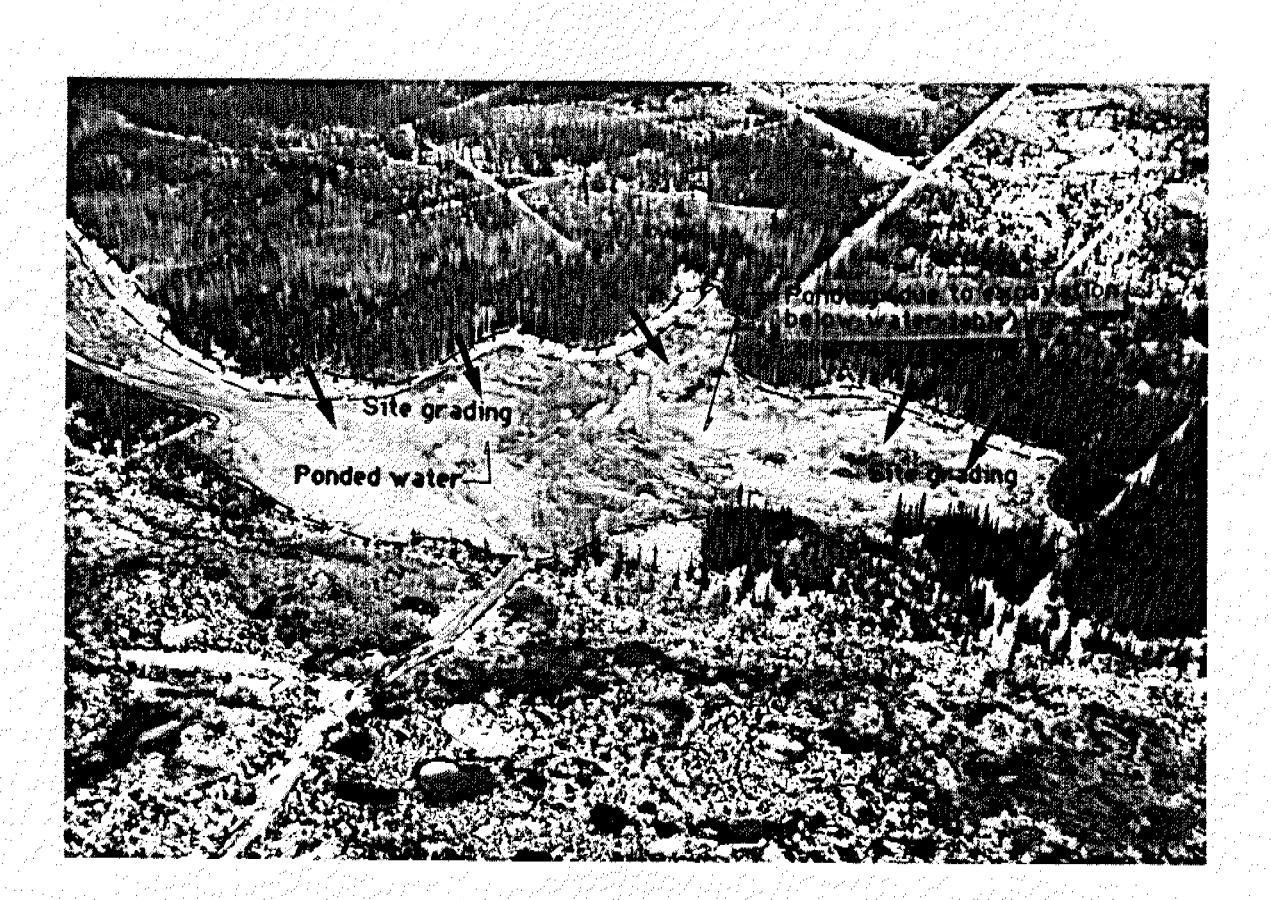
DEPARTMENT OF SUPPLY AND SERVICES	DRAWN IOJ/VV
	CONCEPTUAL RECLAMATION SKETCH	DATE NOVEMBER, 1987 APPROVED FMM
	DEPOSIT 1-2	SCALE N.T.S.
	SOUTH SLAVE GRANULAR STUDY	FILE No 16-5-38
THURBER	CONSULTANTS LTD., Geotechnical Engineers	DRAWING No B1

- consider end uses
- grade site, to eliminate ponding and contour
- pit walls
- promote positive drainage
 encourage natural revegetation

Field observations indicate that the granular materials at this site were extracted down to the underlying glacial till and, in some areas, below the seasonal water table. Since the topography of the pit floor is hummocky, some areas of ponded water have developed as a result. No stockpiles of topsoil and/or overburden (for use in restoration) were observed.

It is recommended that the Deposit 1-2 pit area should be rehabilitated. In view its distance from the highway, it is unlikely that this site will be developed for recreational or other uses; however, this should be discussed with interested parties.

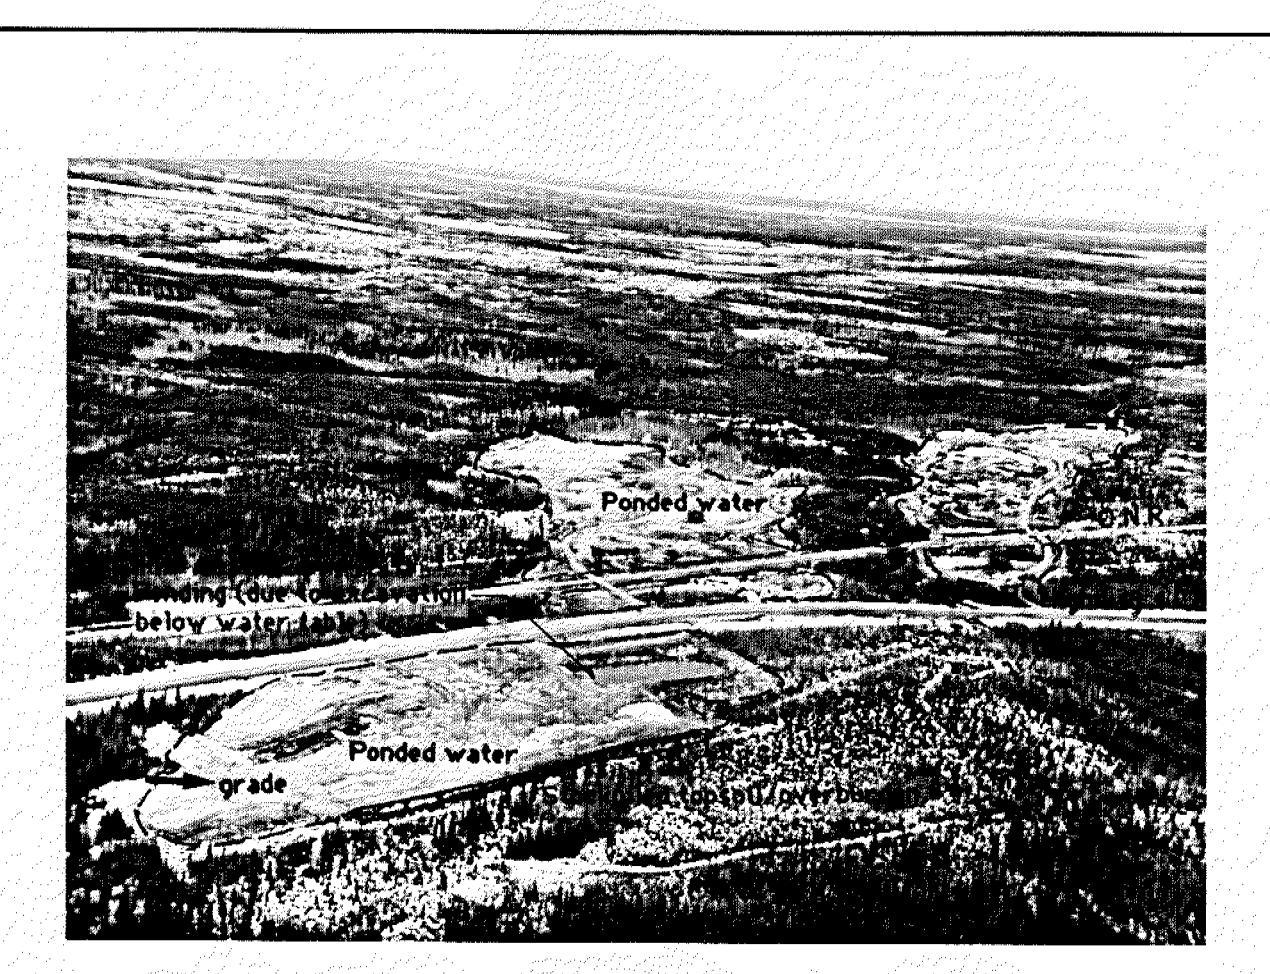
DEPARTMENT OF SUPPLY AND SERVICES	DBAWN IGJ/VV
CONCEPTUAL RECLAMATION SKETCH	DATE NOVEMBER, 1987 APPROVED
DEPOSIT 1-8	SCALE N.T.S.
SOUTH SLAVE GRANULAR STUDY	FILE No 16-5-38
THURBER CONSULTANTS LTD., Geotechnical Engineers	DRAWING No B2

- consider end uses
- grade site, to eliminate ponding
- promote positive drainage
 encourage natural revegetation

Surveys indicate that the granular material has been extracted down to the level of the surrounding terrain. Some ponded water is present where deeper excavations have been made. In one pit area, on the east side of the highway, a small windrow of stockpiled topsoil and/or overburden was observed.

A conceptual sketch showing restoration and reclamation recommendations is shown on Figure B2. Once possible end uses have been considered (the pit areas adjacent to Highway 1 may be suitable for a number of uses), restoration work should consist primarily of site grading and contouring. The objective would be to eliminate areas of ponded water (the deeper excavations will likely have to be retained) and promote positive drainage. Finally, the limited available stockpiled topsoil and/or overburden materials should be spread over the pit areas. It is anticipated that national revegetation should be relatively rapid.

Rehabilitation of the depleted pit areas is recommended.

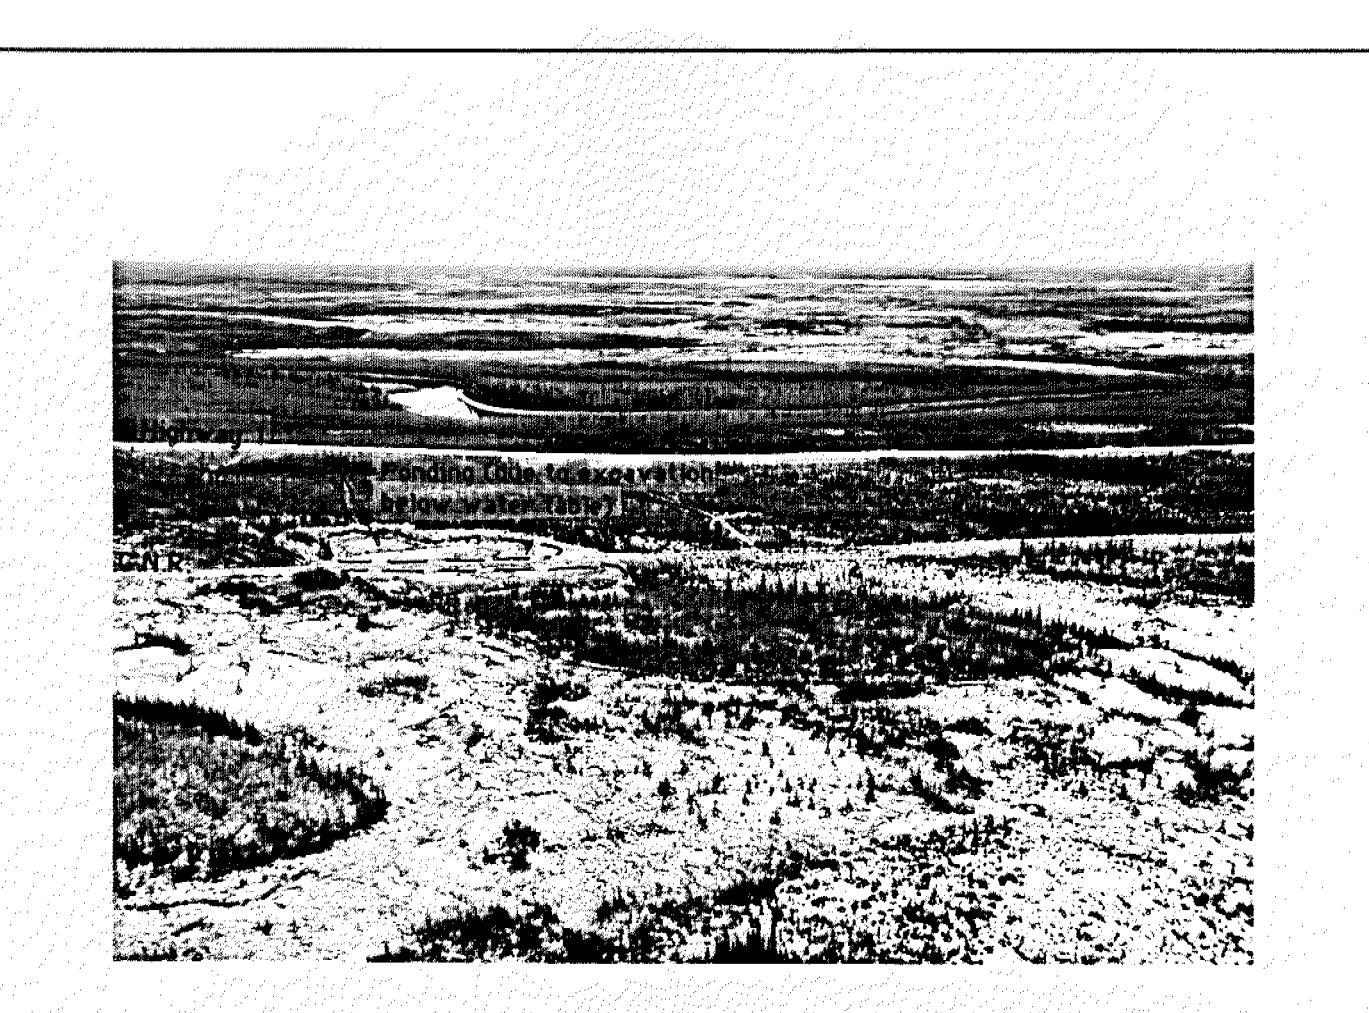
DEPARTMENT OF SUPPLY AND SERVICES	DBAWN IGJ/YY
	CONCEPTUAL RECLAMATION SKETCH	APPROVEDLINU
	DEPOSIT 1-10	SCALE N.T.S.
	SOUTH SLAVE GRANULAR STUDY	FILE No 16-5-38
THURBER	CONSULTANTS LTD., Geotechnical Engineers	DRAWING No B3

- consider end uses
- grade depleted area to eliminate ponding
- strip remaining reserves and replace topsoil/ overburden on depleted area and stockpile
- deplete remaining reserves
- replace stockpiled topsoil/overburden
- promote positive drainage
- encourage natural revegetation

Materials extraction is recommended to continue until the deposits are depleted (i.e. until the seasonal water table is encountered). Topsoil and/or overburden should be stockpiled as the material is extracted; no existing topsoil or overburden stockpiles were observed.

Restoration and rehabilitation work should consist of site grading and contouring, to eliminate terrain depressions and ponding of surface water, and spreading of available topsoil and overburden materials. Figure B3 is a conceptual sketch illustrating these recommendations.

Continued extraction is recommended so that rehabilitation may take place, once the deposit is depleted.

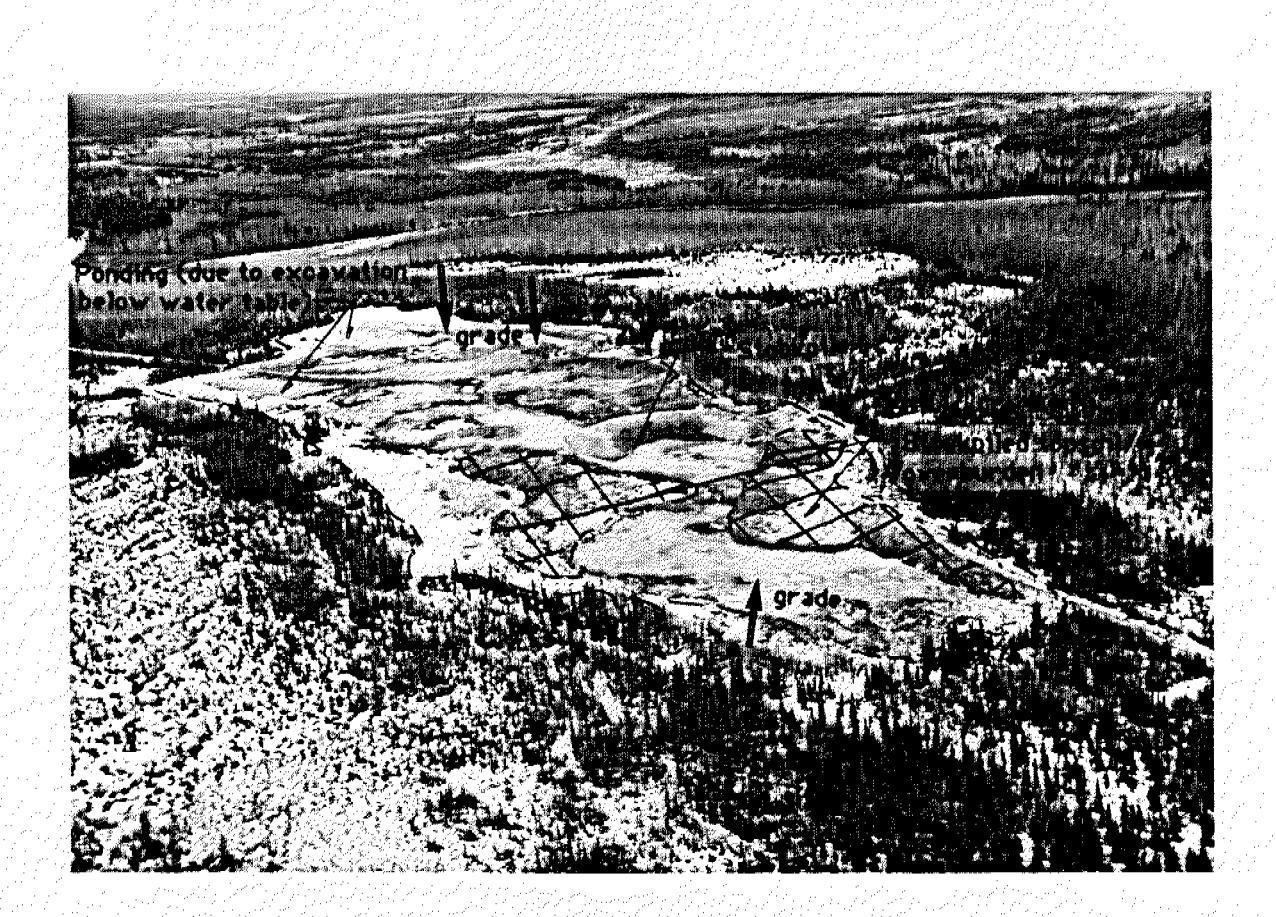
DEPARTMENT OF SUPPLY AND SERVICES	DRAWN IGJ/VV
A Charles and a state of the st	NOVEMBER, 1987
	APPROVED INUL
n var var var seneral s Nordal seneral s	N.T.S.
SOUTH SLAVE GRANULAR STUDY	16-5-38
THURBER CONSULTANTS LTD., Geotechnical Engineers	DRAWING No B4

- grade site, to eliminate ponding and establish stockpile pads
- promote positive drainage
- -replace available topsoil and overburden
- encourage natural revegetation

This deposit was a small glaciofluvial ridge, now depleted, located about 600 m east of Highway 1 at km 48 (Drawing H2). The former pit area is now used by GNWT Highways as a crushing and stockpile site, with access from the highway. Continued utilization of the former pit area as a stockpile and crushing site is recommended.

Restoration of the pit area and continued utilization as a crushing/stockpiling site are recommended.

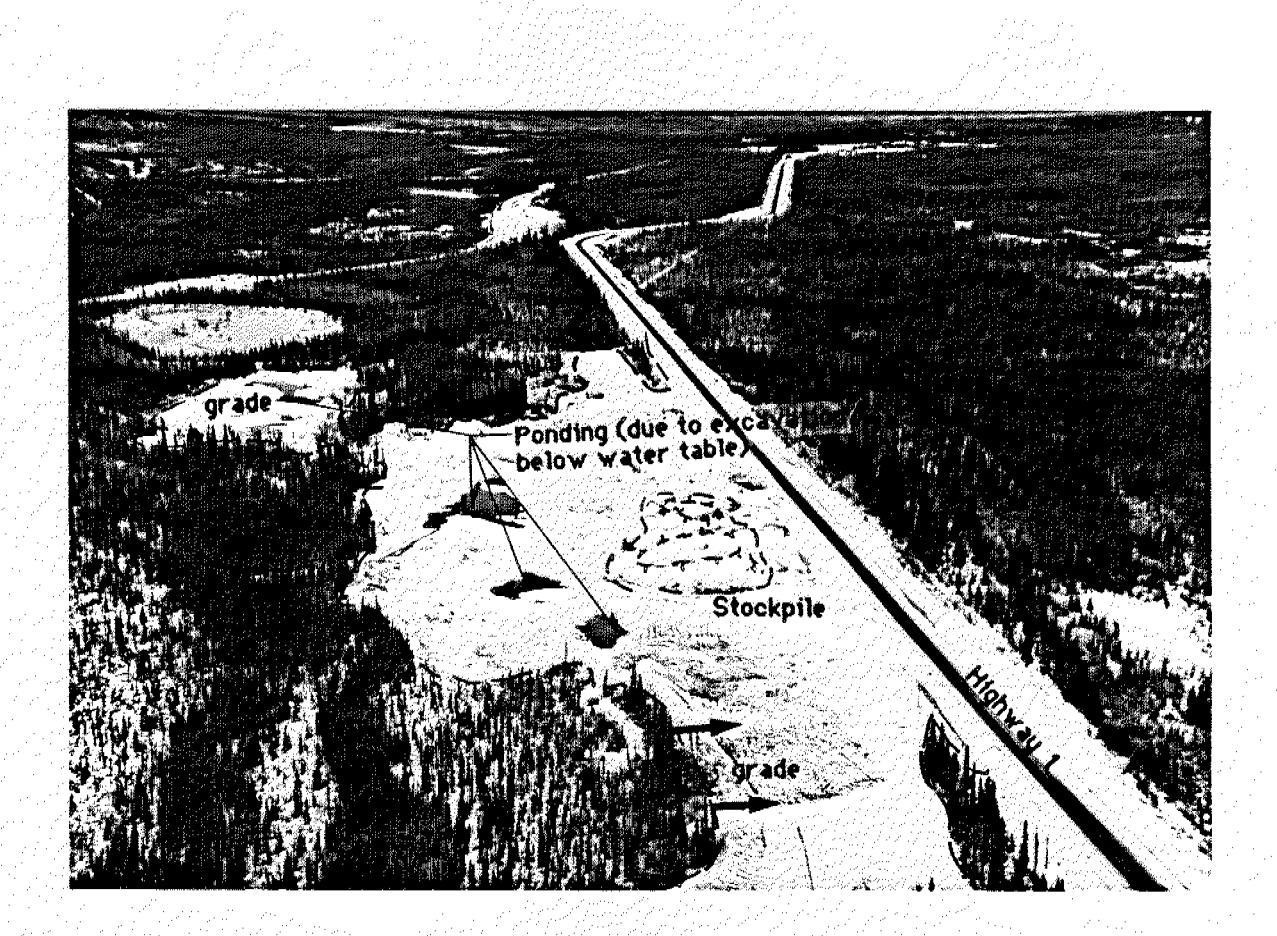
DEPARTMENT OF SUPPLY AND SERVICES	IGJ/YY
CONCEPTUAL RECLAMATION SKETCH	DATE NOVEMBER, 1987 APPROVED
DEPOSIT 1-18	SCALE N.T.S.
CONSULTANTS LTD., Geotechnical Engineers	16-5-38 DRAWING No B5

- grade site, to eliminate ponding promote positive drainage encourage natural revegetation

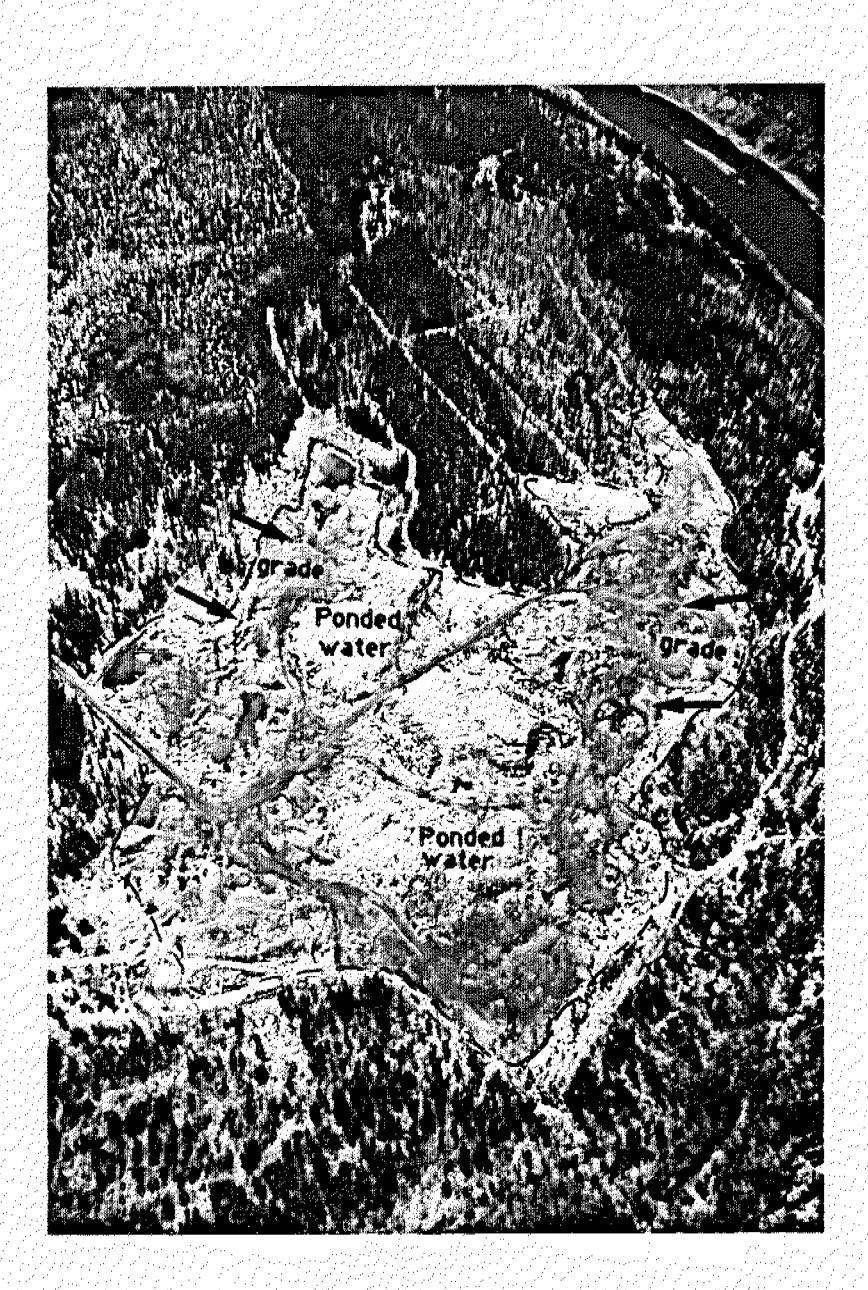
DEPARTMENT OF SUPPLY AND SERVICES	DRAWN IGJ/YY
	CONCEPTUAL RECLAMATION SKETCH	APPHOVED DIN
	DEPOSIT 2-5(GRAVEL PIT) SOUTH SLAVE GRANULAR STUDY	SCALE N.T.S. FILE NO 16-5-38
THURBER	CONSULTANTS LTD., Geotechnical Engineers	DRAWING No C2a

- consider end uses
- grade site, to eliminate ponding and contour pit walls
- promote positive drainage
- encourage natural revegetation

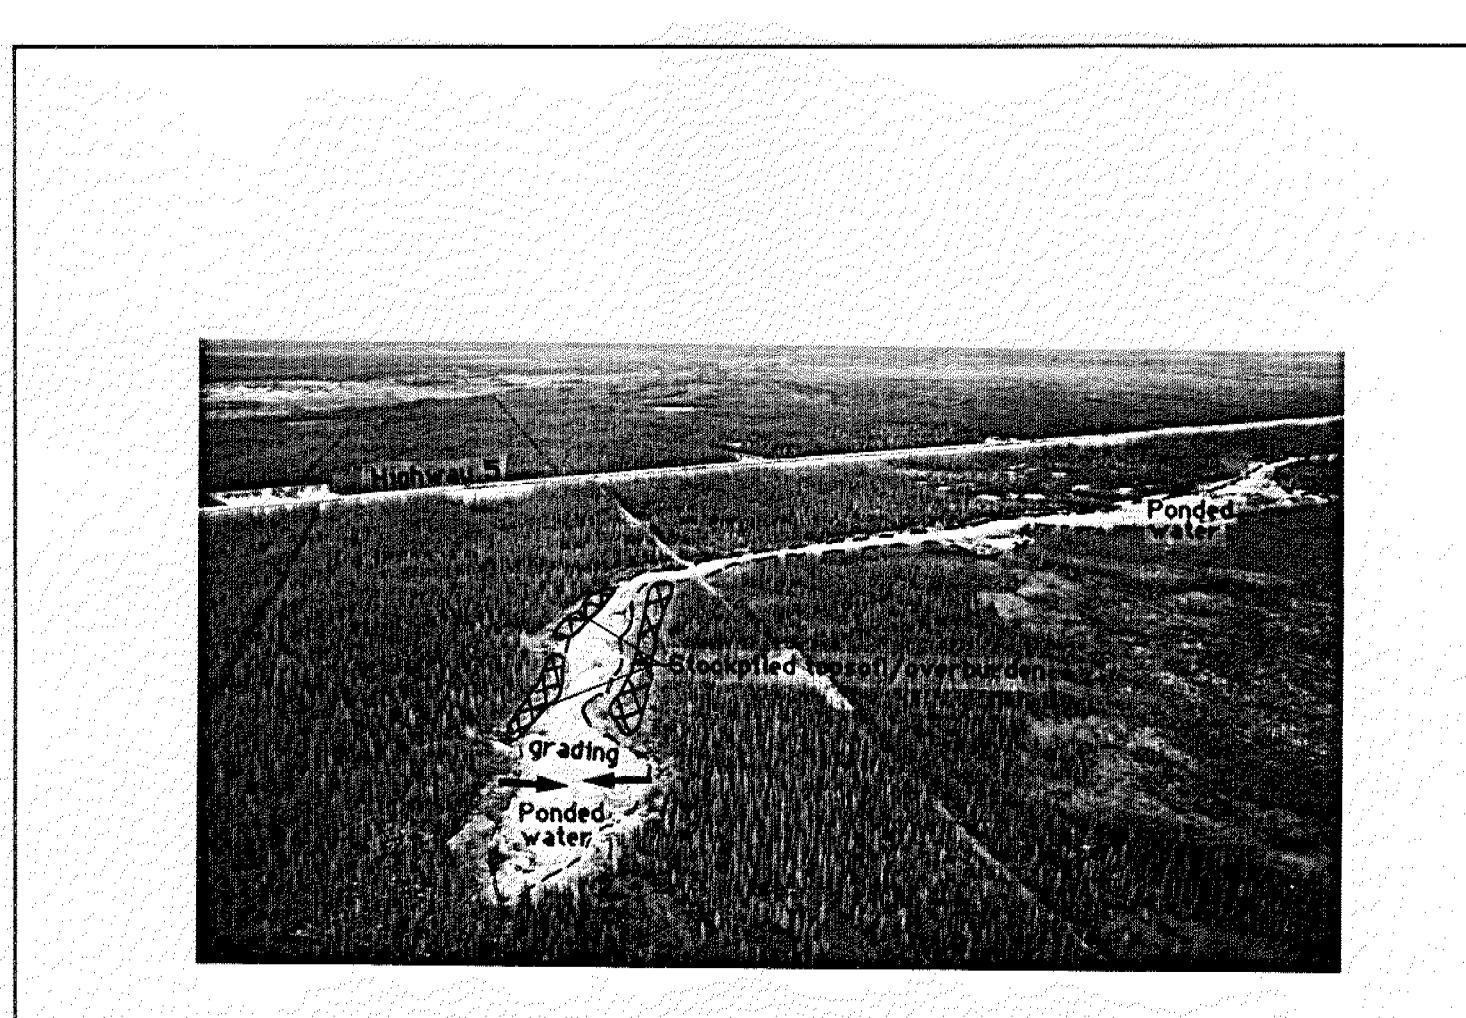
- consider end uses
- grade site, to eliminate ponding and salvage remaining material
- promote positive drainage
- replace topsoil/over burden
- encourage natural revegetation

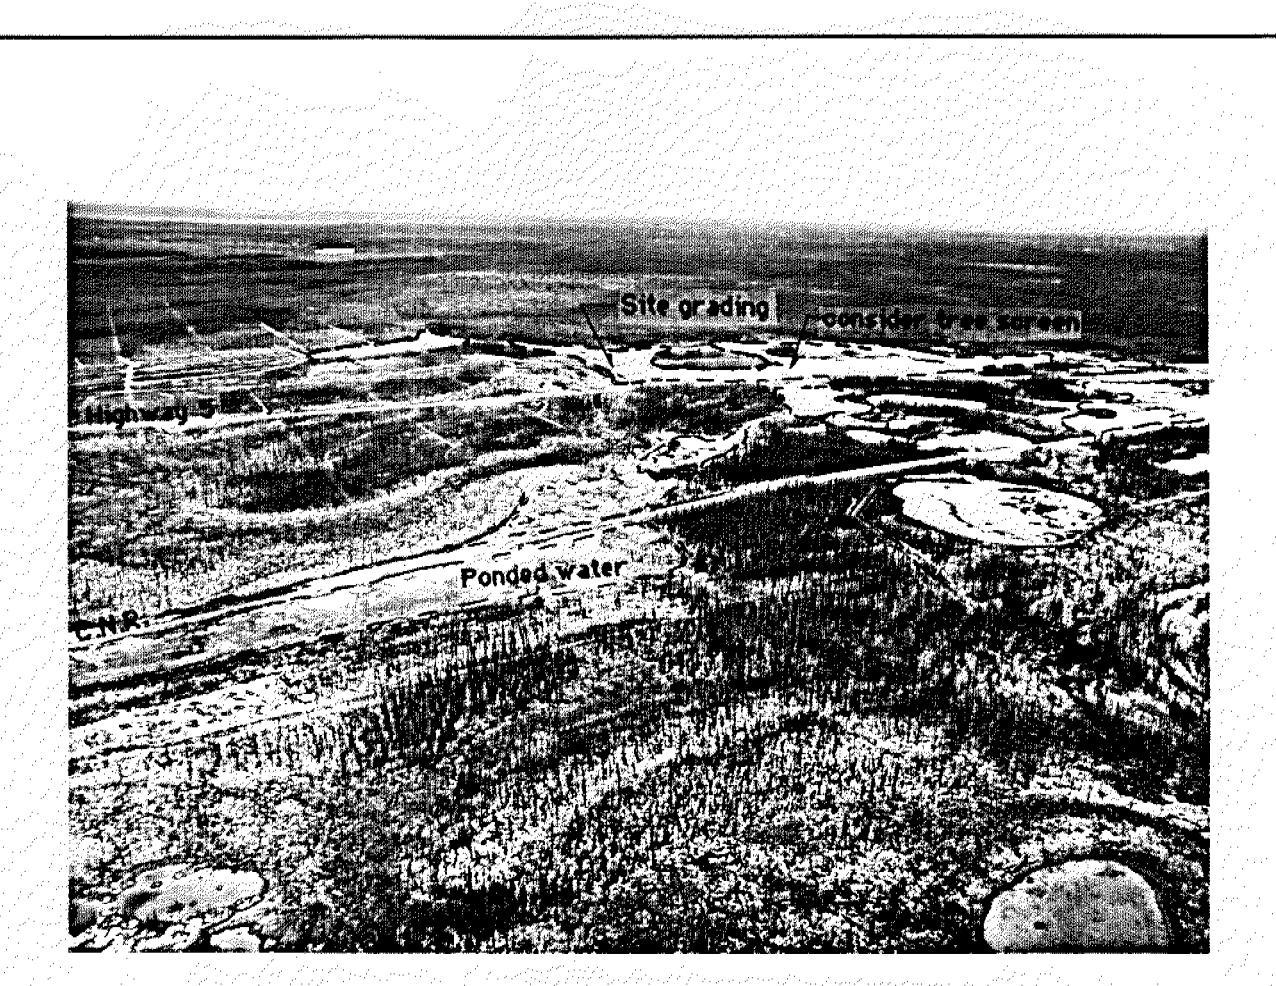
NA TINA TINA MANANA MANANGKA MATANA MANANA MANA	
	DEPARTMENT OF SUPPLY AND SERVICES	ORAWN IGJ7VV
	CONCEPTINAL DECLAMATION OVETCU	APPHOVED - 10
	DEPOSIT 5-19(PART)	SCALE N.T.S.
	SOUTH SLAVE GRANULAR STUDY	FILE No 16-5-38
THURBER	CONSULTANTS LTD., Geotechnical Engineers	DRAWING NO

- consider end uses
- grade site, to eliminate ponding
- consider tree screen, south side of highway
- promote positive drainage
- encourage natural revegetation
