Flow Structure and Channel Stability at the Site of a Deep Scour Hole, Mackenzie Delta, Canada

SPYROS BELTAOS,^{1,2} BOMMANNA G. KRISHNAPPAN,¹ ROBERT ROWSELL,¹ TOM CARTER,³
ROGER PILLING⁴ and PAUL EMILE BERGERON⁵

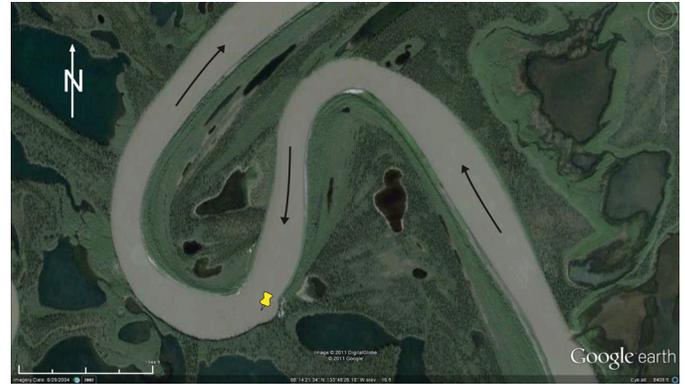
FIG. 2. Plan view of East Channel in the vicinity of the scour hole. The pin approximately indicates the deepest location in the scour hole. The scale bar indicates a length of ~ 600 m. Image source: Google Earth. Imagery date: 29 June 2004. Copyright 2011 Google; image copyright 2011 DigitalGlobe.

The stability of the channel in the SH area is corroborated by the experience of the owner of a nearby summer cabin (William Modeste, pers. comm. 2010, 2011). No change has been noticed in the location of the "whirlpool" or of the water's edge relative to the cabin over the past 20+ years, even though the top of the initially near-vertical bank has moved inland by some 5 to 6 m via flood-induced slumping. In the spring of 2011, heavy bank erosion occurred at various East Channel fishing camps, which are located near scour holes. In the study area, the erosion occurred near the apex of the bend downstream of the SH (Fig. 2).

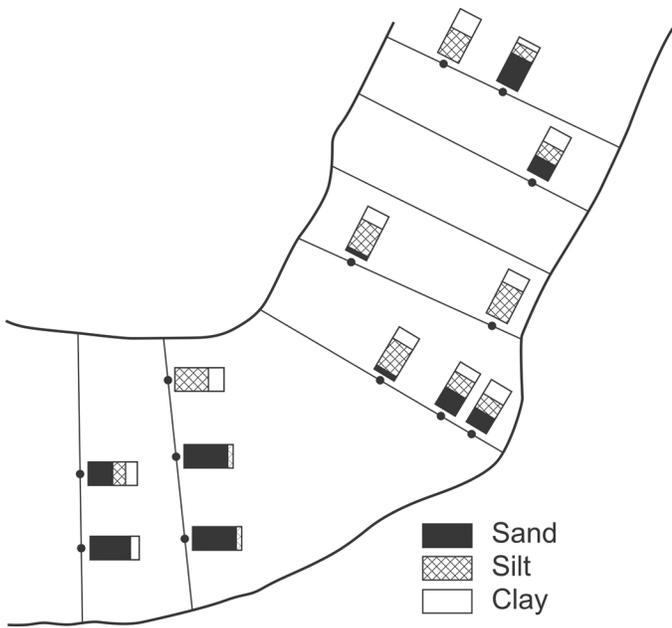
The clay fraction (up to 3.9 μm) of the surface layer (Fig. 3) averages ~21% while the silt-plus-clay content is often high, suggesting potential for cohesive resistance to bed material mobilization by flow shear stresses. This resistance could help explain the very steep walls of the SH, especially on the upstream side (see also next subsection). Large channel-boundary slopes have also been found elsewhere in the delta (Hollingshead and Rundquist, 1977). These authors cited evidence indicating that soil strata near bed level are highly overconsolidated, which could also account for the difficulty encountered in obtaining bed material cores.

FIG. 3. Spatial variability of sand, silt, and clay fractions in the top layer of the bed.

The data of Fassnacht and Conly (2000) exhibited spatial variability similar to that shown in Figure 3, but indicated somewhat lower clay portions (average ~16% over the same area that was covered by the present data). The particle size was slightly larger (average $D_{50} = 83.2 \mu\text{m}$, as opposed to 75.5 μm for the present data). The small discrepancies could be due to differences in sampling methods (grab samplers vs. corers) and possibly in analytical techniques. Fassnacht and Conly (2000) did not mention the silt-clay boundary used in their sediment size analyses, but a value of 4 μm is indicated in Fassnacht (1993), where the raw data are presented in detail.

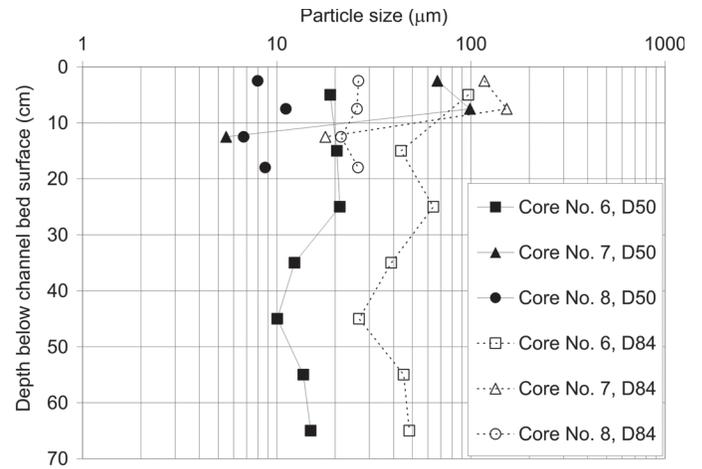
FIG. 4. Example of bed material size variation with depth. Cores 6, 7, 8 were located at $\sim 1/8$, $1/4$, and $1/2$ of channel width from the Left (East) Bank, respectively.

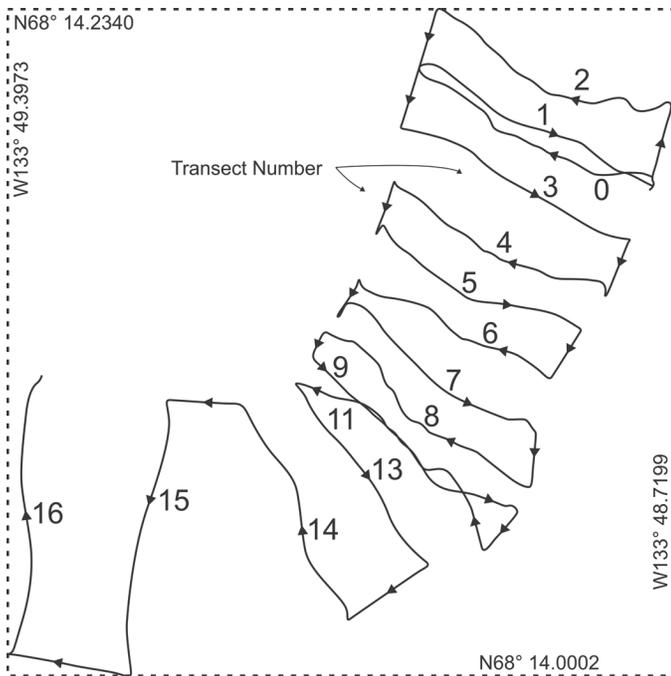
The study reach contains the scour hole area as well as entry and exit segments, for a total length of 600 m. Figure 5 shows the GPS-derived plan view of the 2005 boat track and transects in terms of latitude and longitude. Though every effort was made to maintain a straight course for each transect, Figure 5 indicates that the actual boat trajectories were curvilinear. Strong turbulence, presence of shear

FIG. 5. Plan view of boat track and actual transect shapes, ADCP survey, June 2005.

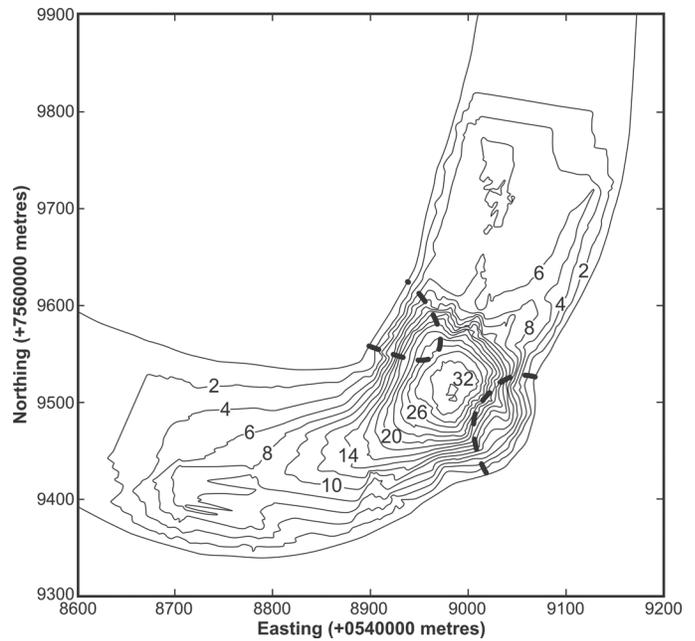
zones, and flow reversals were contributing factors. The boat track commenced near the left bank at transect 0 and ended at the right bank of transect 16, following the direction of the arrows. The numbers 10 and 12 do not appear in Figure 5 because they did not represent actual survey transects. The detailed bathymetric data were processed to obtain the isobaths shown in Figure 6 using the contour plot function (contour.m) in MATLAB.

FIG. 6. Bathymetry of the East Channel scour hole, as measured by the ADCP on 11 June 2005. The dashed lines indicate approximate limits of reverse-flow areas near the channel banks.

changes. Considering “average” distances at different transects, the approximate horizontal extent of reverse-flow areas is depicted in Figure 6, where isobaths are also shown. It is evident that the approach flow is directed towards the deepest area of the SH when it reaches the edge of the steep upstream side of the hole.

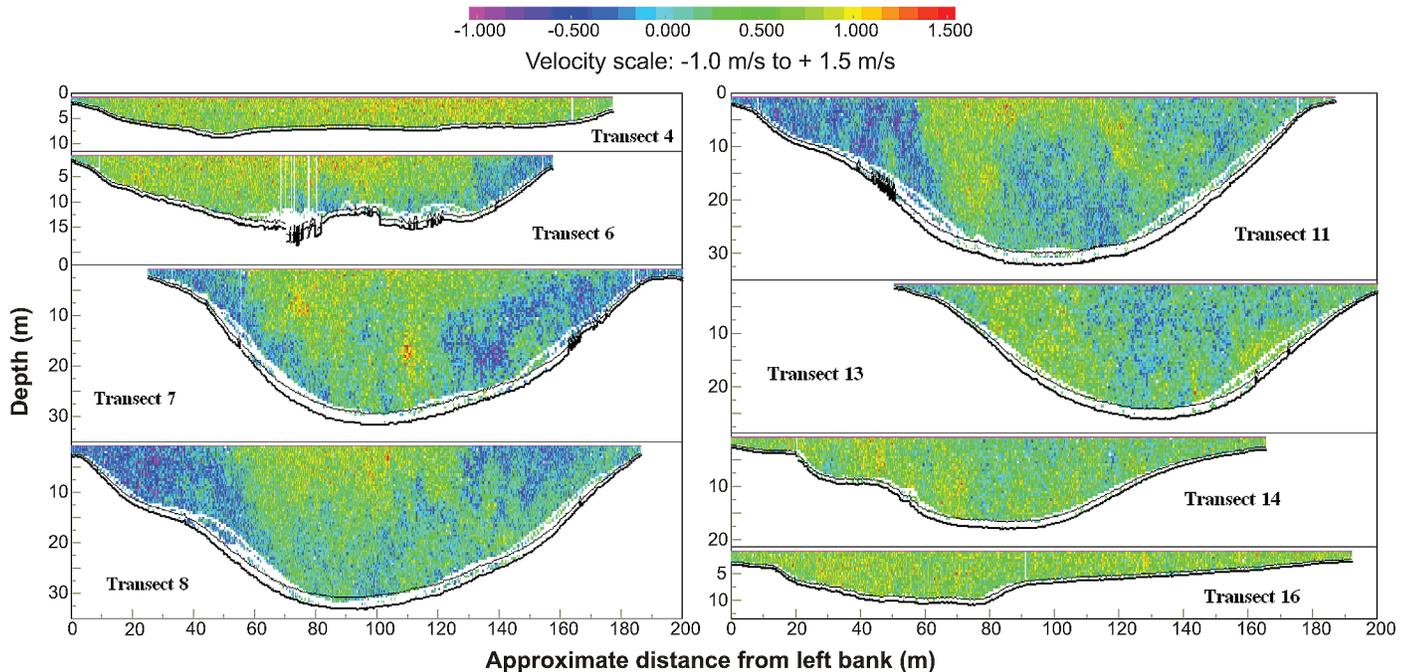
The three-dimensional field of “streamwise” velocity is depicted in Figure 7. Here, the “streamwise” direction is the mean flow direction within a given transect, as determined by the ADCP software. No-data strips near the water surface and next to the channel bed are clearly indicated. The velocity field is fairly uniform within the entry reach, which is well represented by transect 4. Transect 6 is near the beginning of the SH area, and already shows increased channel depth, as well as some flow reversals near the right bank (blue tones). Channel depth increases as one progresses downstream into the main SH area, while flow reversal zones are evident near both banks (transects 7–11). In this region, there are also zones where both positive and negative velocities occur within the same vertical. Flow reversals essentially disappear by transect 13: here,

FIG. 7. Cross-sectional geometry and streamwise velocity component along the study reach, 11 June 2005. Note zones of reverse flow (blue tones) in scour hole area (transects 6 to 14). Transect views are for an observer facing downstream.

Close inspection of Figure 7 shows that the boundaries separating forward and reverse flows are not vertical, but occur at different distances from the banks as the depth

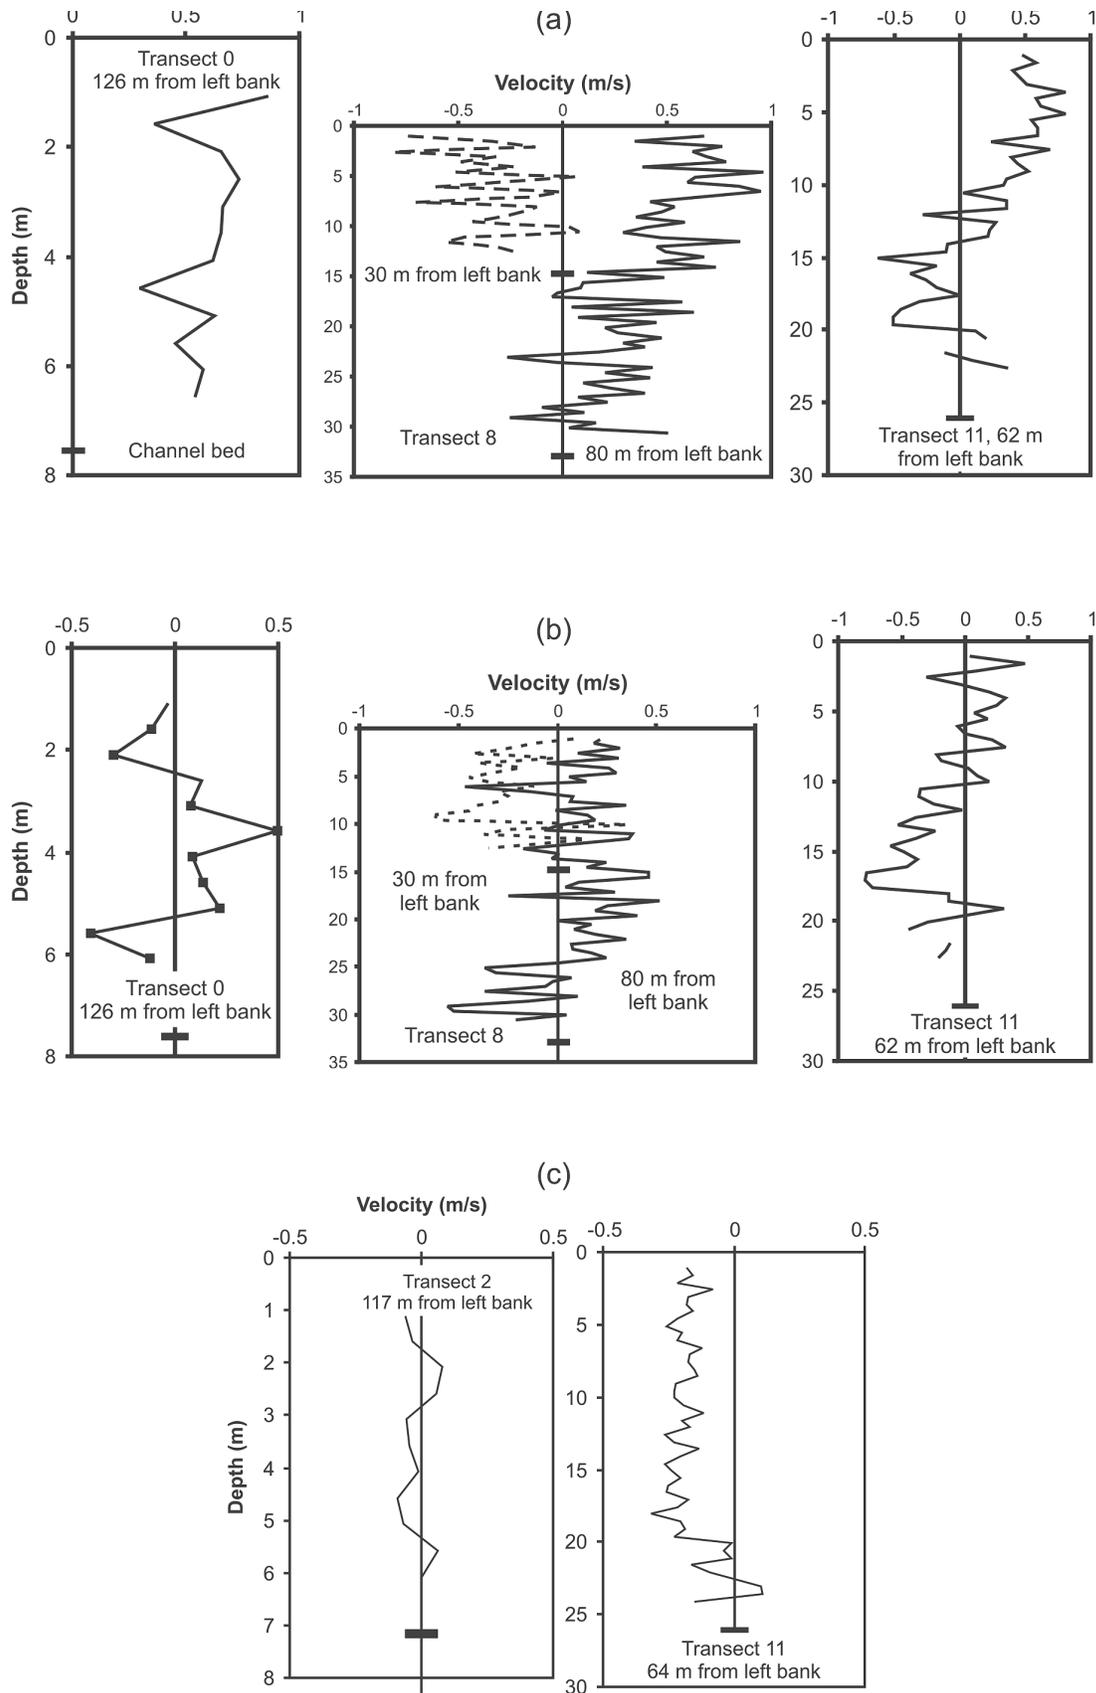
FIG. 8. (a) Vertical profiles of streamwise velocity component, obtained by summing the projections of measured north and east components onto the mean flow direction within each transect, 11 June 2005. (b) Vertical profiles of transverse velocity component, obtained by summing the projections of measured north and east components onto a perpendicular to the mean flow direction within each transect, 11 June 2005. Positive values indicate flow towards the Left Bank. (c) Vertical profiles of upward velocity component, 11 June 2005.

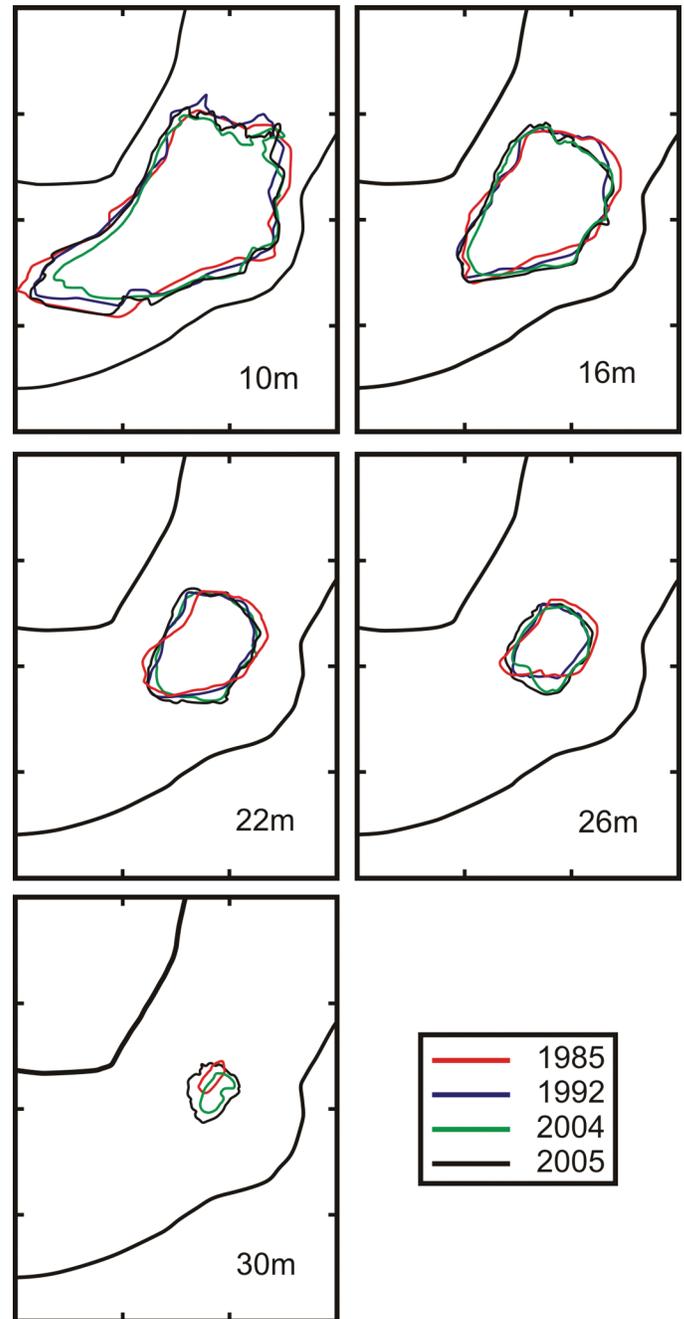
A detailed comparison of bathymetries is illustrated in the series of plots of Figure 9 and shows that the SH has remained largely unchanged during the period 1985 to 2005. Upon comparing individual isobaths of any one pair of surveys in Figure 9, small areas of erosion and deposition become apparent. These areas also suggest dynamic stability, though they could be partly attributed to observational uncertainties arising from sounding or horizontal positioning errors (GPS systems used in the 2004 and 2005 surveys; acoustic distance-measuring devices in 1985 and 1992).

FIG. 9. Isobath comparisons of four different surveys. All depths are referred to the 1992 water level (approx. geodetic elevation = 2.51 m, per Table 1).

Because the earlier (1985, 1992) and later (2004, 2005) surveys involved differences in horizontal datum, UTM coordinates were adjusted so as to match channel boundaries, as described earlier. Strictly speaking, therefore, the preceding findings indicate that the SH is stable relative to the channel boundaries, but do not preclude simultaneous and identical migrations of both the channel and the SH. Lapointe's (1986b) "migration-rates map" (1950 to 1984) indicates a peak rate of 0.7 m/yr near the apex of the 180° bend (Fig. 2) that is located some 500 m downstream of the SH. The peak values apply to migration zones that typically extend from slightly upstream to some distance downstream of the apex. Considering the large distance between the apex and the SH, it is unlikely that the latter has been subject to discernible migration in recent decades. A comparison between the (NTv2-shifted) 1992 survey and a recently georeferenced air photo, taken in 2004 under MVAP (NWT Centre for Geomatics, 2011), indicated little change in the channel boundaries at the SH site. Downstream of the SH, deposition and erosion (~ 10 m) were indicated along the inner and outer banks, respectively.
