**THURBER CONSULTANTS LTD.**

RE: GRANULAR RESOURCES MANAGEMENT STUDY  
SOUTH SLAVE REGION (DSS FILE: 38ST.A0632-6-5023)

In accordance with the contract for the above study, we are pleased to submit this photo album for your information. It provides documentation of the granular sources visited during the recent field reconnaissance.

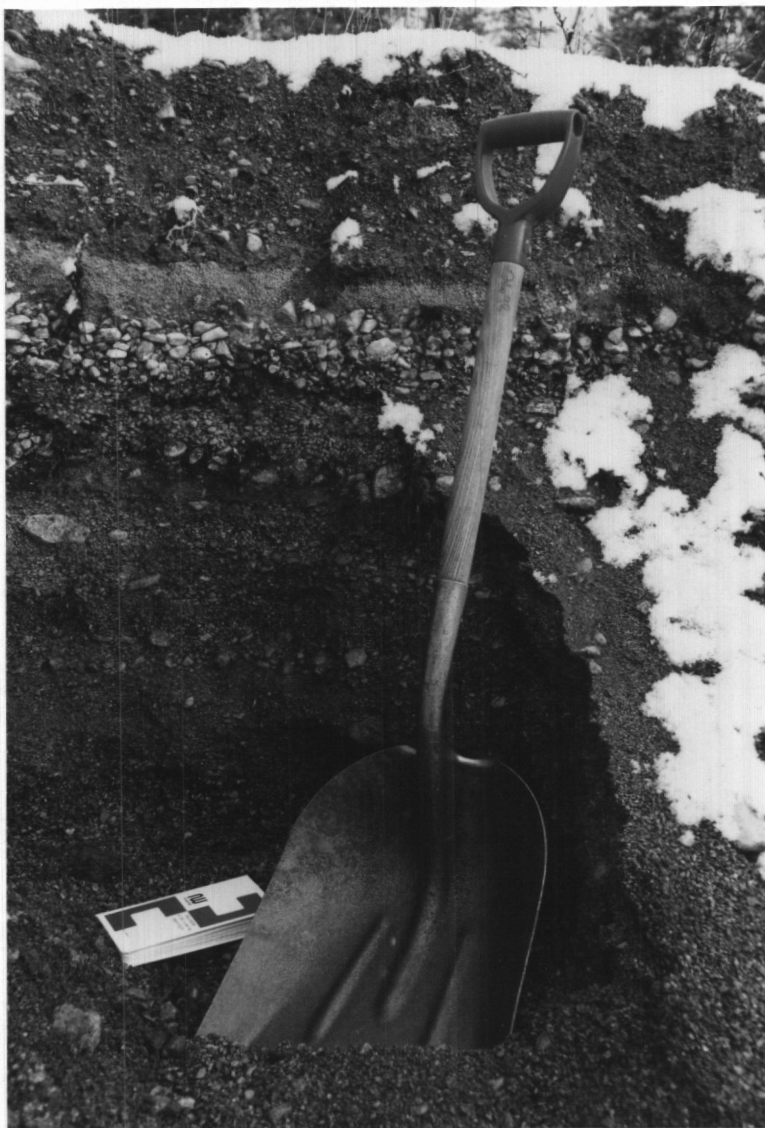
PHOTO 2: Foxhole South (Berton's) Pit, Deposit 5-69. In situ gravelly sand exposed at east end of existing pit.

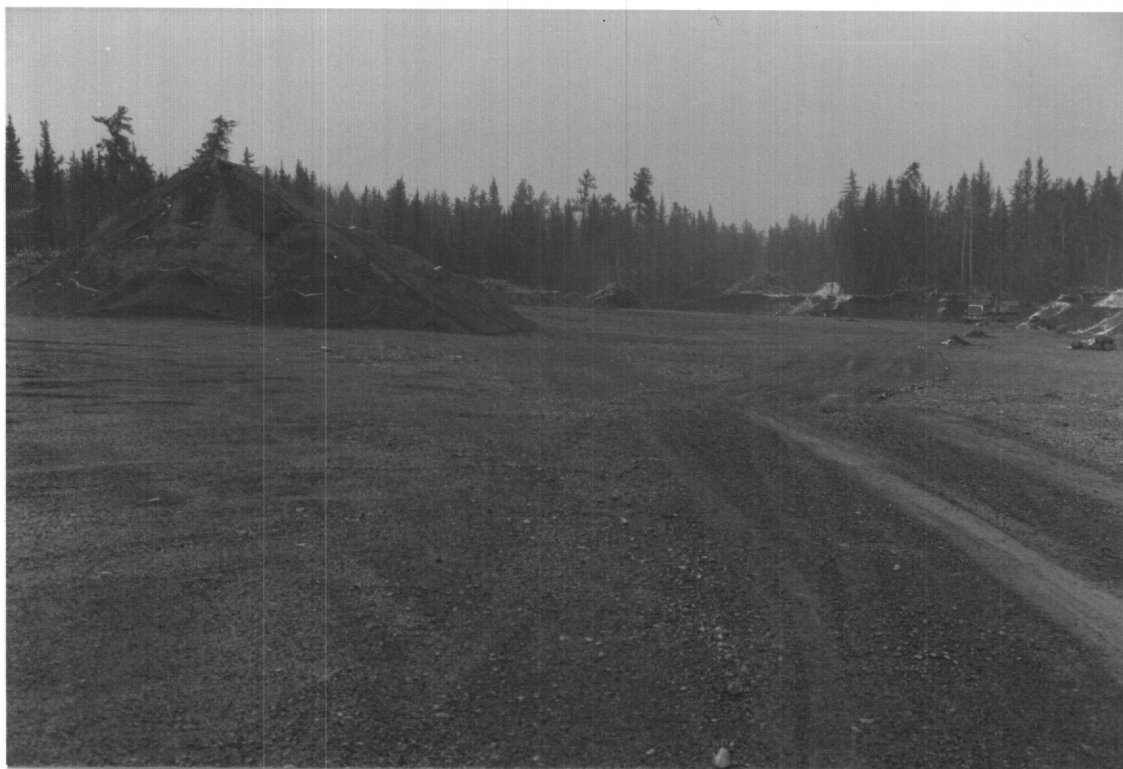
PHOTO 8: Salt Mountain North Pit, Deposit 5-69. General view of pit (towards the north).

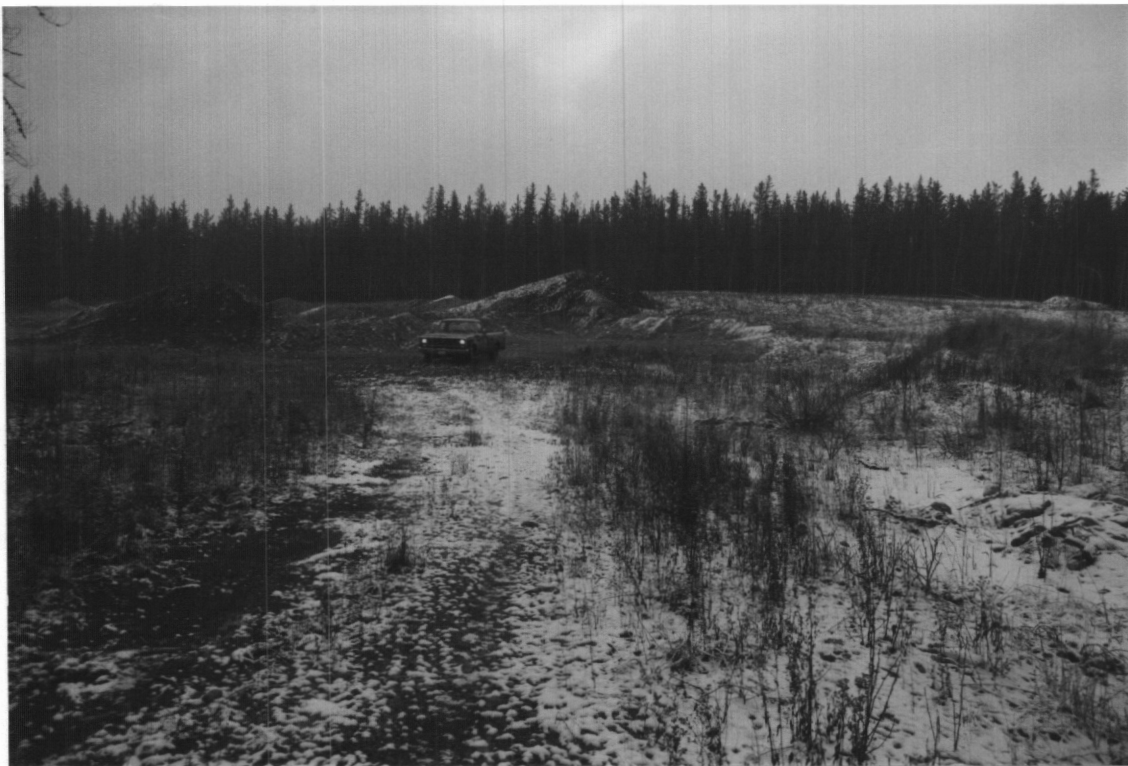
PHOTO 9: "Forestry Lookout" Pit, Deposit 5-70. Abandoned pit on north side of Highway 5 contains gap graded cobbly sand. The granular materials appear to be very shallow.

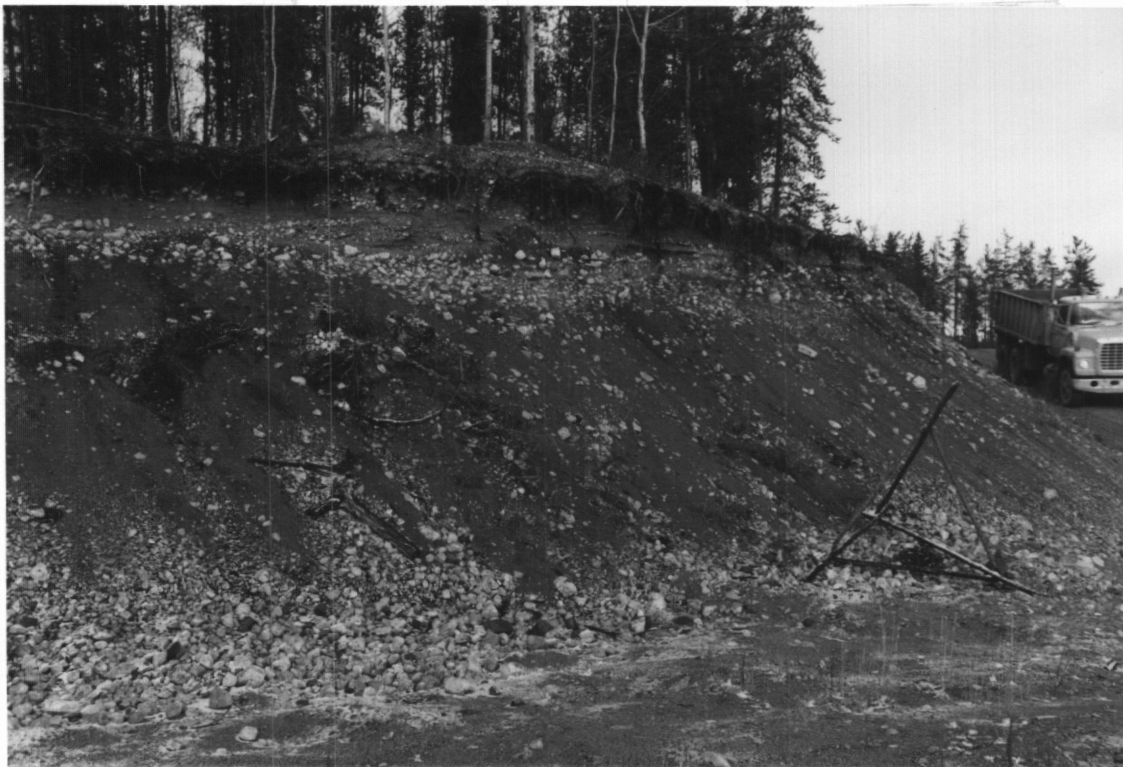
PHOTO 10: Salt Mountain DPW Pit (Km 232.5), Deposit 5-70. Exposure along north pit wall shows typical sandy gravel material.

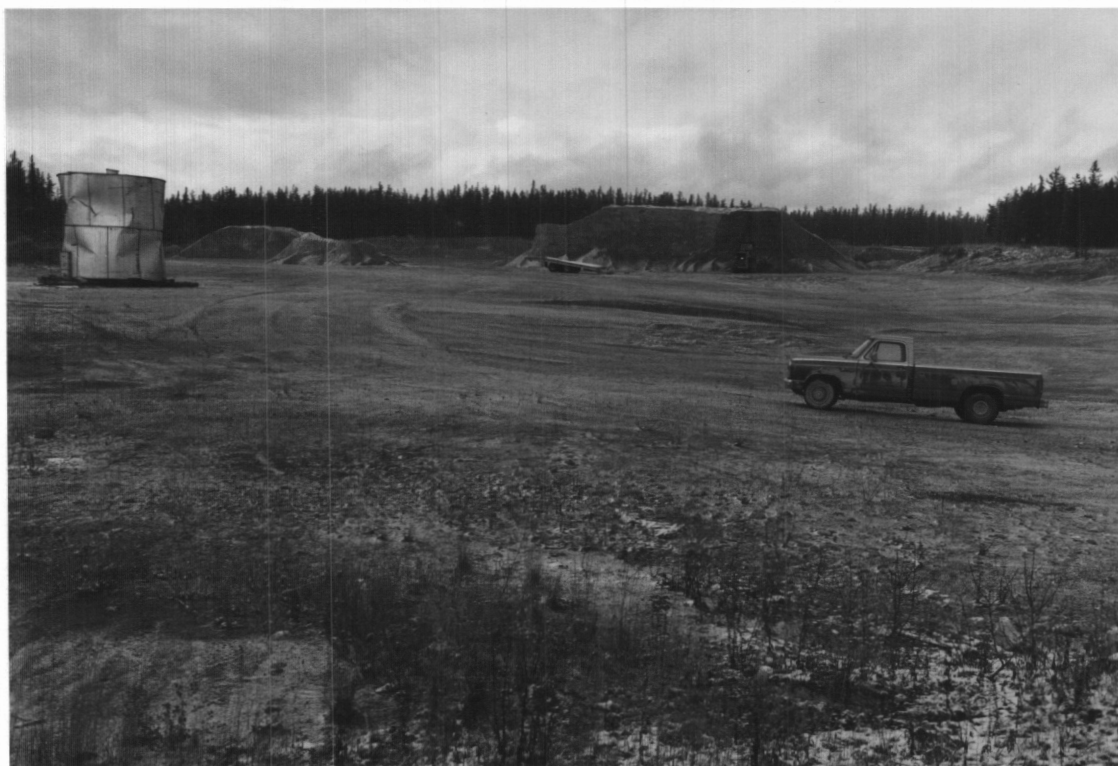
PHOTO 11: Salt Mountain DPW Pit (km 232.5), Deposit 5-70. General view of pit area.

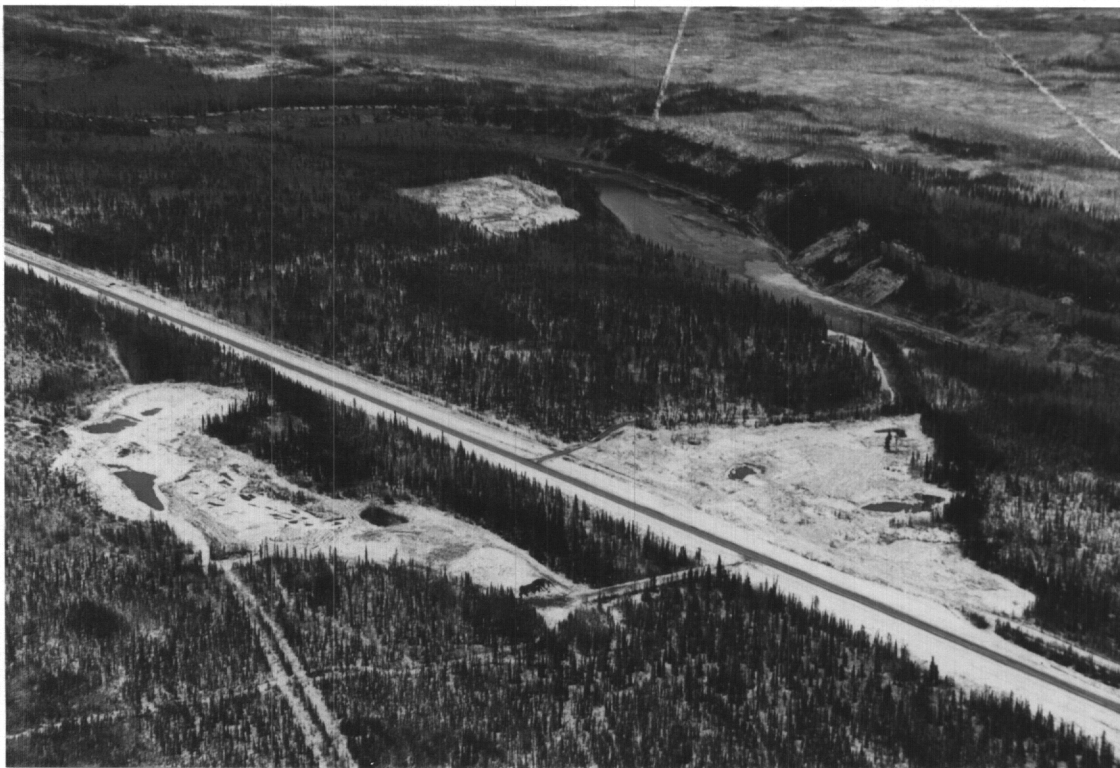
PHOTO 19: Deposit 1-16 (DPW km 77.2). Sand from this source is being blended, on an experimental basis, with crushed limestone from Deposit 1-15, to produce aggregate for highways maintenance.

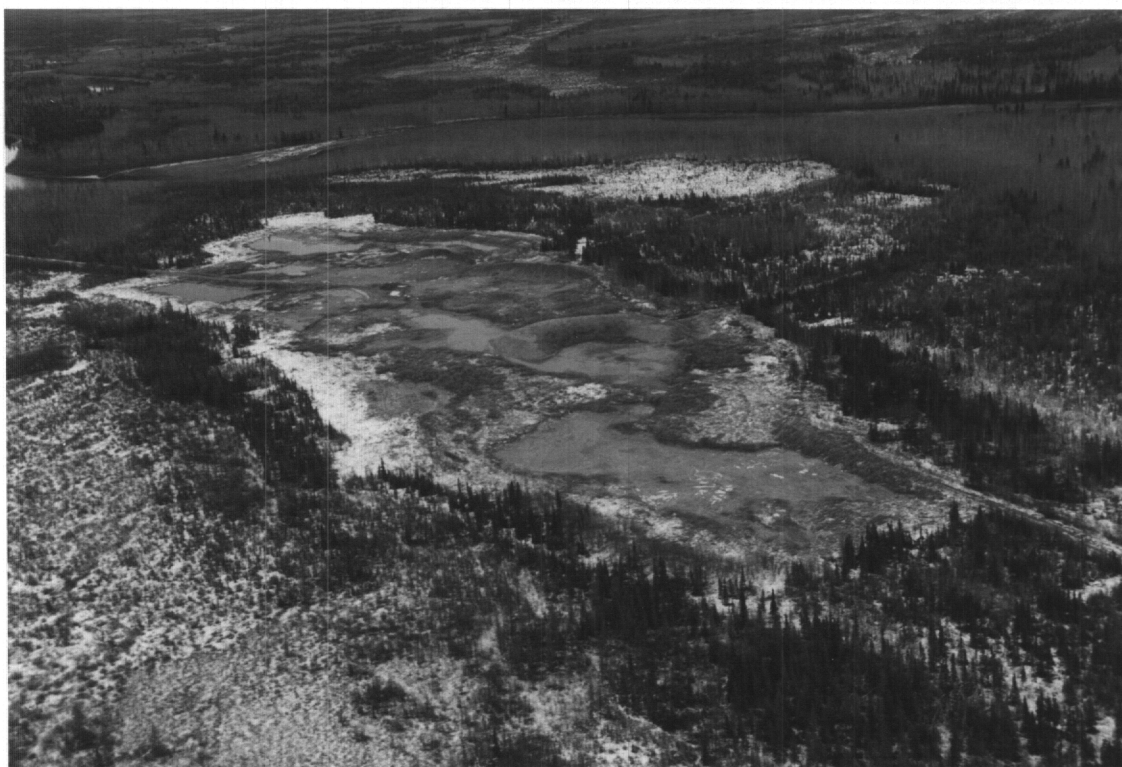
PHOTO 22: Depleted site of Deposit 1-11, now used as a crushing and stockpile site by DPW.

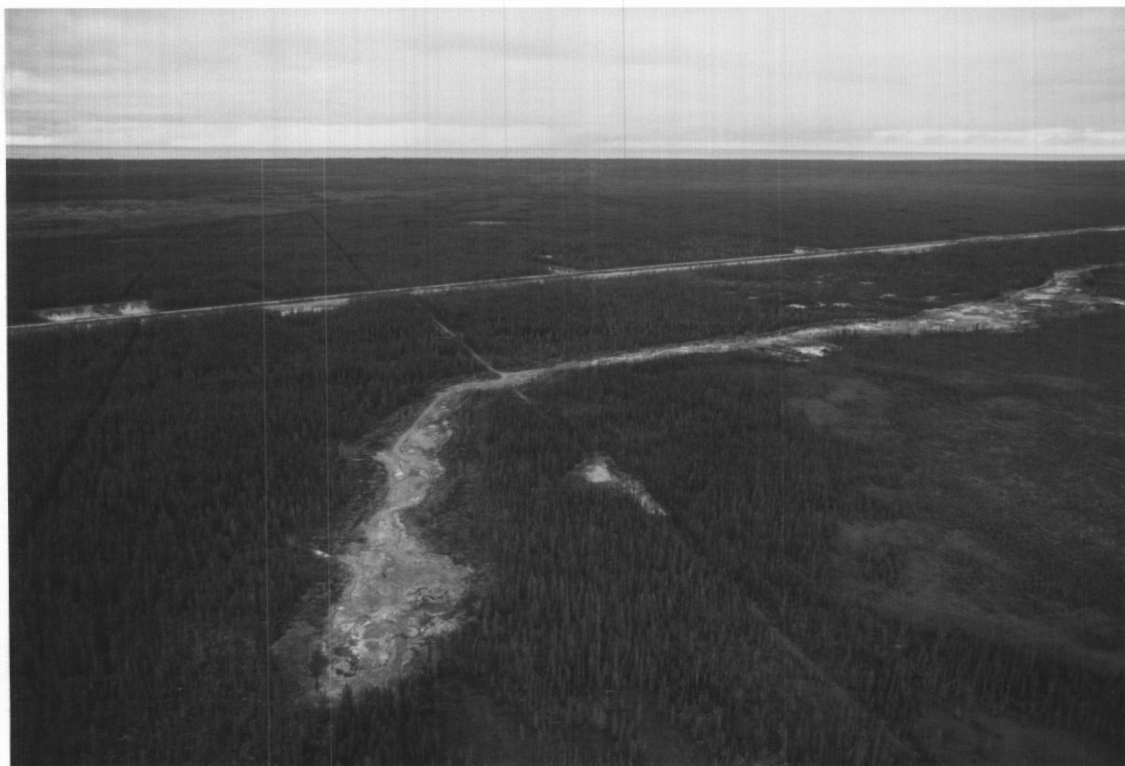
PHOTO 27: View to northeast along axis of depleted eastern section of Deposit 5-11 (HR-107A). Some ponded water is visible.

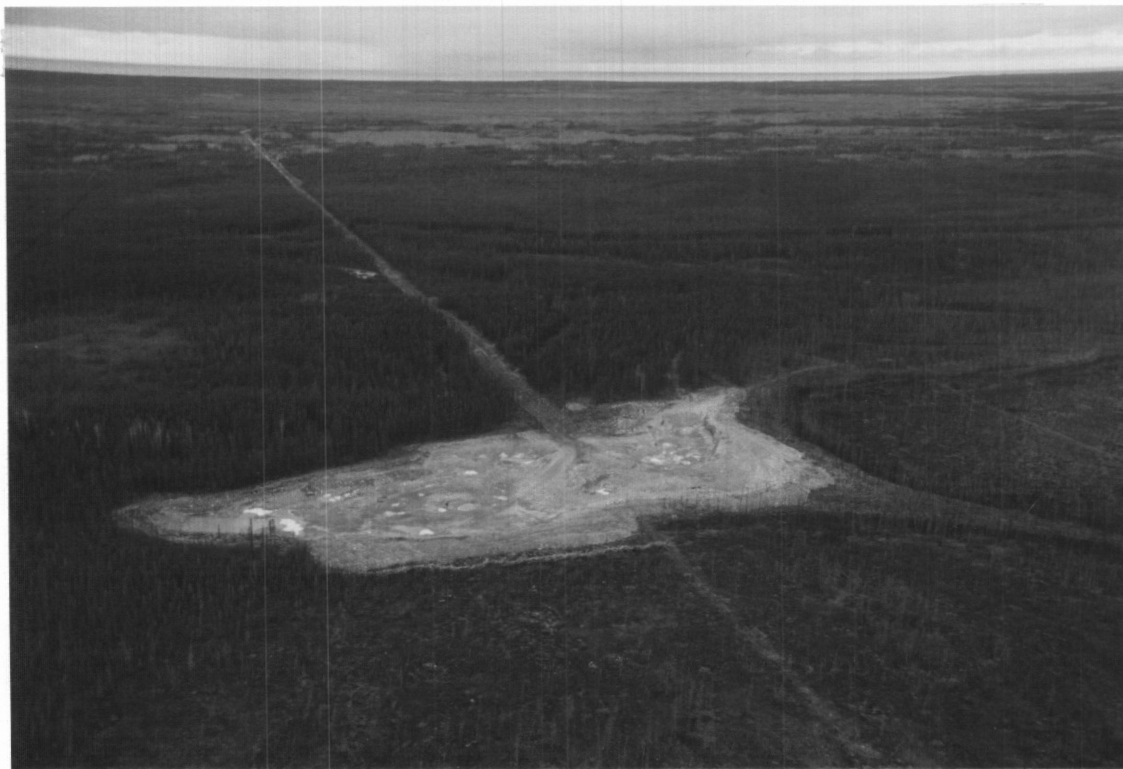
PHOTO 29: Deposit 5-14 (HR-124A), showing pit opened in winter 1986-1987 by DPW. The glacial till that underlies the granular aggregate is visible (as blue area) on pit floor to left.

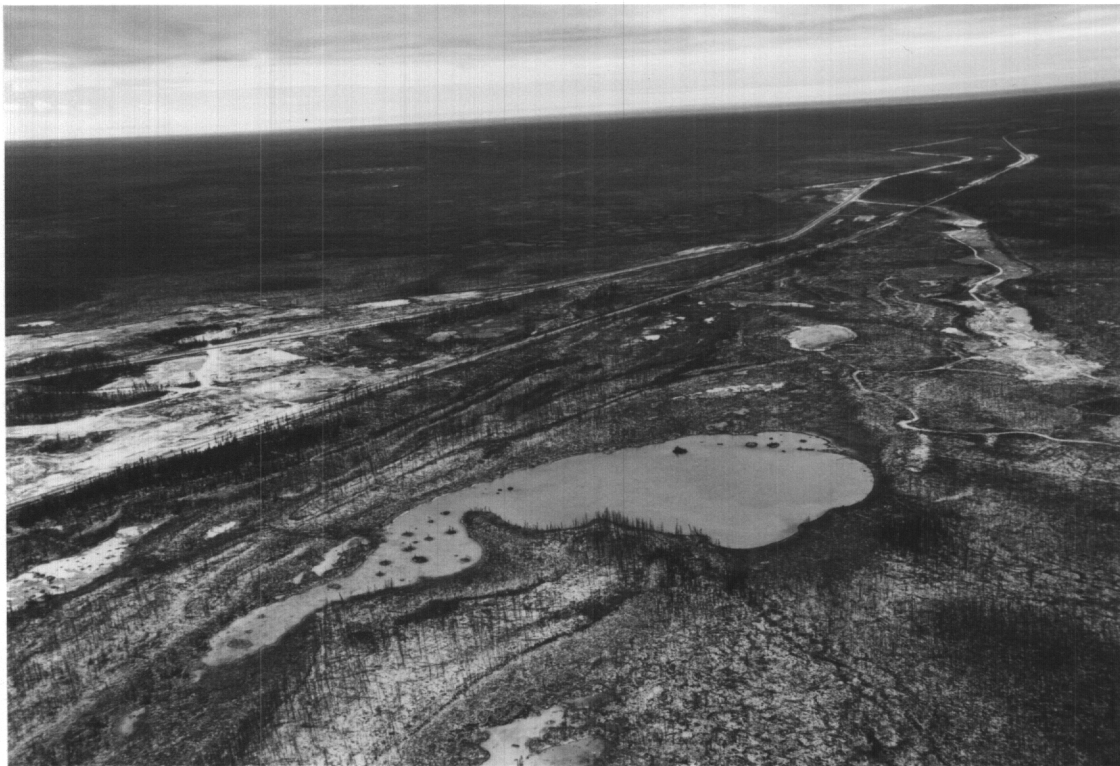
PHOTO 31: Deposit 5-19 (HR-119, 121 and 122; Mile 21), showing a series of depleted pit areas adjacent to Highway 5 at west end of source.

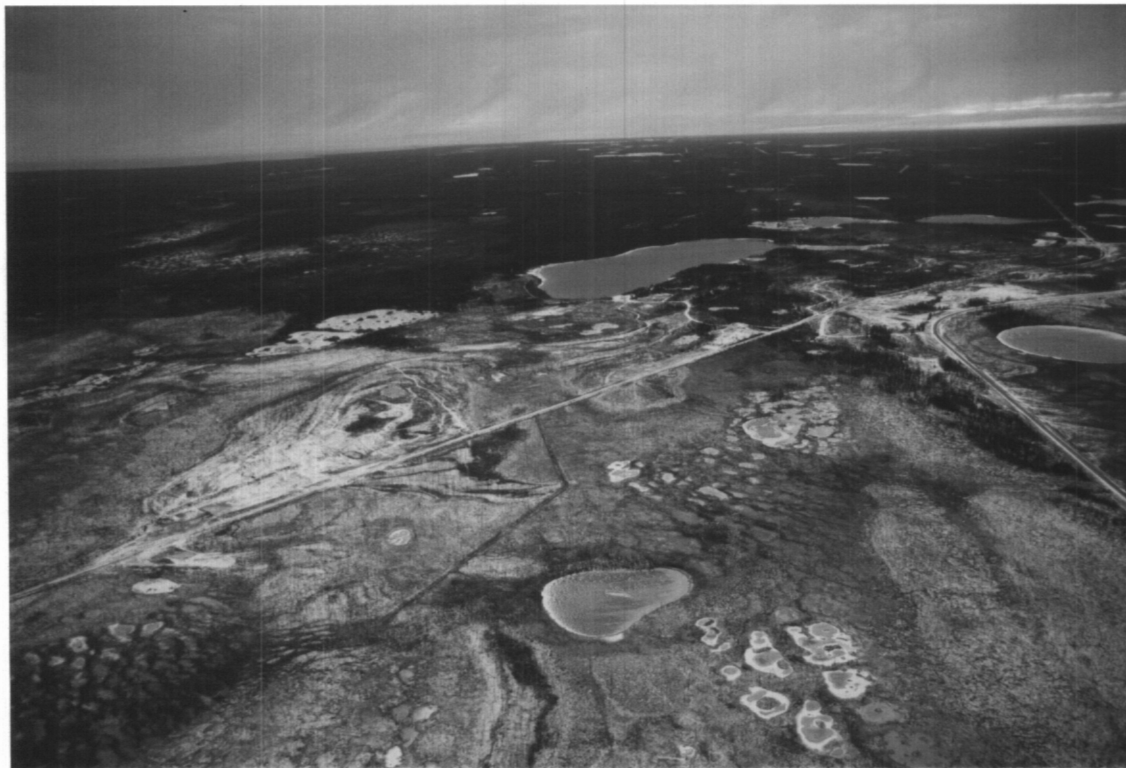
PHOTO 35: View to the northeast across Deposit 5-29 (Mile 31) towards Polar Lake. A number of abandoned pits are visible along the railway.

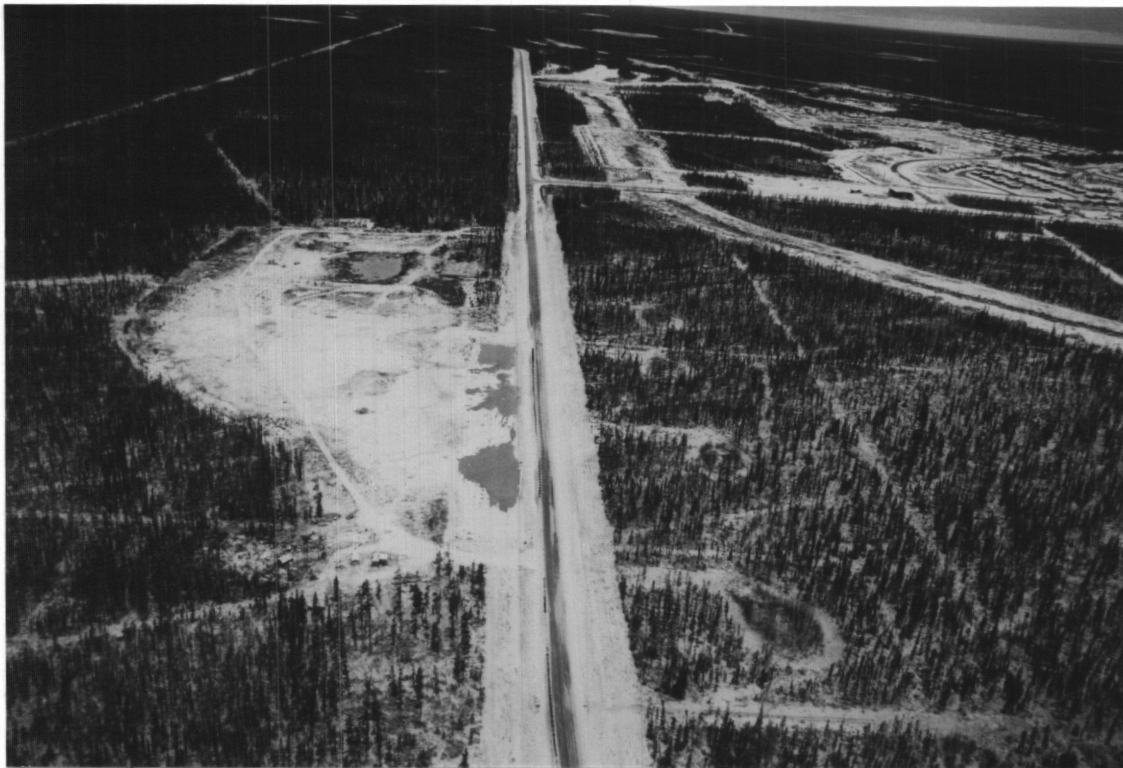
PHOTO 47: Depleted Deposit 6-10, along Highway 6 to the southwest of Pine Point.

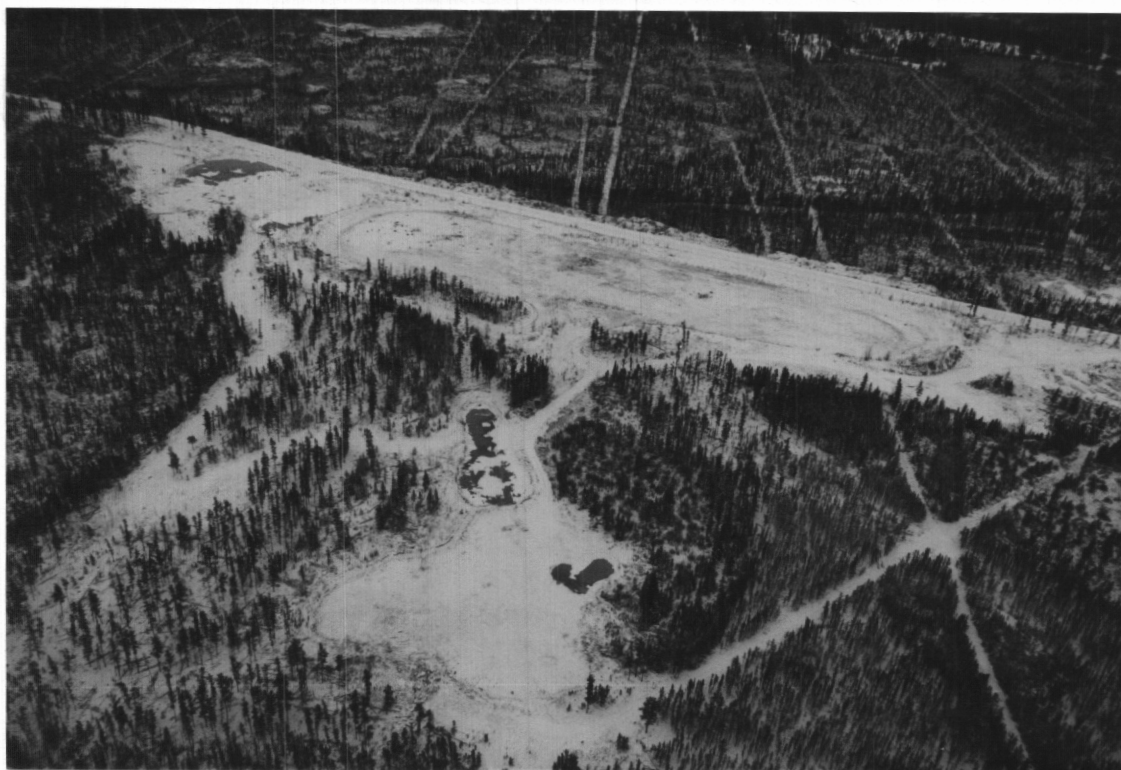
PHOTO 48: Deposit 6-11 (Town of Pine Point pit), showing depleted pit area closest to community.

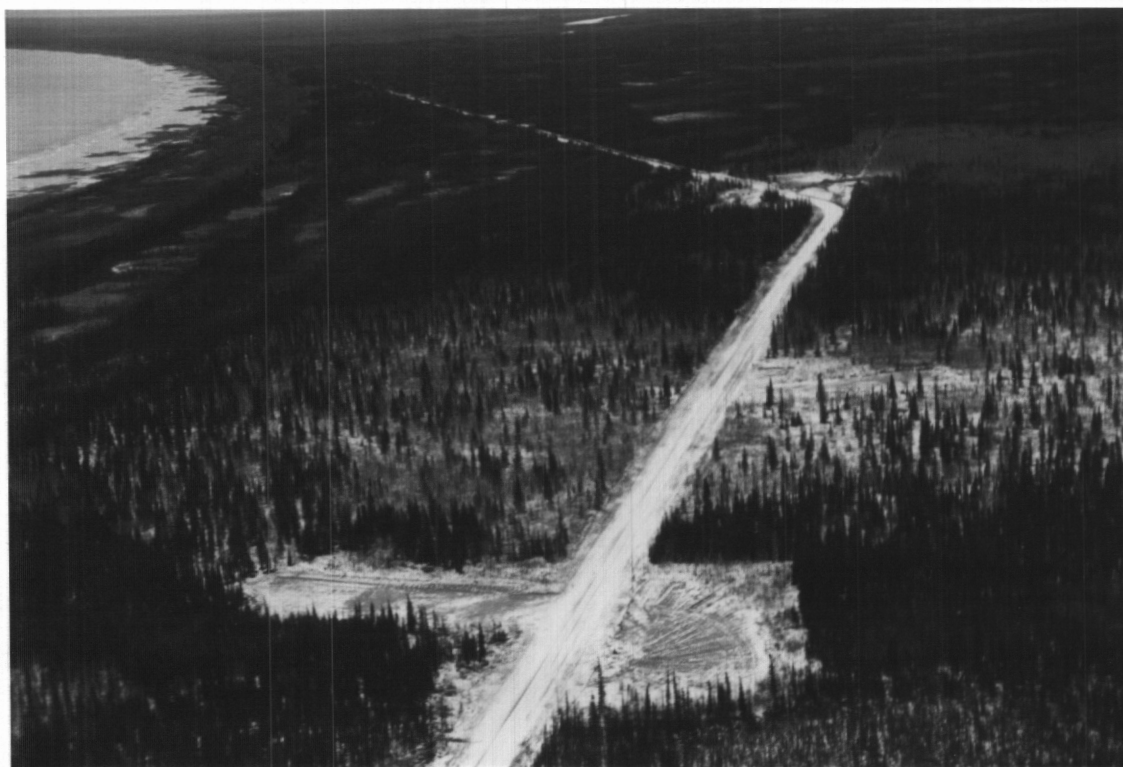
PHOTO 52: Deposit 6-20, showing road side pits developed for highway maintenance material.

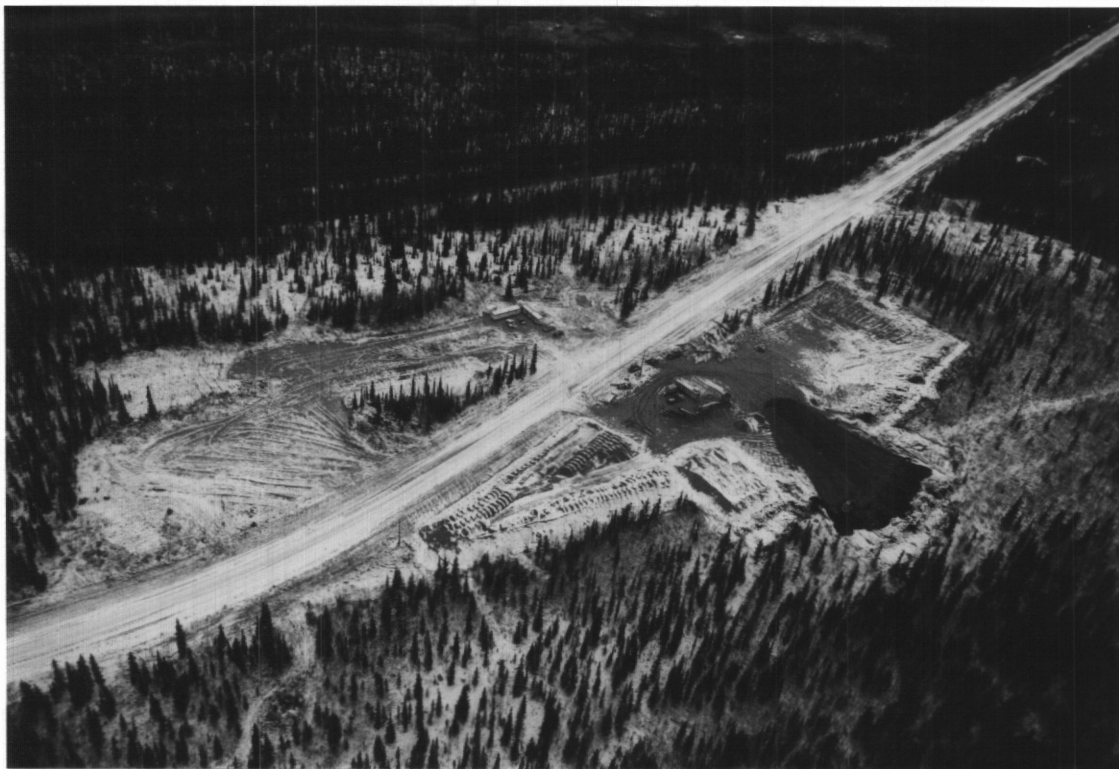
PHOTO 53: Active pit area, Deposit 6-20. Material is being extracted for use in highways maintenance.

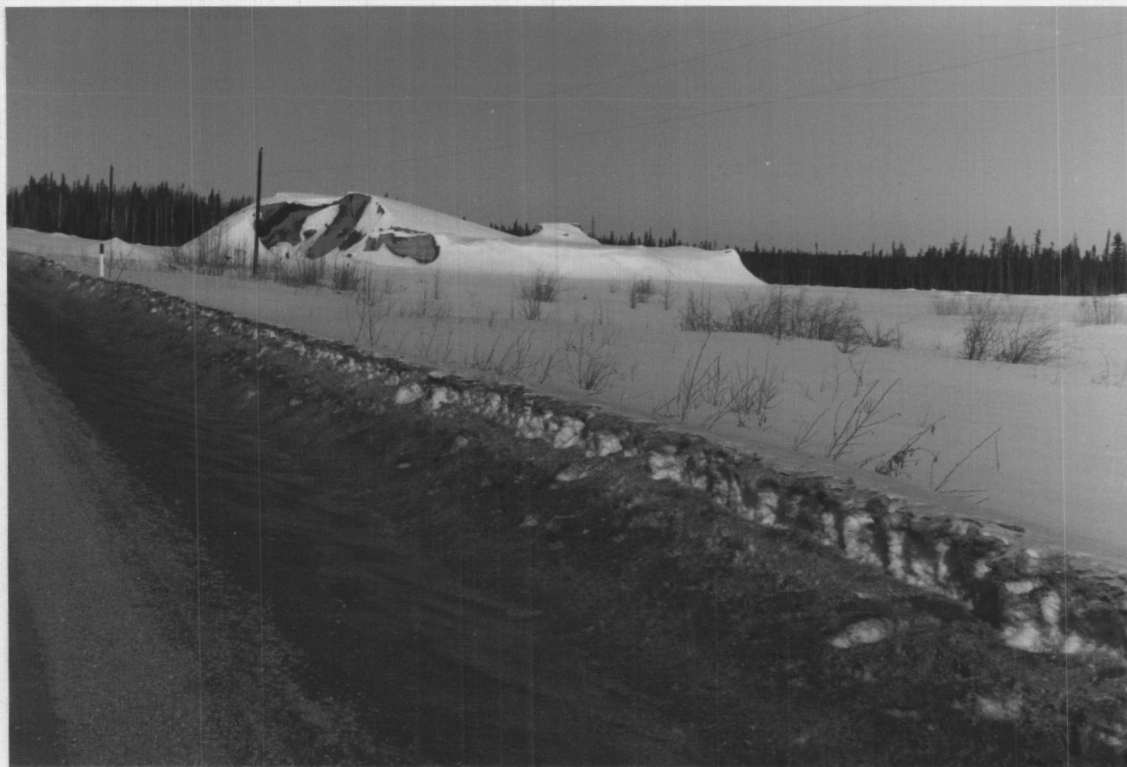
5. Deposit 1-17 (HR-100): View to west from Highway 1 to Highways Department crush stockpile in depleted area of deposit.

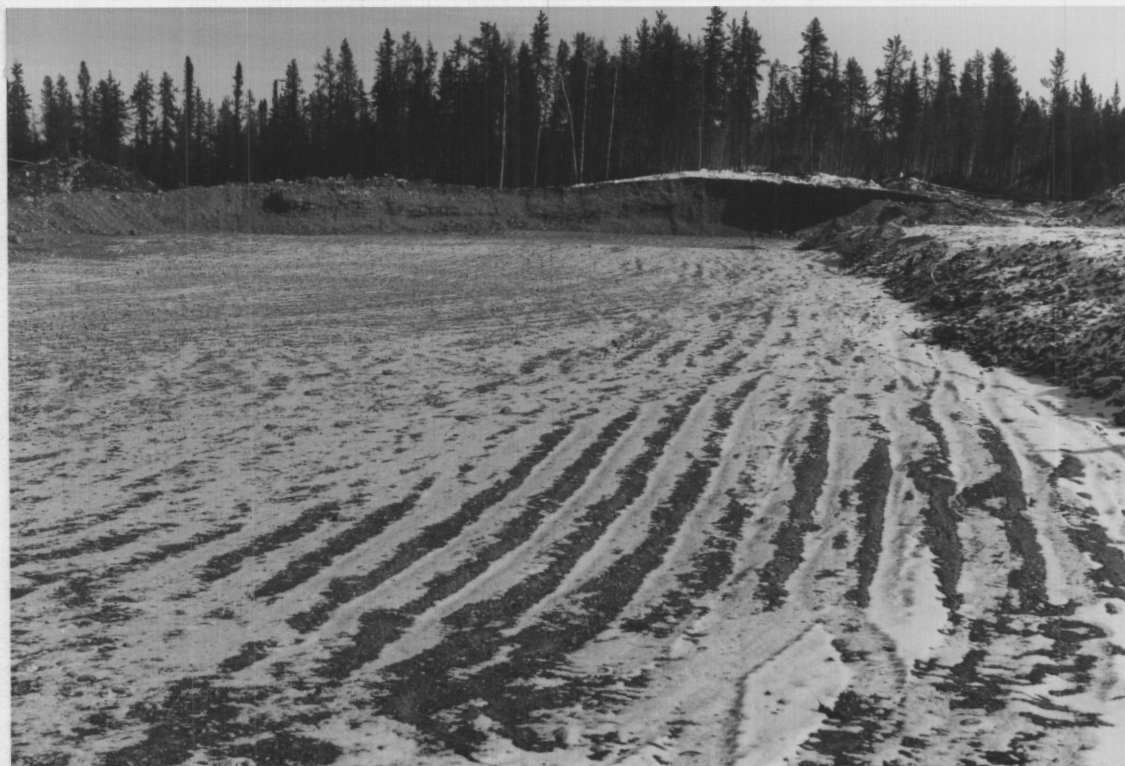
10. Deposit 5-6 (HR-109A): View to east of recently-excavated pit within eastern part of deposit.

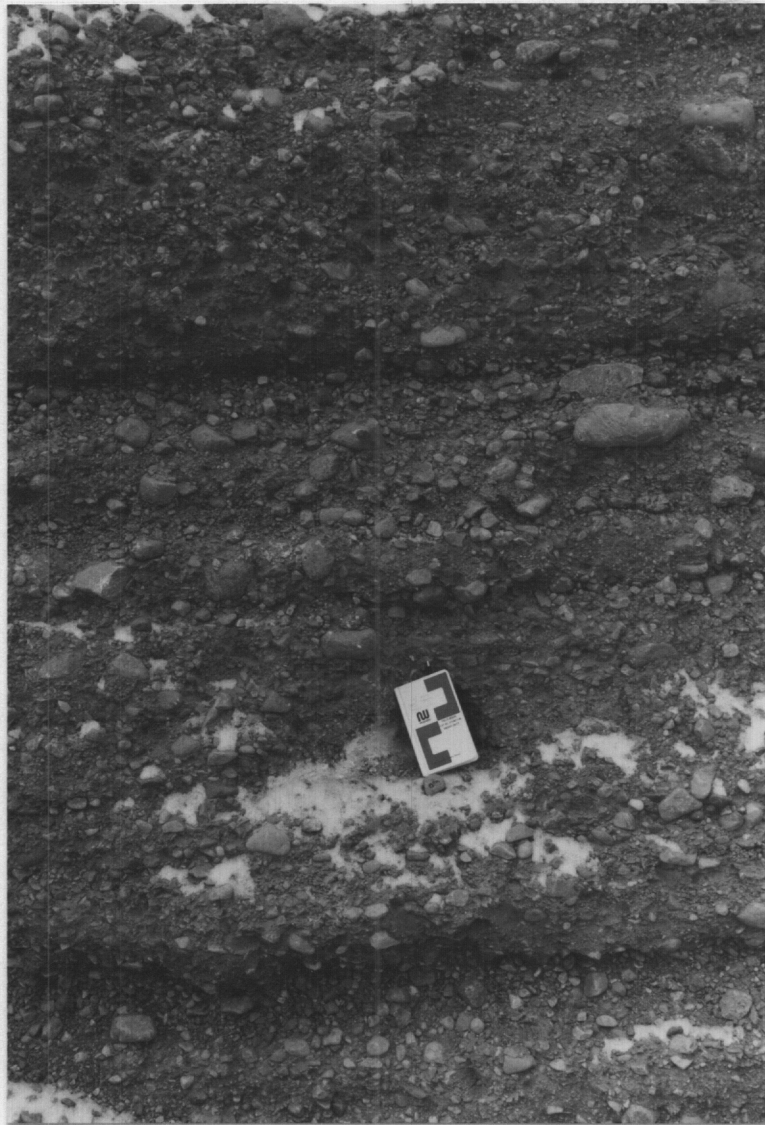
21. Deposit 5-14 (HR-124A): Close-up of access ramp exposure.

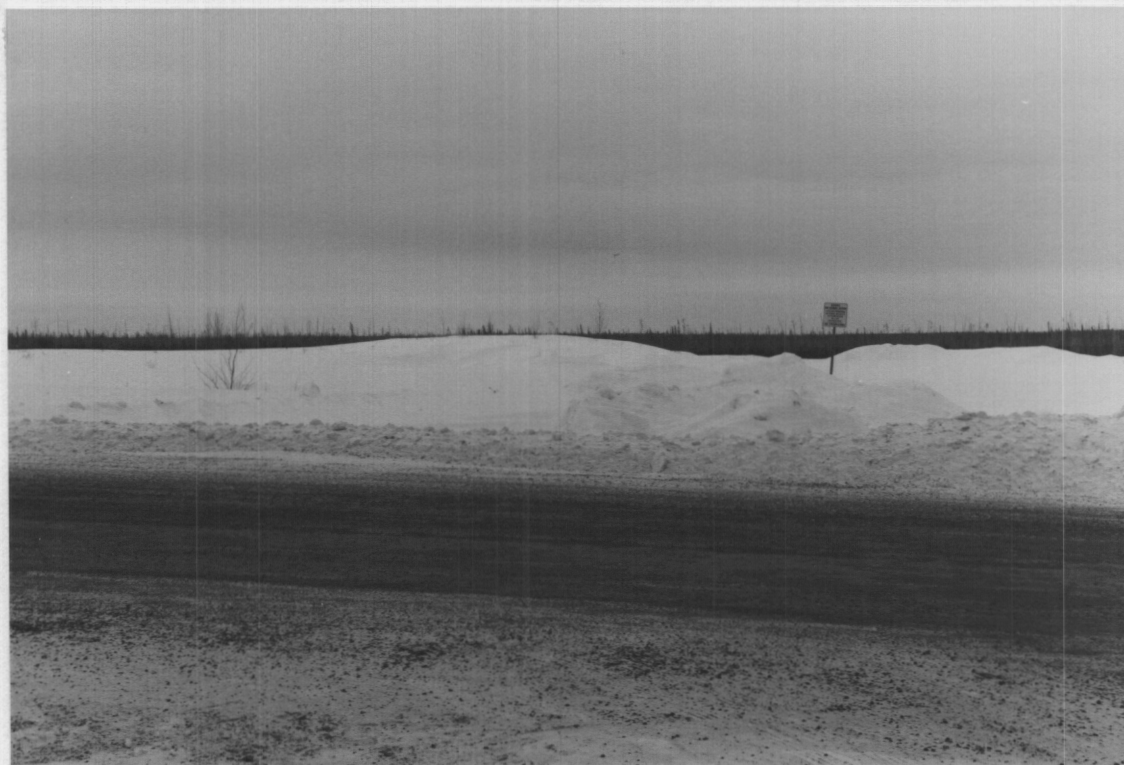
29. Abandoned Highways Department pit on west side of Highway 5, at km 64.5
